Clacton and Holland-on-Sea Beach Monitoring Report

13 December 2017

Tendring District Council
Town Hall,
Station Road,
Clacton-on-Sea,
Essex,
CO15 1SE

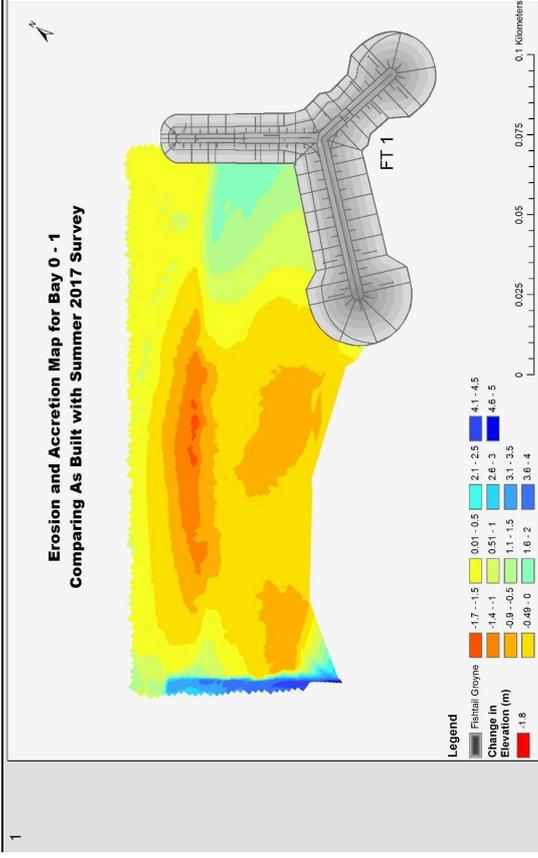
- Highest erosion at berm, over 1.8m decrease in beach elevation.
- Accretion highest behind the FT1 at 1.6m-2m increase in elevation.
- As this bay has only one rock groyne erosion is occurring in the middle and to the south (close to the pier) and thus a typical bay shape has not formed.

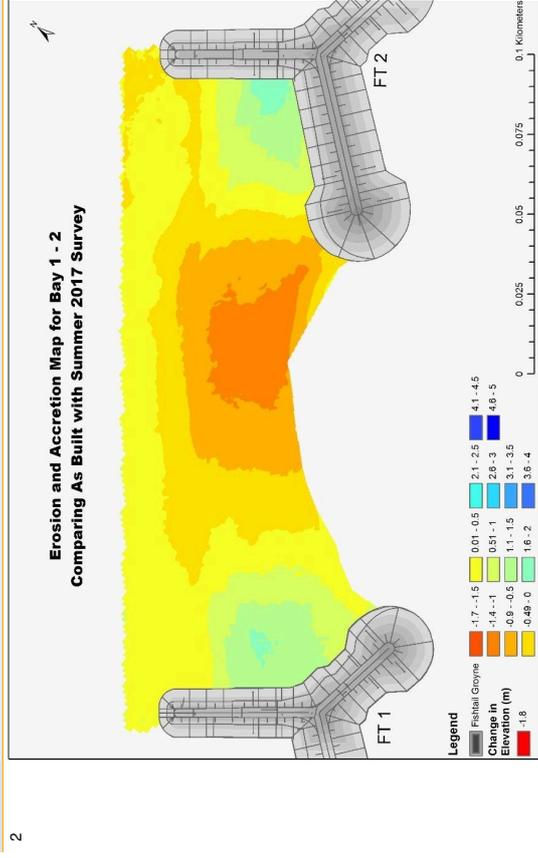
- Highest erosion at centre of bay, by 1m-1.4m decrease in beach elevation.
- Accretion highest behind FT2 at 1.6m-2m increase in elevation.
- FT 2 has a larger area of accretion adjacent to it than FT1.

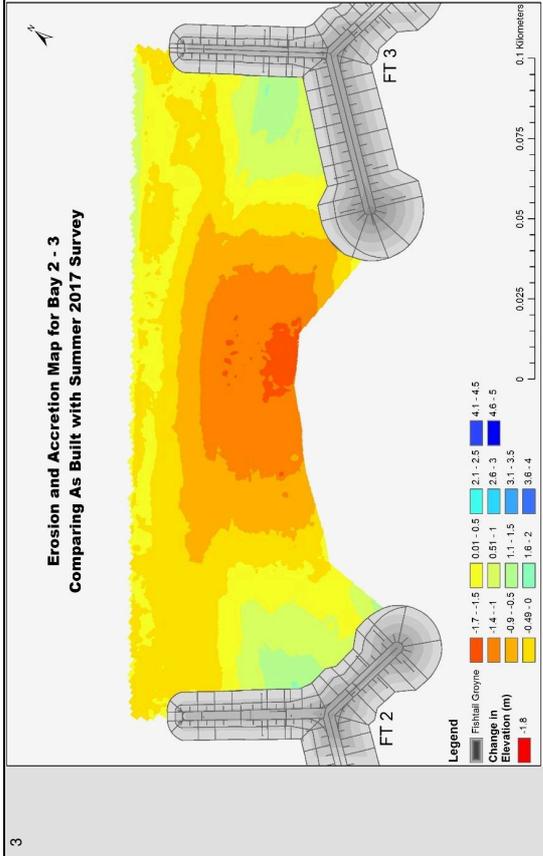
- Highest erosion at centre of bay ,by 1.5-1.7m decrease in beach elevation.
- Accretion highest behind FT2 at 1.1m-1.5m increase in elevation.
- FT 3 has a larger area of accretion adjacent to it than FT 2.

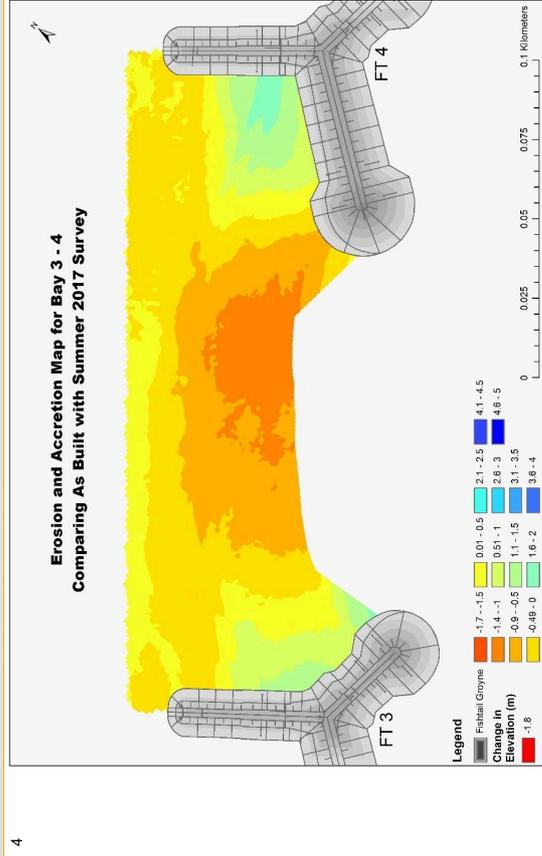
- Highest erosion at centre of bay ,by 1m-1.4m decrease in beach elevation.
- Accretion highest behind FT4 at 1.6m-2m increase in elevation.
- FT 4 has a larger area of accretion adjacent to it than FT 3.

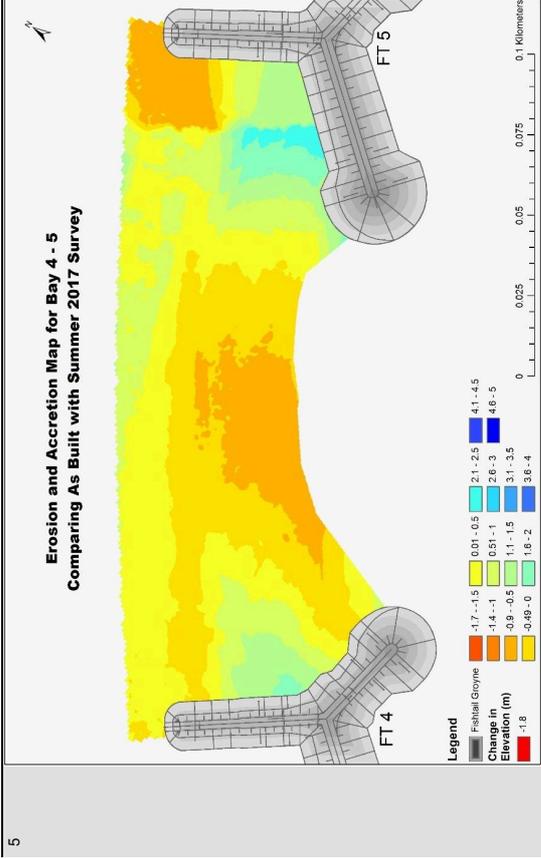
- Highest erosion at centre of bay and around the top of the shore connected arm of FT5, by 0.5m-0.9m decrease in beach elevation.
- Erosion has occurred closer to FT 4, this could be due to the outfall close to FT 4 causing increased scour in this area.
- Accretion highest behind FT5 at 2.1m-2.5m increase in elevation.
- FT 5 has a larger area of accretion adjacent to it than FT 4.
- The cause of erosion at the top of the shore connected arm of FT5, is unknown and should be monitored in future surveys.

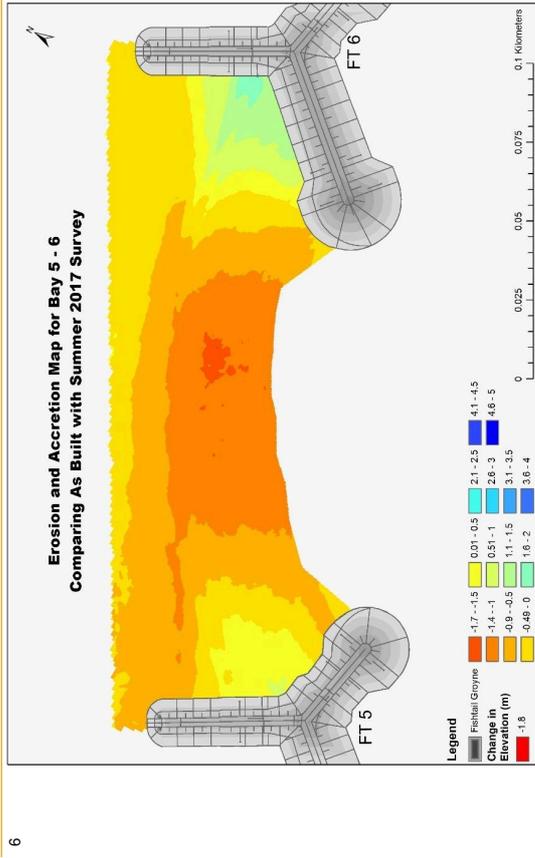
- Highest erosion at centre of bay and higher up the beach, by 1.5m-1.7m decrease in beach elevation.
- There is also significant erosion high up the beach around the top of the shore connected arm of FT5. The reason for this is unknown, but should be monitored in future surveys
- Accretion highest behind FT6 at 1.6m-2m increase in elevation.
- FT 6 has a larger area of accretion adjacent to it than FT 5.

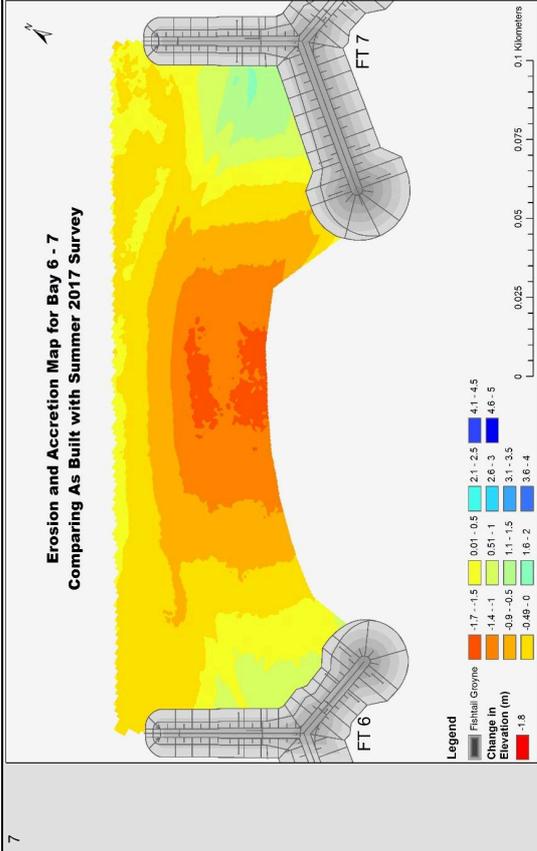
- Highest erosion at centre of bay, by 1.5m-1.7m decrease in beach elevation.
- Accretion highest behind FT7 at 1.6m-2m increase in elevation, but with a more general high of 1.1m-1.5m.
- FT 7 has a larger area of accretion adjacent to it than FT 6.

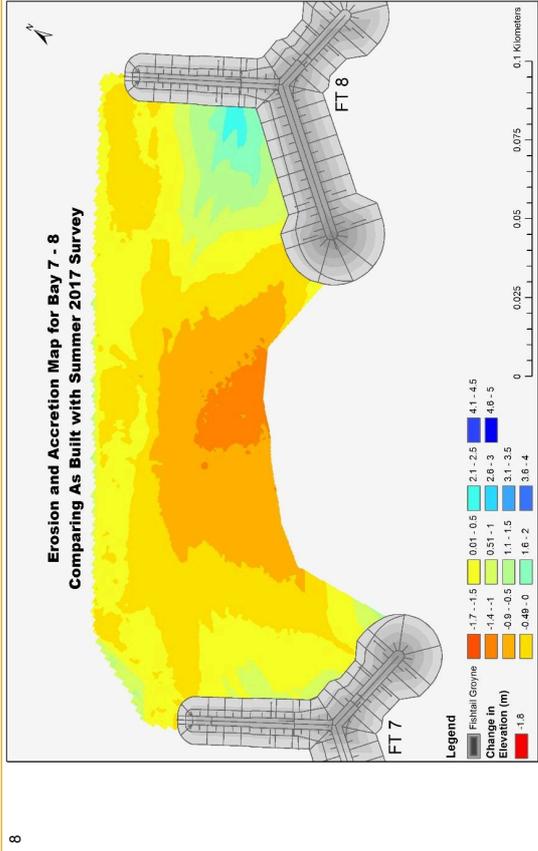
- Highest erosion at centre of bay, by 1.5m-1.7m decrease in beach elevation.
- There is a larger area of erosion near to FT7 and this is likely due to the promenade being set back within this bay and the beach adjusting to this.
- Accretion highest behind FT8 at 2.1m-2.5m increase in elevation, but with a more general high of 1.1m-1.5m.
- FT 8 has a larger area of accretion adjacent to it than FT 7.

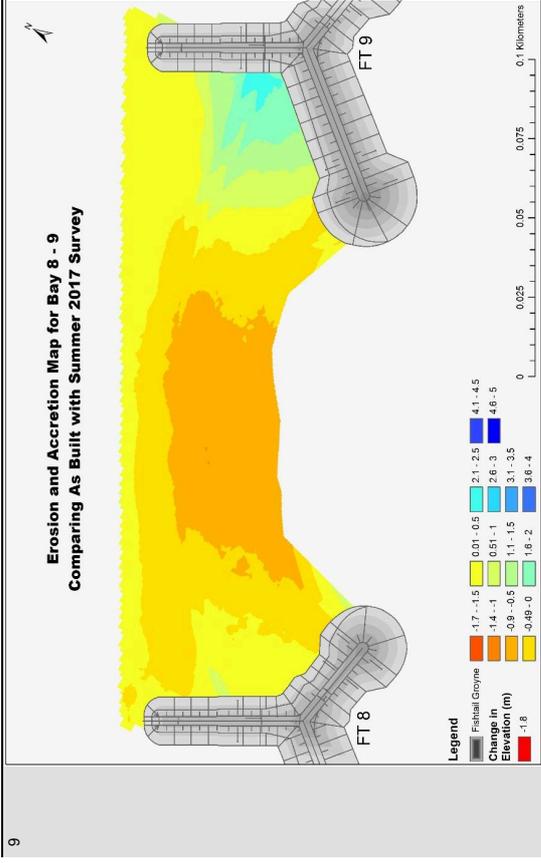
- Highest erosion at centre of bay ,by 0.5m-0.9m decrease in beach elevation.
- However, erosion has occurred slightly closer to FT 8 unlike all the other bays along the frontage. This is likely due to the slight change in orientation at this point along the frontage.
- Accretion highest behind FT9 at 2.1m-2.5m increase in elevation.
- FT 9 has a larger area of accretion adjacent to it than FT 8.

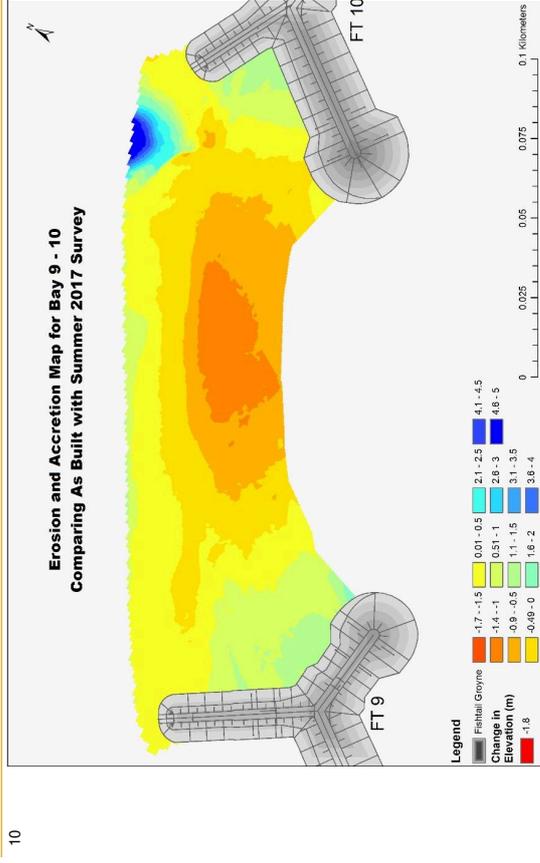
- Highest erosion at centre of bay ,by 1m-1.4m decrease in beach elevation.
- Accretion highest behind FT9 at 1.1m-1.5m increase in elevation, but with a more general high of 0.51m-1m.
- An area of high accretion can be seen near to the top of FT 10, but this is from a projecting manmade headland rather than the beach processes.
- Unlike the majority of bays along the frontage the largest area of accretion is behind the more southerly groyne FT9. This is likely due to the fact FT10 has a smaller shore connected arm and at a different orientation to the other groynes along the frontage and thus being less effective at trapping sediment.

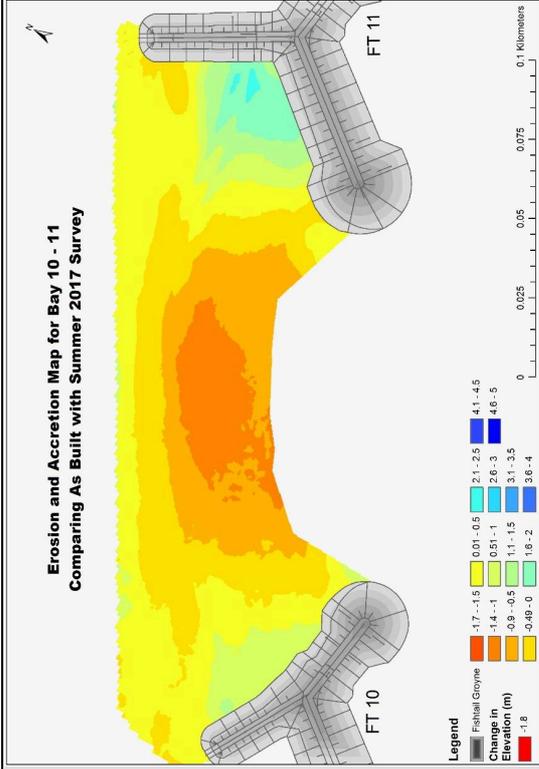
11

- Highest erosion at centre of bay ,by 1m-1.4m decrease in beach elevation.
- However, erosion is slightly skewed towards to FT 10, which is likely due to FT10 having a smaller shore connected arm and at a different orientation to the other groynes along the frontage and thus being less effective at trapping sediment.
- Accretion highest behind FT11 at 2.1m-2.5m increase in elevation, but with a more general high of 1.6m-2m.

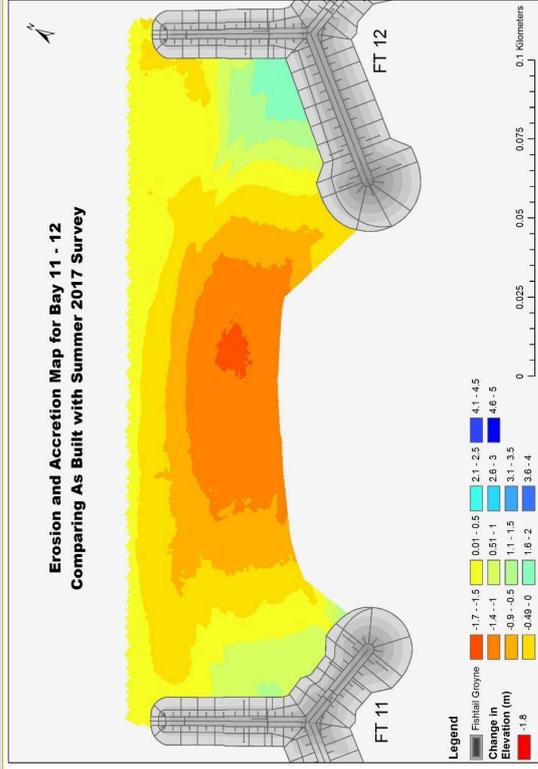
- Highest erosion at centre of bay ,by 1.5m-1.7m decrease in beach elevation.
- Accretion highest behind FT12 at 1.6m-2m increase in elevation.
- FT 12 has a larger area of accretion adjacent to it than FT 11.

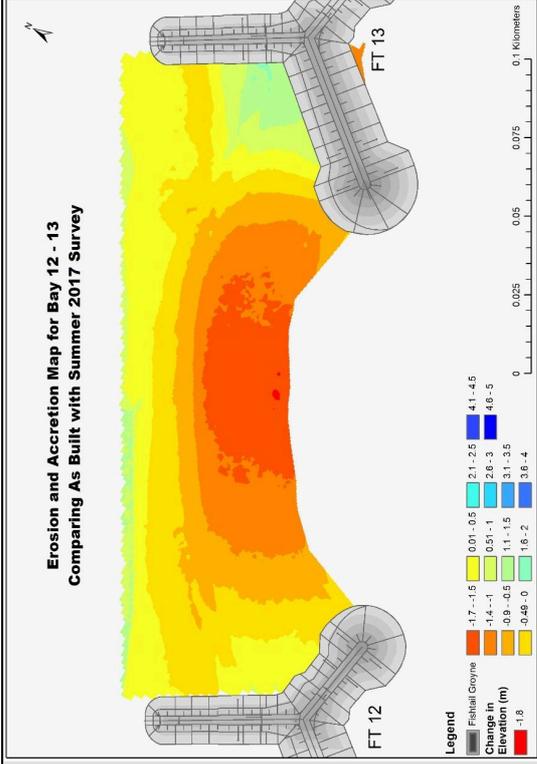
- The highest level of erosion is experienced right at the centre of the bay with over 1.8m decrease in elevation, though a more general 1.7-1.5m decrease in elevation has occurred at the centre of bay overall.
- Accretion highest behind FT13 at 1.1m-1.5m increase in elevation.
- FT 13 has a larger area of accretion adjacent to it than FT 12.

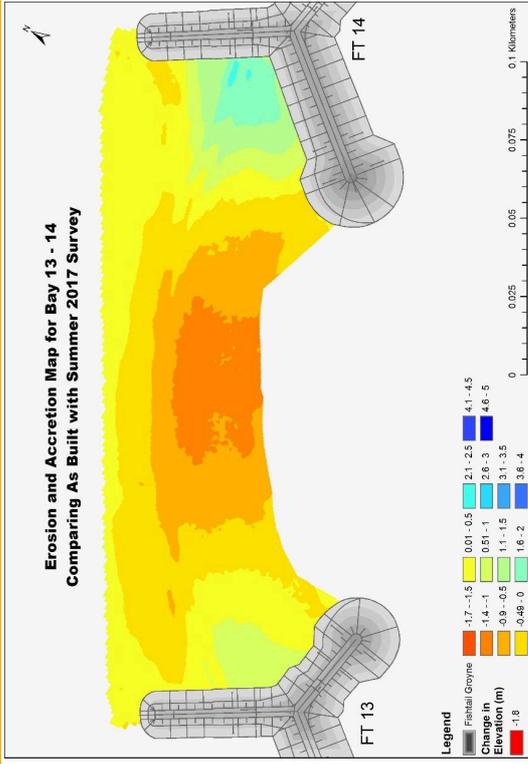
- Highest erosion at centre of bay, by 1m-1.4m decrease in beach elevation.
- Accretion highest behind FT14 at 2.1m-2.5m increase in elevation, but with a more general high of 1.6-2m
- FT 14 has a larger area of accretion adjacent to it than FT 13.

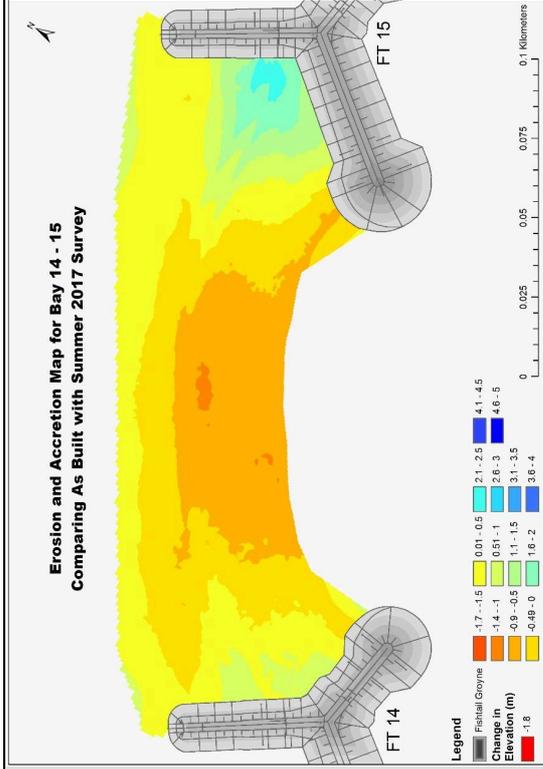
- The highest level of erosion is experienced at the centre of the berm by 1.4-1m decrease in elevation, though a more general 0.5-0.9m decrease in elevation has occurred at the centre of bay overall.
- Accretion highest behind FT15 at 2.1m-2.5m increase in elevation.
- FT 15 has a larger area of accretion adjacent to it than FT 14.

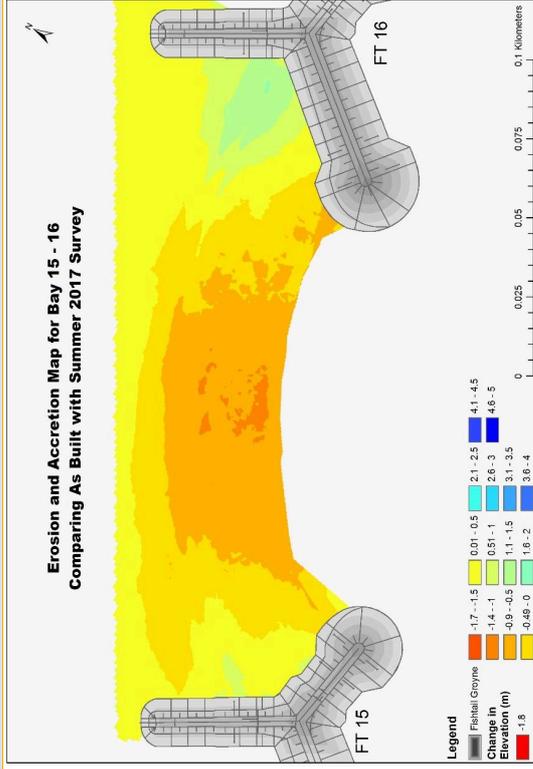
- The highest level of erosion is experienced right at the centre of the bay by 1.4-1m decrease in elevation, though a more general 0.5-0.9m decrease in elevation has occurred at the centre of bay overall.
- Accretion highest behind FT16 at 1.1m-1.5m increase in elevation.
- FT 16 has a larger area of accretion adjacent to it than FT 15.

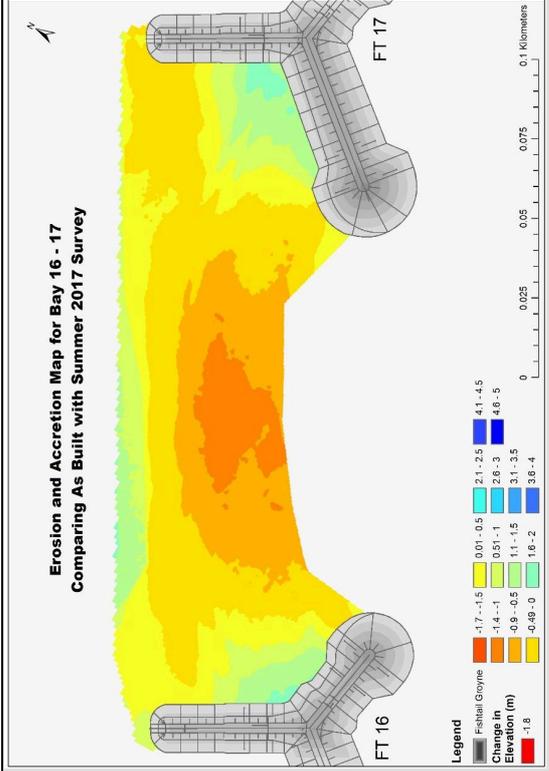
- Highest erosion at centre of bay, by 1.4m-1m decrease in beach elevation.
- Accretion highest behind FT17 at 2.1m-2.5m increase in elevation.
- FT 17 has a larger area of accretion adjacent to it than FT 16.

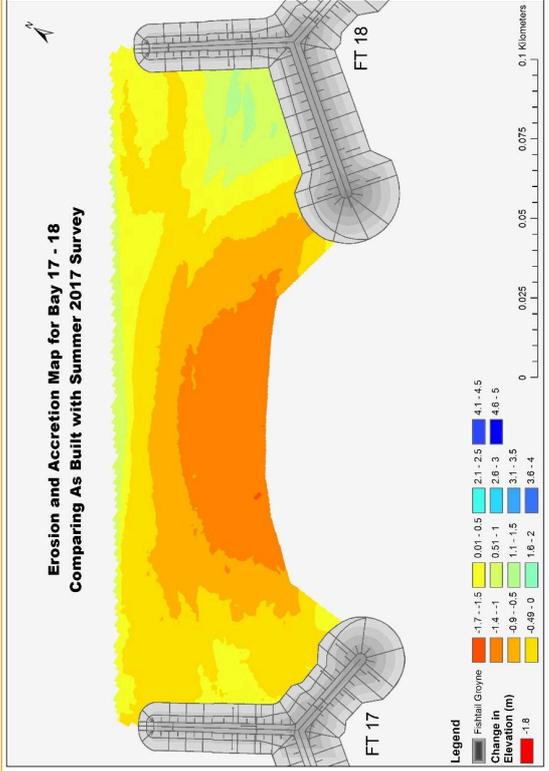
- Highest erosion at centre of bay, by 1.4m-1m decrease in beach elevation.
- Accretion highest behind FT18 at 1.1m-1.5m increase in elevation.
- FT 18 has a larger area of accretion adjacent to it than FT 17.

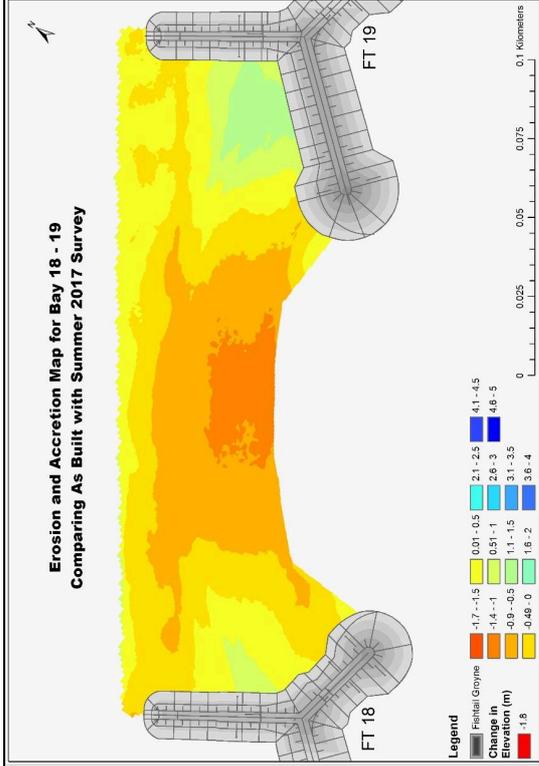
- Highest erosion at centre of bay , by 1.4m-1m decrease in beach elevation.
- Accretion highest behind FT19 at 1.1m-1.5m increase in elevation.
- FT 19 has a larger area of accretion adjacent to it than FT 18.

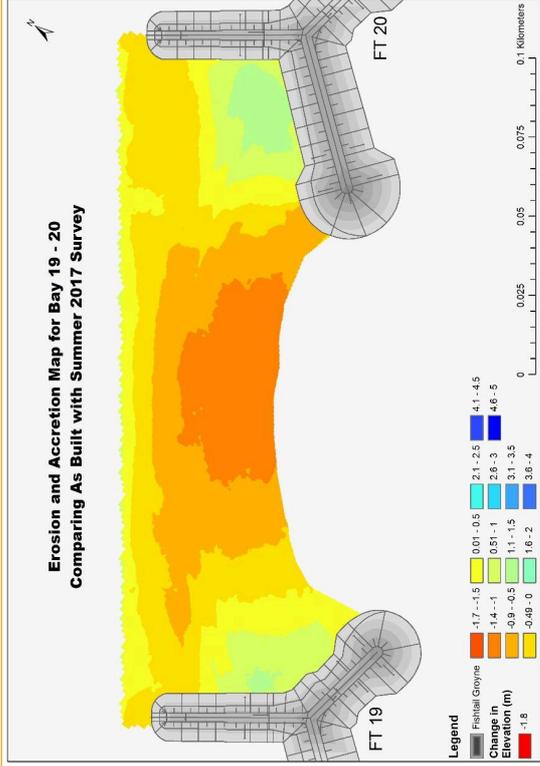
- Highest erosion at centre of bay , by 1.4m-1m decrease in beach elevation.
- Accretion highest behind FT20 at 1.1m-1.5m increase in elevation.
- FT 20 has a larger area of accretion adjacent to it than FT 19.

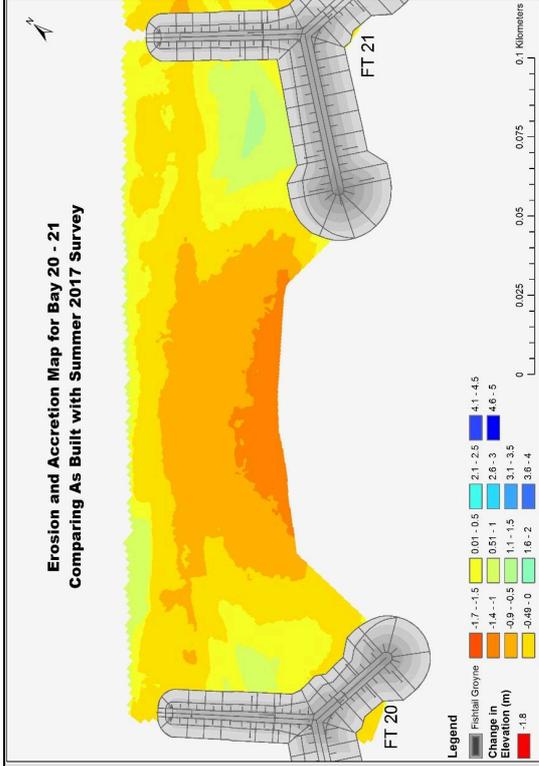
- Highest erosion at centre of bay , by 1.4m-1m decrease in beach elevation.
- Accretion highest behind FT21 at 1.1m-1.5m increase in elevation.
- FT 21 has a larger area of accretion adjacent to it than FT 20.

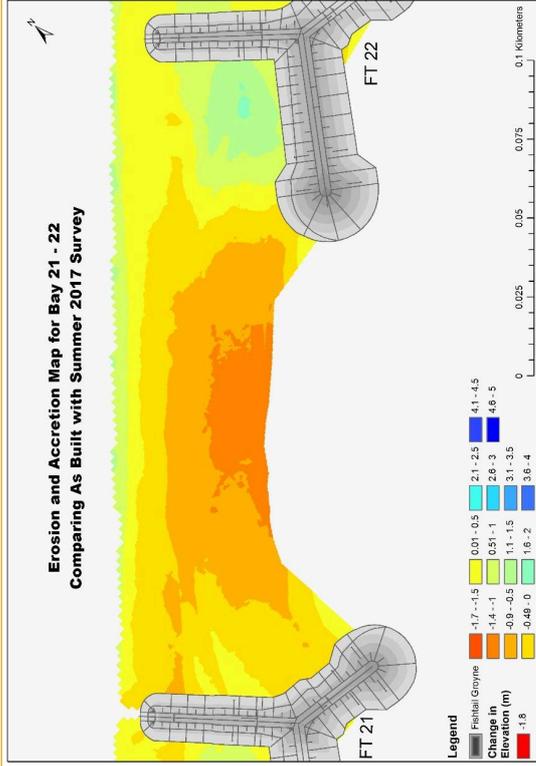
- Highest erosion at centre of bay , by 1.4m-1m decrease in beach elevation.
- Unlike other bays along the frontage FT21 has virtually no accretion around the shore connected arm. This is likely due to the slight change in orientation at this point along the frontage.
- Accretion highest behind FT22 at 1.6m-2m increase in elevation, but a with a more general high of 1.5m-1.1 m.
- FT 22 has a larger area of accretion adjacent to it and FT 21, which has minimal accretion.

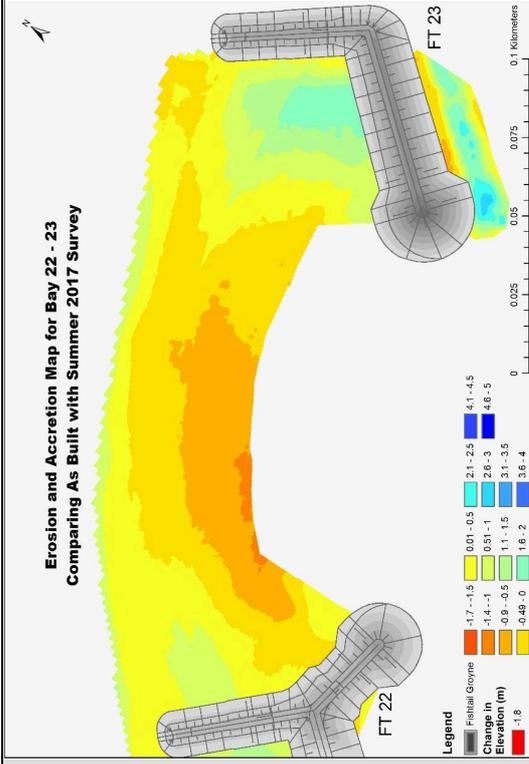
- Highest erosion is skewed to the south of the bay, at 1.4m-1m decrease in beach elevation.
- Accretion highest behind FT 23 at 1.6m-2m increase in elevation. In comparison FT 22 has experienced only 1.1m-1.5m increase in elevation in a relatively smaller area. This difference in accretion between the groyne is likely due to the extended arm of FT23 coupled with material transported by longshore drift in a northerly direction.
- The skewed erosion to the south and the higher levels of accretion in the north of this bay indicated that the extended arm of the rock groyne has increased wave defraction.

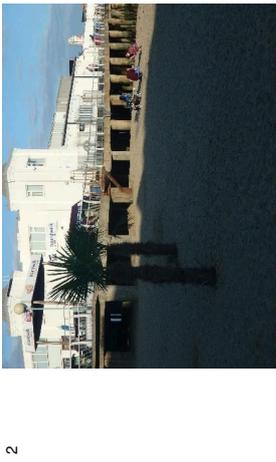
The beach is very wide, with the slope from the berm down to the foreshore again very level at low tide. From the adjacent images, it is evident that material has been trapped higher up the beach and remaining stable.
3

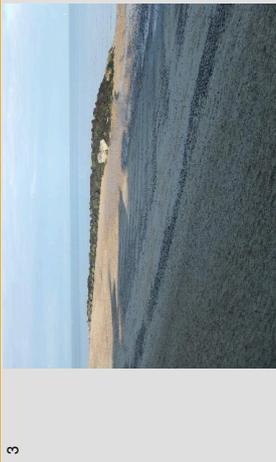
The beach width varies along this profile, with the beach being wider closer to the rock groyne and narrow towards the pier, indicating this profile has experienced longshore drift in a northward direction. Closer to the pier the gradient from the berm to the foreshore is steeper than at the rock groyne. A more defined berm and beach scalp has formed closer to the rock groyne, indicating that erosive processes for a bay formation has occurred.

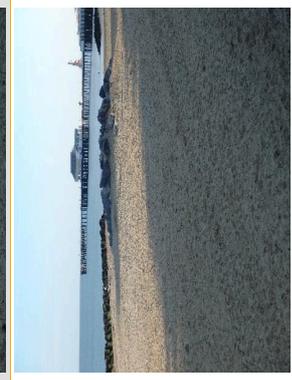
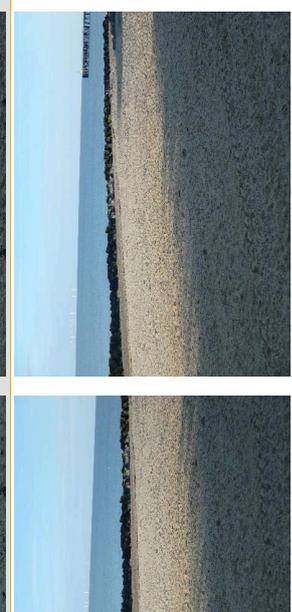
8

<p>The end of the groyne (protruding into the sea) has little sediment around it, suggesting erosion due to wave defraction has occurred.</p>

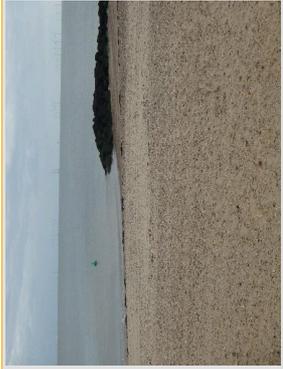
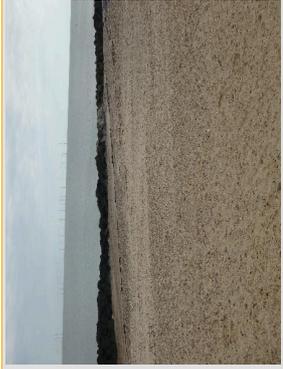
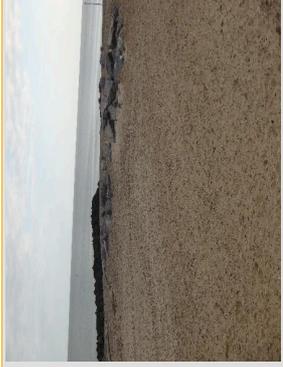
The end of the groyne (protruding into the sea) has little sediment around it, suggesting erosion due to wave defraction has occurred.
