Clacton and Holland-on-Sea Beach Monitoring Report

12 December 2018

Tendring District Council
Town Hall,
Station Road,
Clacton-on-Sea,
Essex,
CO15 1SE

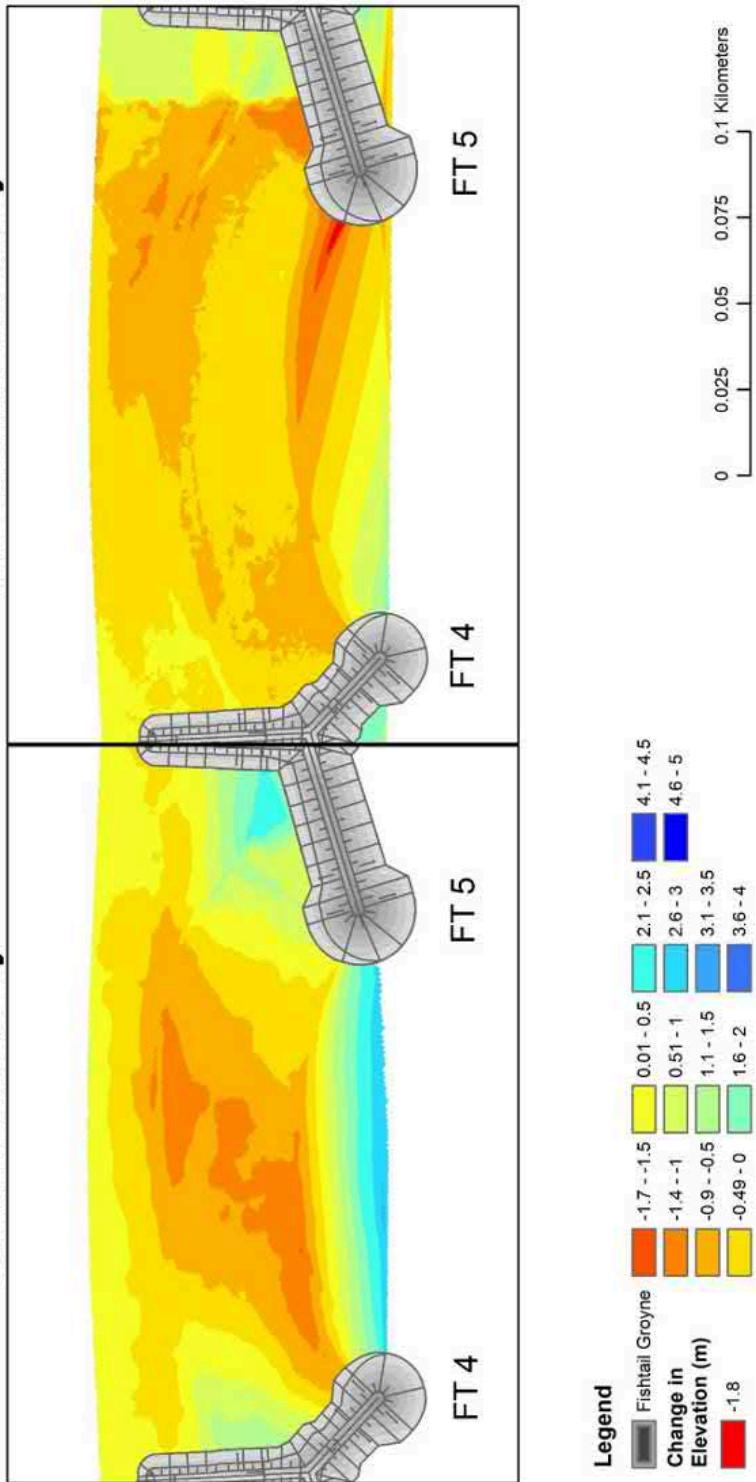
- Highest erosion has occurred along the berm, in the middle of the bay and behind FT4's sea protruding arm, by -1.4m to -1m decrease in beach elevation.

- Erosion close to FT4 is potentially caused by the outfall nearby causing increased scour in this area.
- Accretion has been highest behind FT5 at a high of 2.1m to 2.5m increase in beach elevation and is the largest area of accretion in this bay.

- Between the summer 2017 and summer 2018 surveys the top of the shore connected arm of FT5 appears to have accreted. However, in 2017 this was an area of unexplained erosion. In 2018 this area experienced an overall lowering of the beach since the As Built conditions, like other bays. Thus, the decrease in beach elevation in 2017 was most likely due to beach management activities than natural processes.

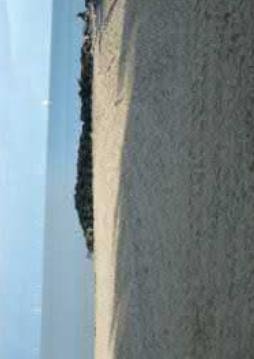
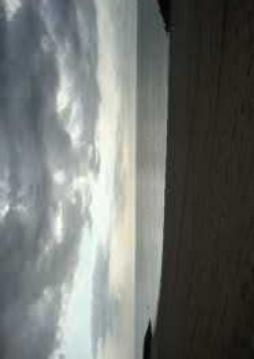
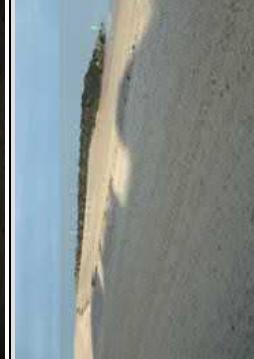
Similar to what was observed in 2017, there is more sediment around the end of the rock groyne to the north than the one in the south. This suggests the continued trend of longshore drift in a northerly direction.
12	2018

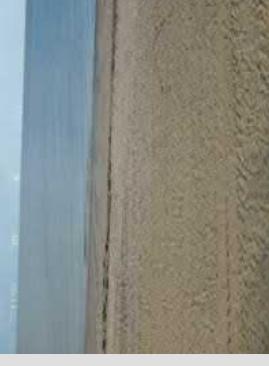
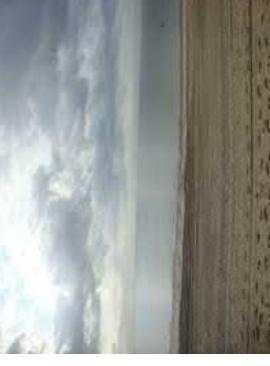
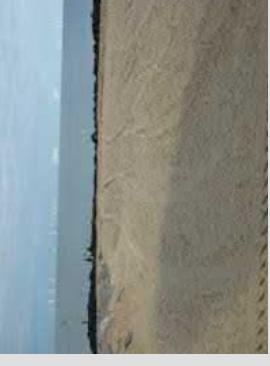
Similar to what was observed in 2017, there is more sediment around the end of the rock groyne to the north than the one in the south. This suggests the continued trend of longshore drift in a northerly direction.
16	2017

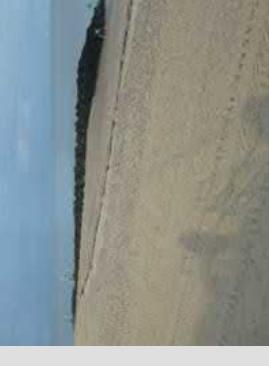
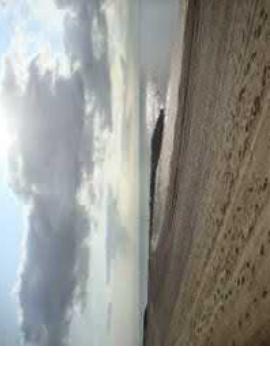
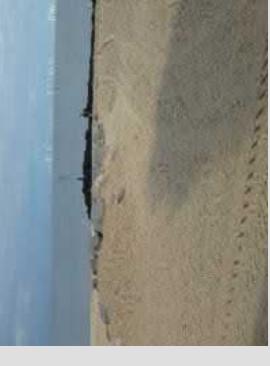
Little visual change from 2017, suggesting beach is relatively stable.
16	2018

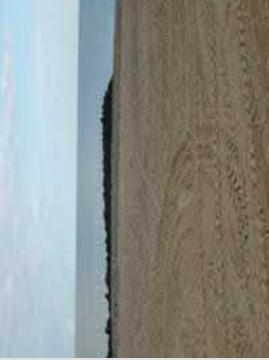
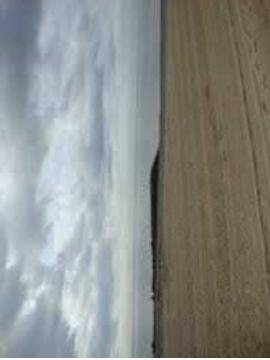
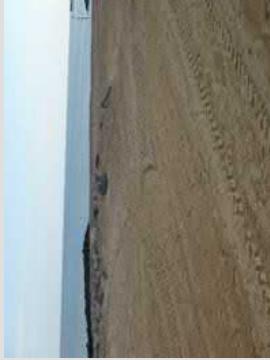
Little visual change from 2017, suggesting beach is relatively stable.
19	2018

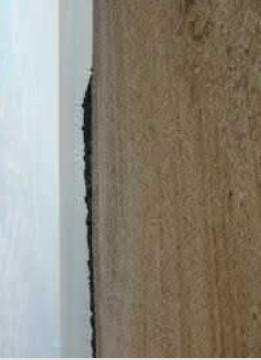
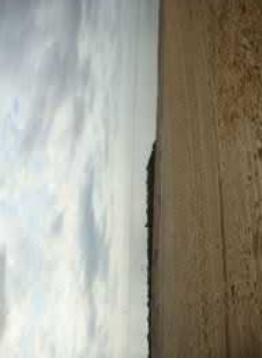
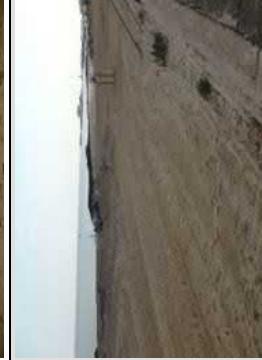
The spine of the groyne appears to have less sand cover in 2018 than in 2017, where the rocks appeared to be more exposed. Rest of the beach shows little visual change from 2017, suggesting the beach is relatively stable.
25	2018

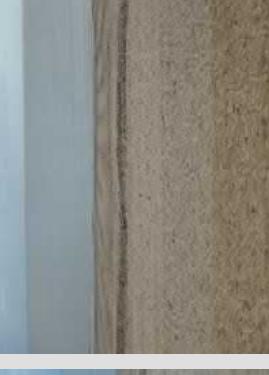
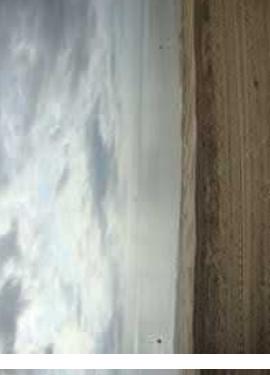
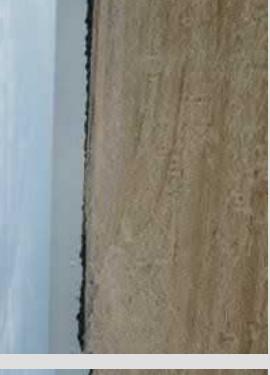
Similar to what was observed in 2017, there is more sediment around the end of the rock groyne to the north than the one in the south. This suggests the continued trend of longshore drift in a northerly direction.
28	2017

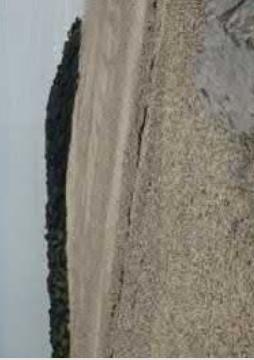
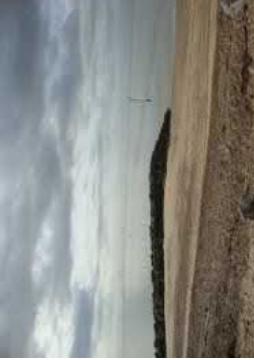
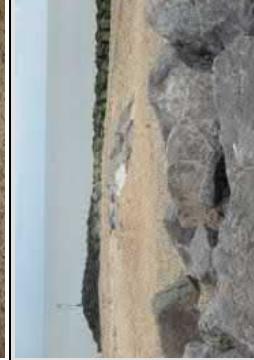
Compared to 2017, the 2018 survey indicates there has been significant exposure of rock at the top of the fishtail's spine. This fishtail groyne here is in front of sheet piles that protrudes out from the seawall; thus the spine is shorter and at a different angle than the other fishtail groynes along the frontage. Note the profile was taken slightly to the south of the photos, so the profile could be taken from the seawall and not the sheet piles.
31	2018

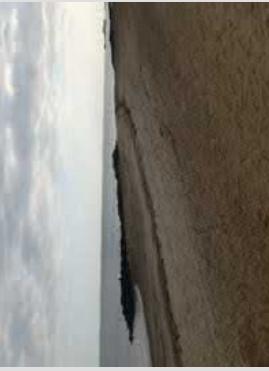
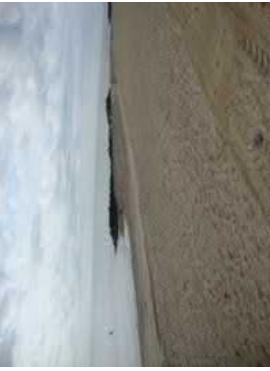
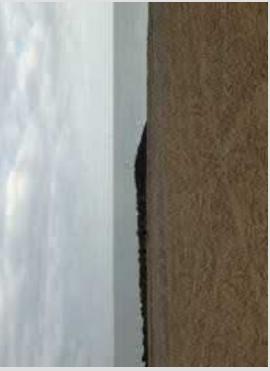
Unlike in 2017, the more southern rock groyne has more material around the arm projecting into the sea. In the 2018 picture, it appears as fine sediment has gathered around it, with more boulder/stone like material scattered close by. This is likely to have been caused by activities on the beach or a storm event.
39	2018

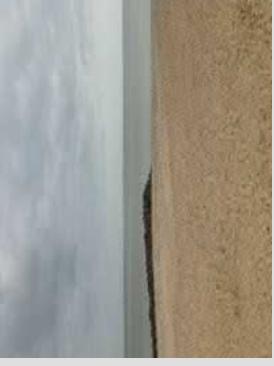
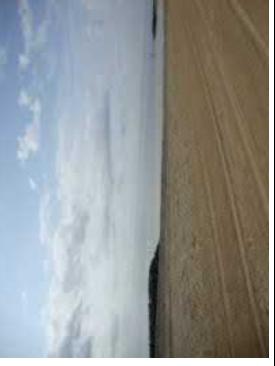
Little visual change from 2017, suggesting beach is relatively stable.
55	2018

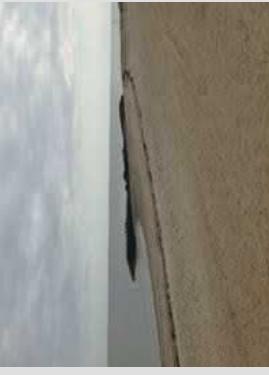
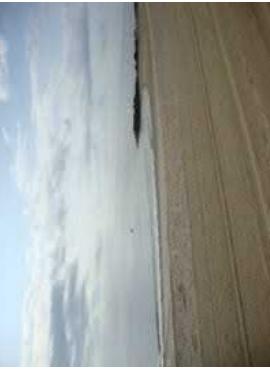
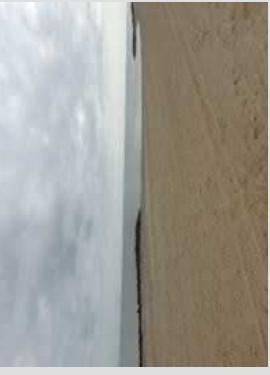
Similar to what was observed in 2017, there is more sediment around the end of the rock groyne to the north than the one in the south. This suggests the continued trend of longshore drift in a northerly direction.
57	2018

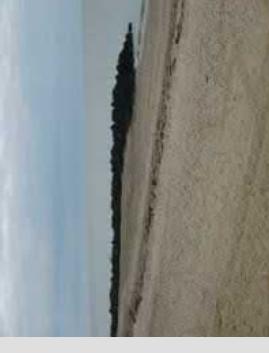
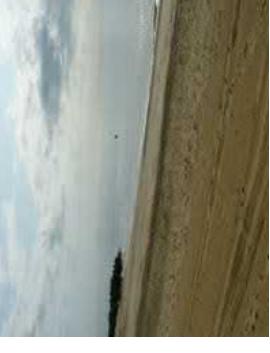
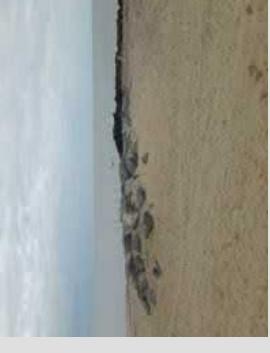
Little visual change from 2017, suggesting beach is relatively stable.
64	2018

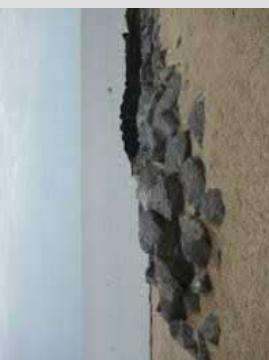
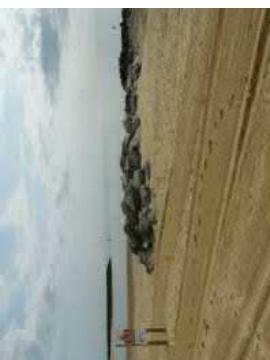
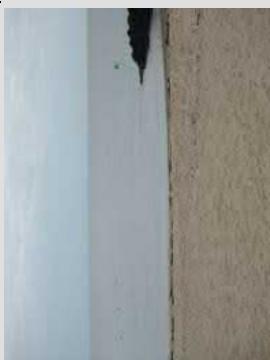
The spine of the rock groyne is covered by more sand than in 2017. This is likely to be due to aeolian sand being trapped here, which is has been observed in other parts of the bay here.
68	2018
