## Options Appraisal: 11 Windmill Road Bradfield

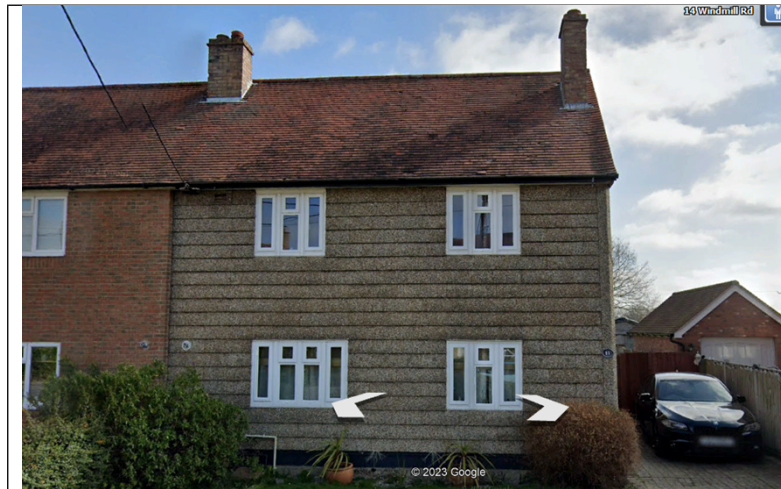
A three bedroomed semi-detached Airey house with substantial grounds. Begun as a void reinstatement but structural and other issues discovered: Failure of concrete columns.

- Structural alteration needs repair.
- Concrete planks holed and loose,
- full insulation and relining of external walls needed
- internal wall replacement required.
- Roof tiling needs to be replaced.
- Structural system must be regarded as limited life.
- Renewal of wiring
- Removal and refitting of heating and bathroom
- New kitchen and flooring
- Driveway outbuilding and grounds repairs
