Clacton and Holland-on-Sea Beach Monitoring Report

13 December 2017

Tendring District Council
Town Hall,
Station Road,
Clacton-on-Sea,
Essex,
CO15 1SE

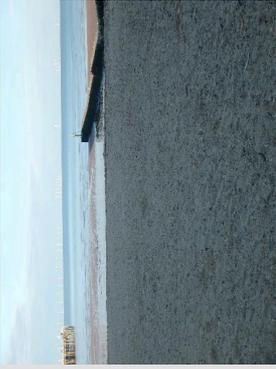
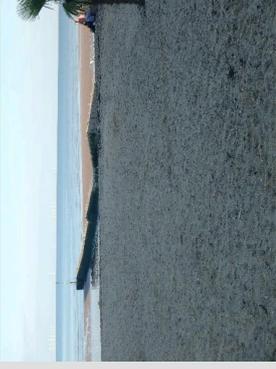
The beach is very wide, with the slope from the berm down to the foreshore at low tide being quite level. This is a well-established beach and it is evident that the beach material is stable higher up the beach.
2

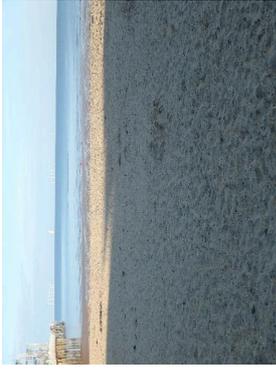
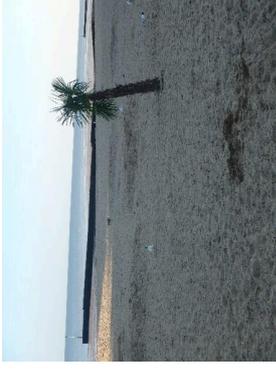
The beach is very wide, with the slope from the berm down to the foreshore again very level at low tide. From the adjacent images, it is evident that material has been trapped higher up the beach and remaining stable.
3

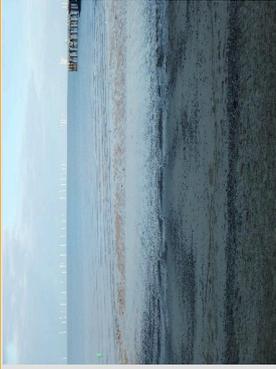
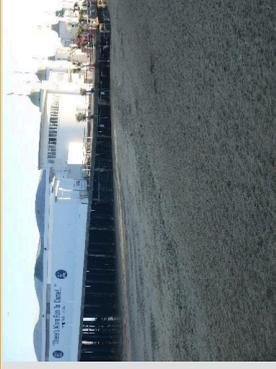
The beach width varies along this profile, with the beach being wider closer to the rock groyne and narrow towards the pier, indicating this profile has experienced longshore drift in a northward direction. Closer to the pier the gradient from the berm to the foreshore is steeper than at the rock groyne. A more defined berm and beach scalp has formed closer to the rock groyne, indicating that erosive processes for a bay formation has occurred.

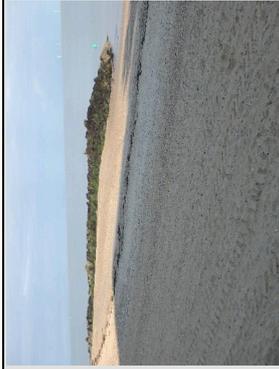
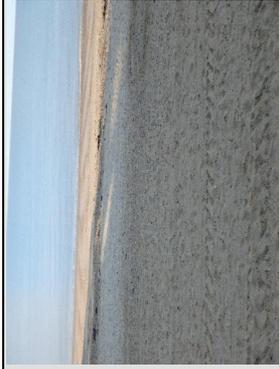
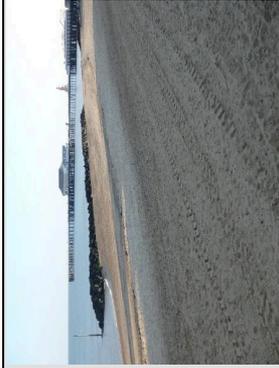
Noticeably there is more sediment around the end of the rock groyne to the north than the one in the south. This suggest the coastline has experienced longshore drift in a northwards direction here.

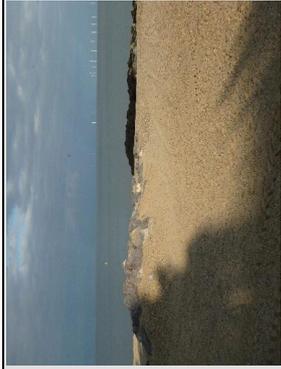
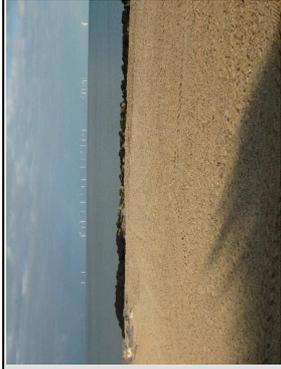
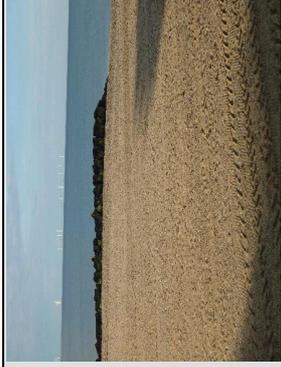
The end of the groyne (protruding into the sea) has little sediment around it, suggesting erosion due to wave defraction has occurred.

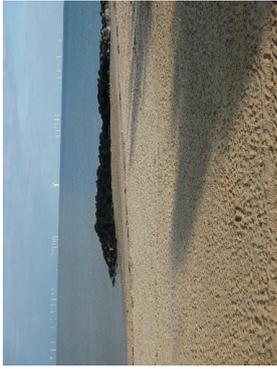
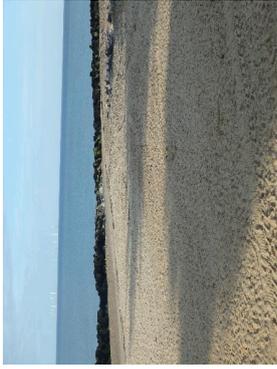
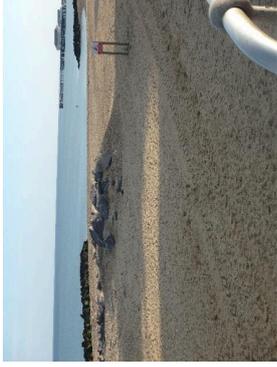
14

Noticeably there is more sediment around the end of the rock groyne to the north than the one in the south. This suggest the coastline has experienced longshore drift in a northwards direction here.

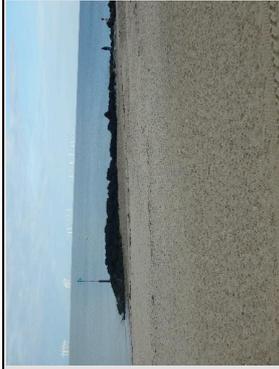
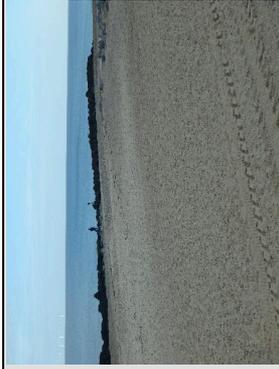
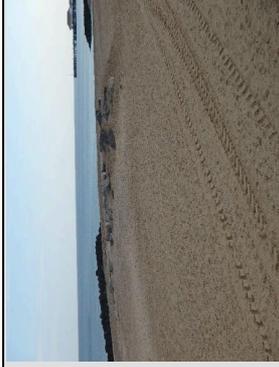
17

The end of the groyne (protruding into the sea) has little sediment around it, suggesting erosion due to wave defraction has occurred.

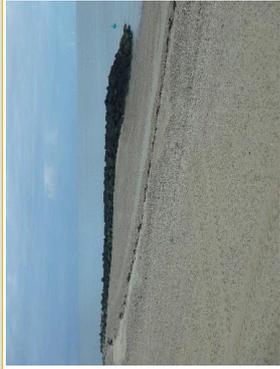
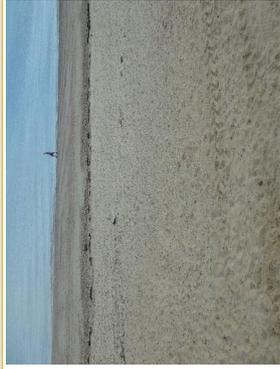
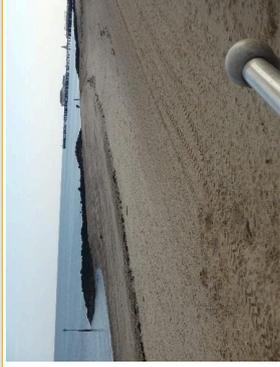
18

Noticeably there is more sediment around the end of the rock groyne to the north than the one in the south. This suggest the coastline has experienced longshore drift in a northwards direction here.

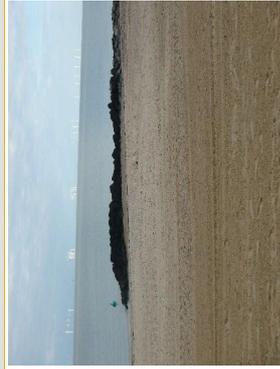
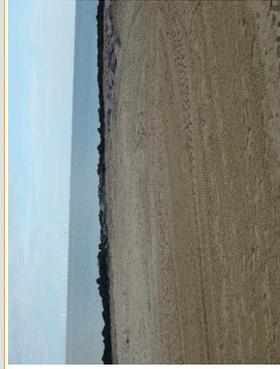
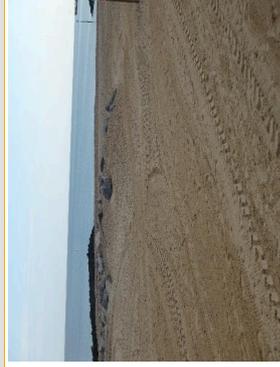
20

The end of the groyne (protruding into the sea) has little sediment around it, suggesting erosion due to wave defraction has occurred.

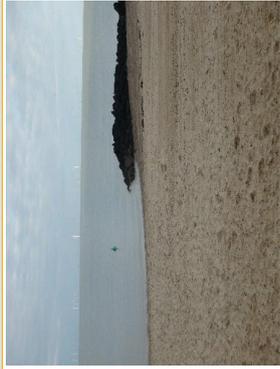
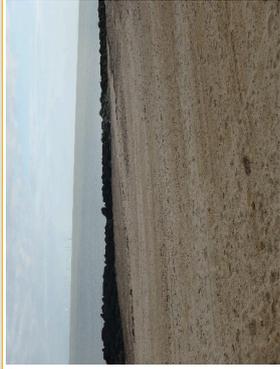
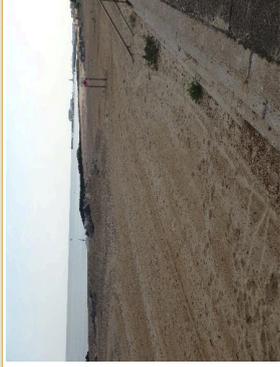
26

The end of the groyne (protruding into the sea) has little sediment around it, suggesting erosion due to wave defraction has occurred.

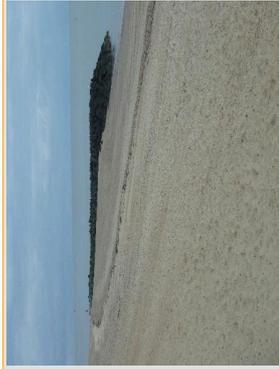
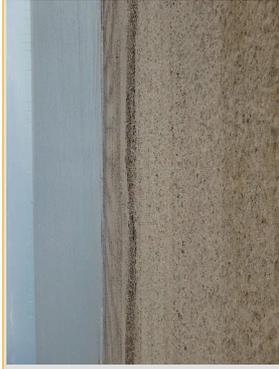
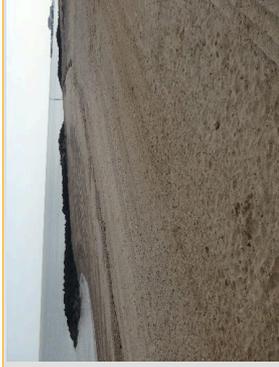
27

Noticeably there is more sediment around the end of the rock groyne to the north than the one in the south. This suggest the coastline has experienced longshore drift in a northwards direction here.

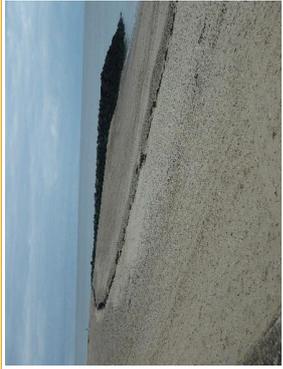
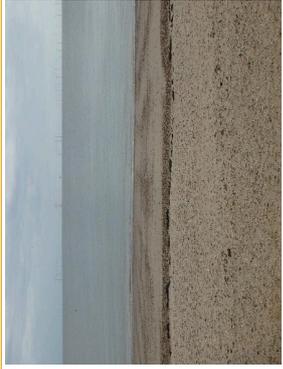
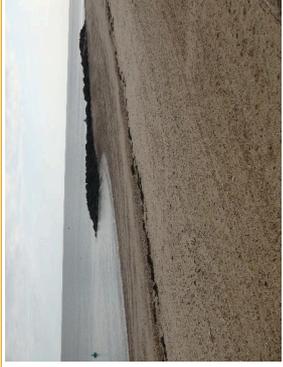
35

Noticeably there is more sediment around the end of the rock groyne to the north than the one in the south. This suggest the coastline has experienced longshore drift in a northwards direction here.

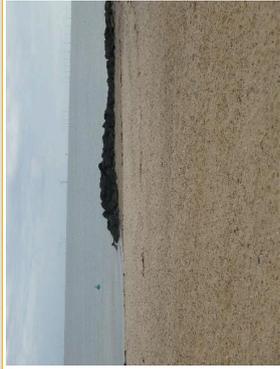
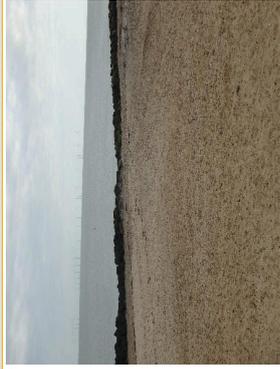
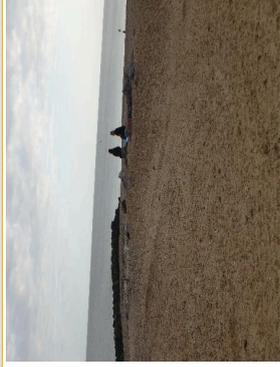
38

The end of the groyne (protruding into the sea) has little sediment around it, suggesting erosion due to wave defraction has occurred.

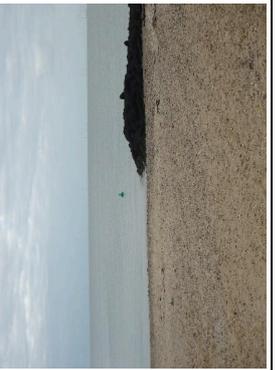
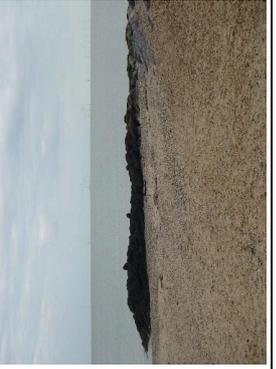
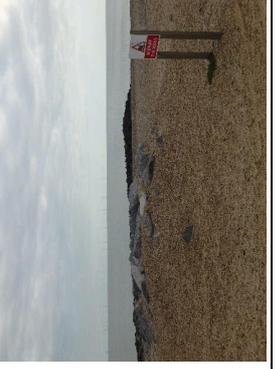
44

The end of the groyne (protruding into the sea) has little sediment around it, suggesting erosion due to wave defraction has occurred.

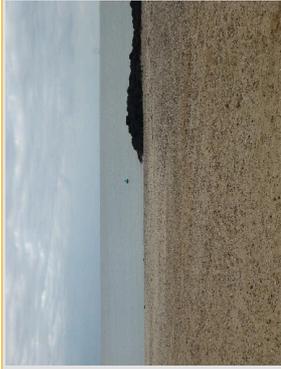
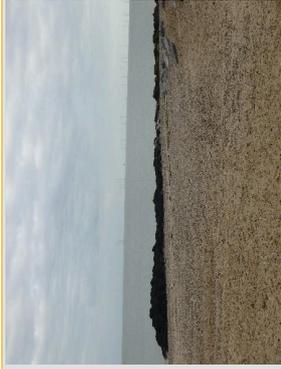
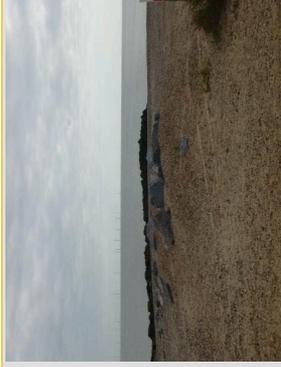
47

The end of the groyne (protruding into the sea) has little sediment around it, suggesting erosion due to wave defraction has occurred.

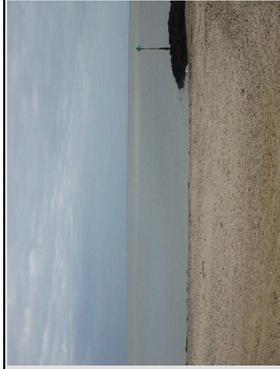
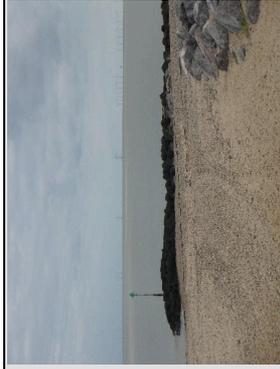
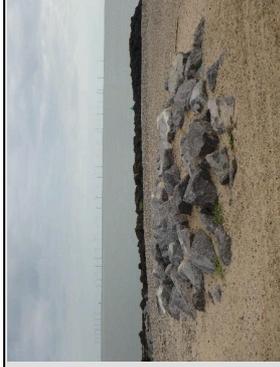
53

The end of the groyne (protruding into the sea) has little sediment around it, suggesting erosion due to wave defraction has occurred.

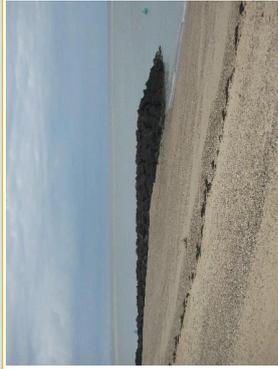
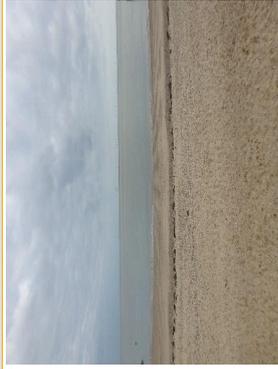
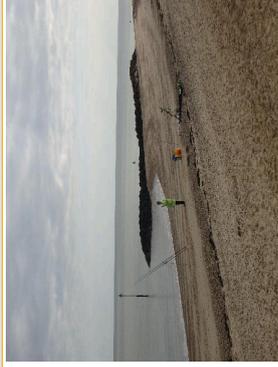
54

Noticeably there is more sediment around the end of the rock groyne to the north than the one in the south. This suggest the coastline has experienced longshore drift in a northwards direction here.

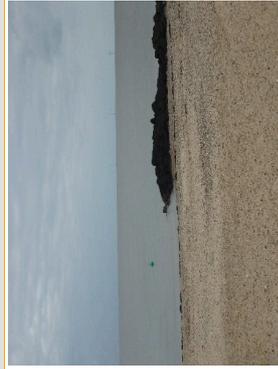
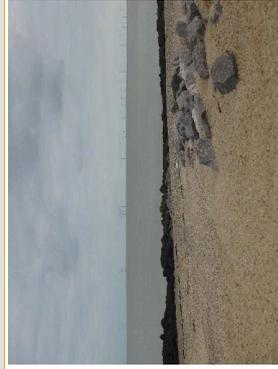
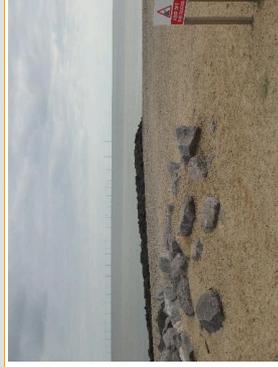
56

The end of the groyne (protruding into the sea) has little sediment around it, suggesting erosion due to wave defraction has occurred.

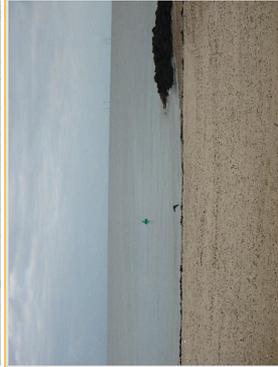
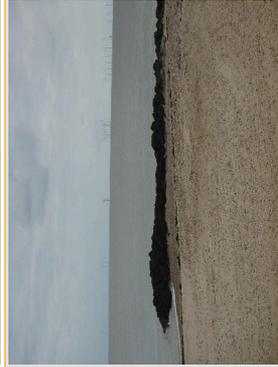
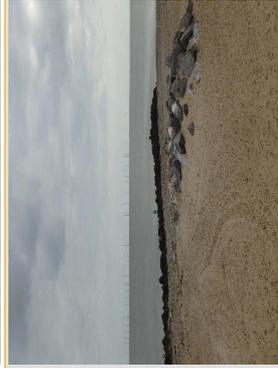
59

The end of the groyne (protruding into the sea) has little sediment around it, suggesting erosion due to wave defraction has occurred.

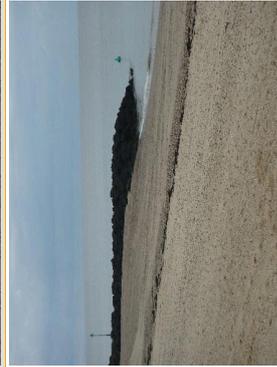
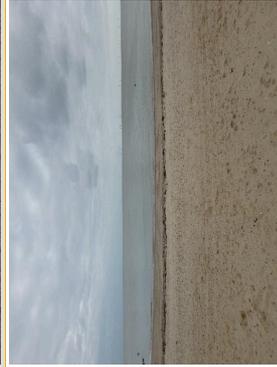
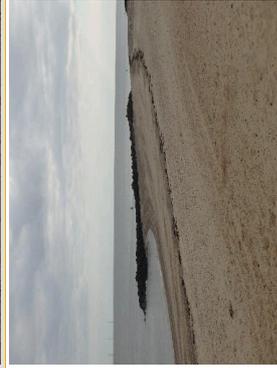
60

Noticeably there is more sediment around the end of the rock groyne to the north than the one in the south. This suggests the coastline has experienced longshore drift in a northwards direction here.

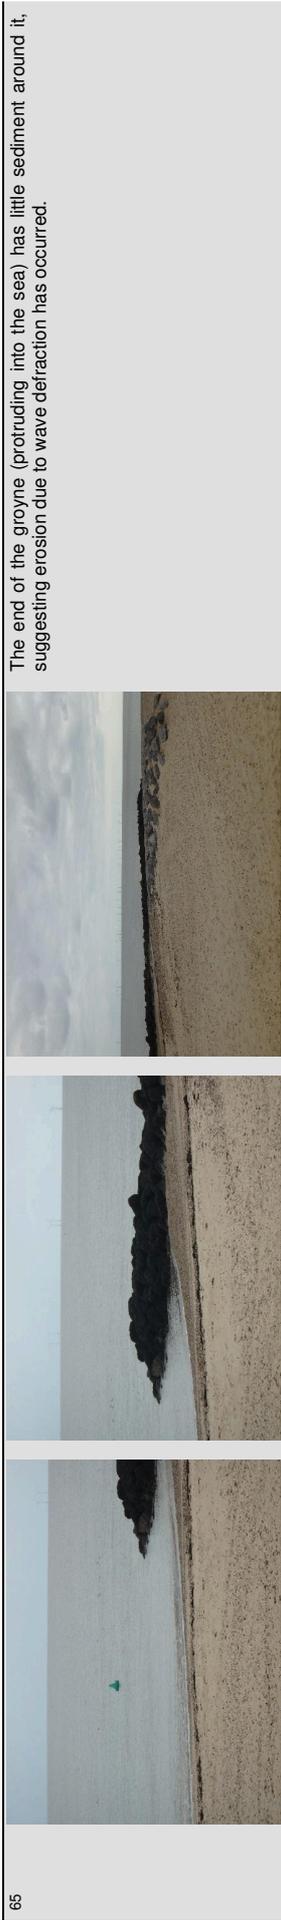
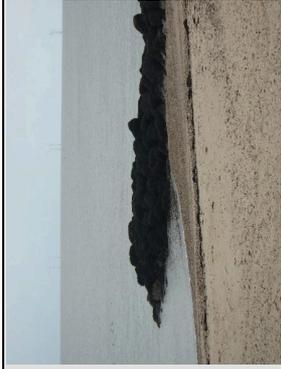
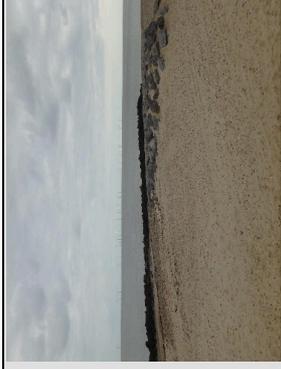
The end of the groyne (protruding into the sea) has little sediment around it, suggesting erosion due to wave defraction has occurred.

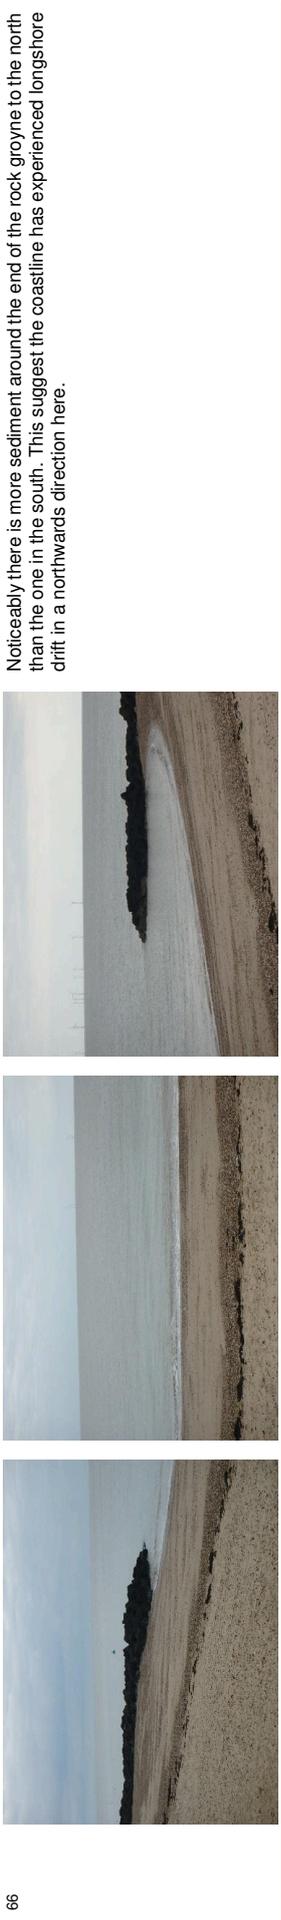
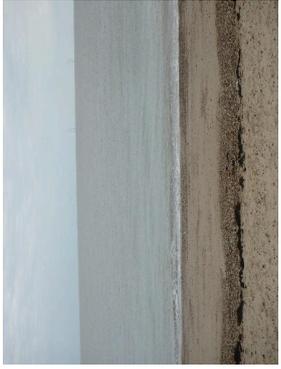
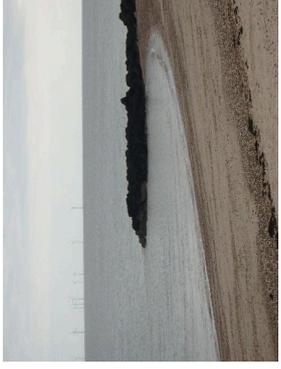
Noticeably there is more sediment around the end of the rock groyne to the north than the one in the south. This suggest the coastline has experienced longshore drift in a northwards direction here.

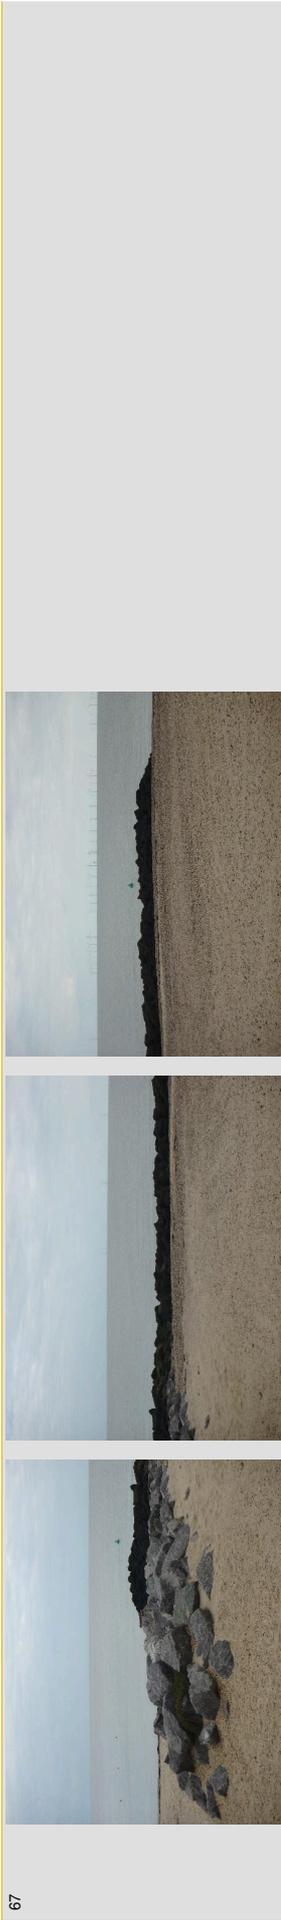
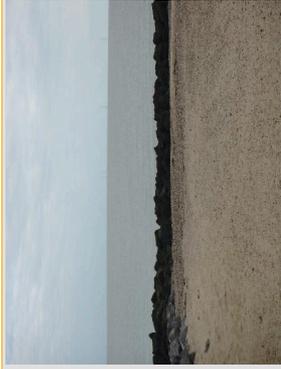
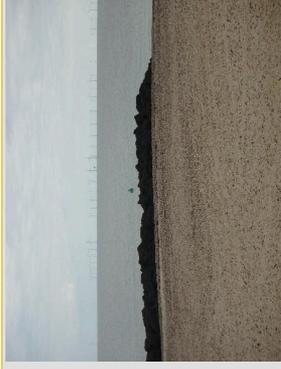
The end of the groyne (protruding into the sea) has little sediment around it, suggesting erosion due to wave defraction has occurred.

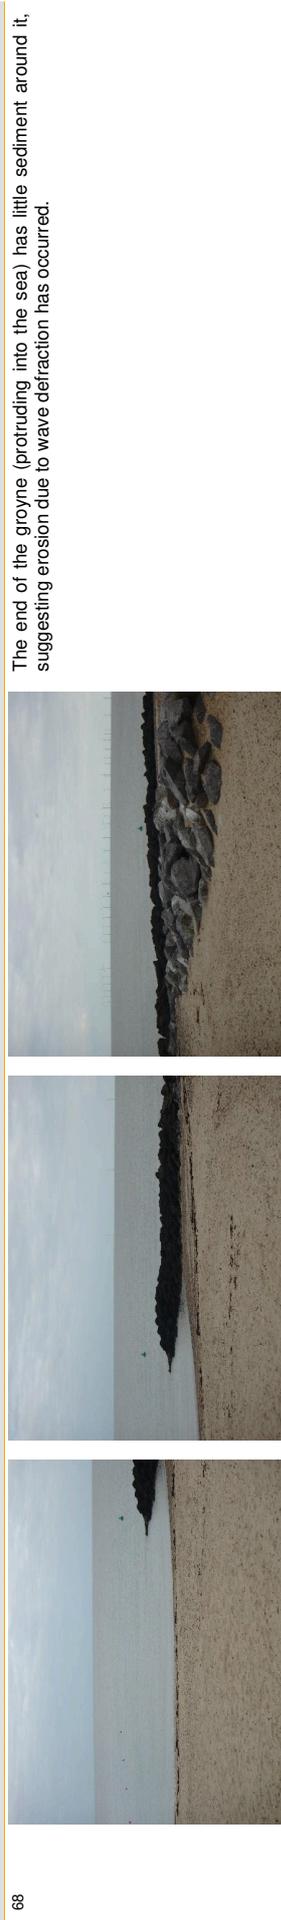
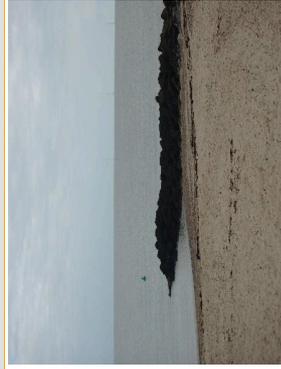
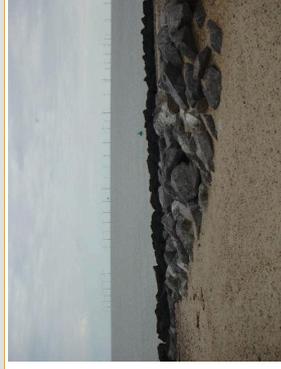
The end of the groyne (protruding into the sea) has little sediment around it, suggesting erosion due to wave defraction has occurred.

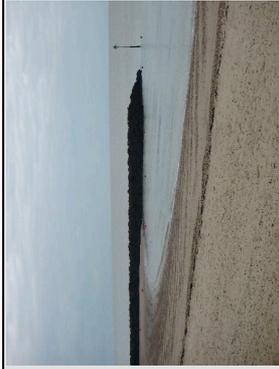
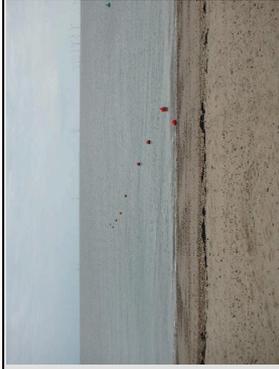
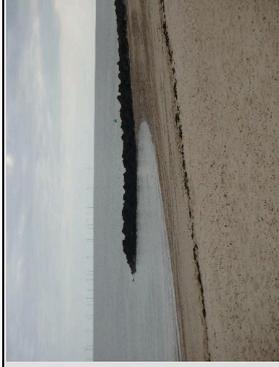
Unlike other bays, there is a significant amount of erosion at either end of the rock groyne. This is likely due to the slight change in orientation at this point along the frontage and the extended arm of the rock groyne affecting wave defraction.

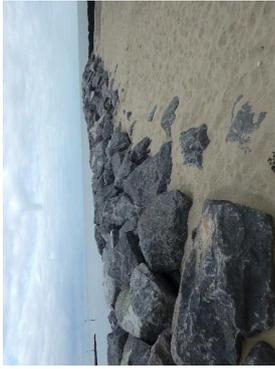
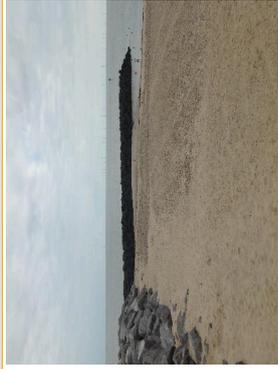
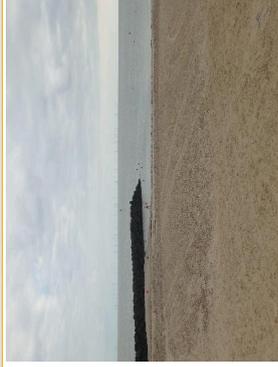
69

The beach is very wide with a good amount of beach material. However, unlike other profiles taken on the south side of the groyne, there is very little sediment around the end of the groyne (protruding out to sea). This is likely due to the slight change in orientation at this point along the frontage and the extended arm of the rock groyne affecting wave defraction.

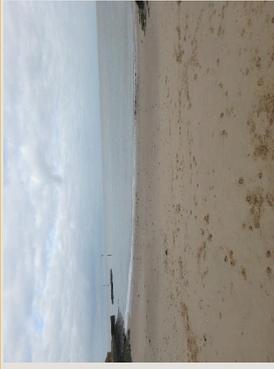
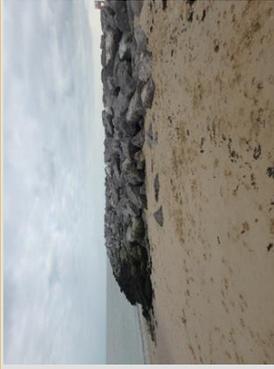
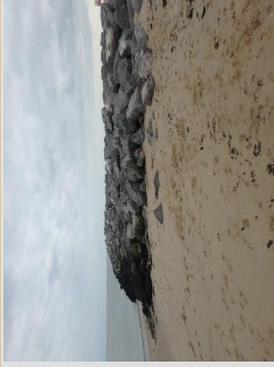
70

The beach is very wide, with the slope from the berm down to the foreshore at low tide being quite level. The beach appears to be relatively stable, though no accretion processes appear to have occurred here.
