Clacton and Holland-on-Sea Beach Monitoring Report

12 December 2018

Tendring District Council
Town Hall,
Station Road,
Clacton-on-Sea,
Essex,
CO15 1SE

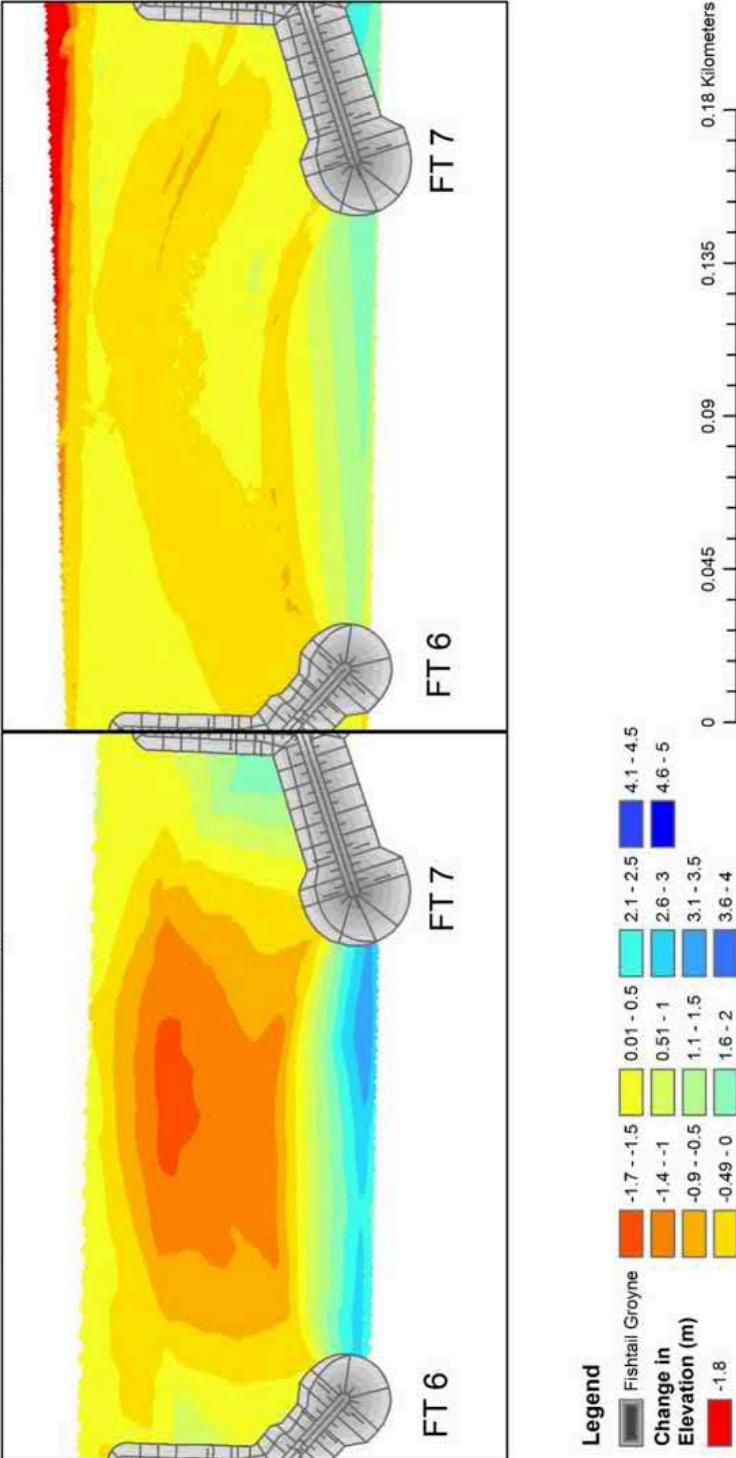
- Highest erosion has occurred along the berm and in the middle of the bay, with a high of -1.7m to -1.5m decrease in beach elevation along the berm.
- Accretion has been highest behind FT7 at a high of 1.6m to 2m increase in beach elevation and is the largest area of accretion in this bay.

- These observations are a continued trend from 2017. Though the berm has been an area of more beach lowering in 2018 than in 2017.
- There has been less intense lowering in the middle of the bay and between summer 2017 and 2018 the middle of the bay appears to have accreted a little, by 0.01-0.5m.

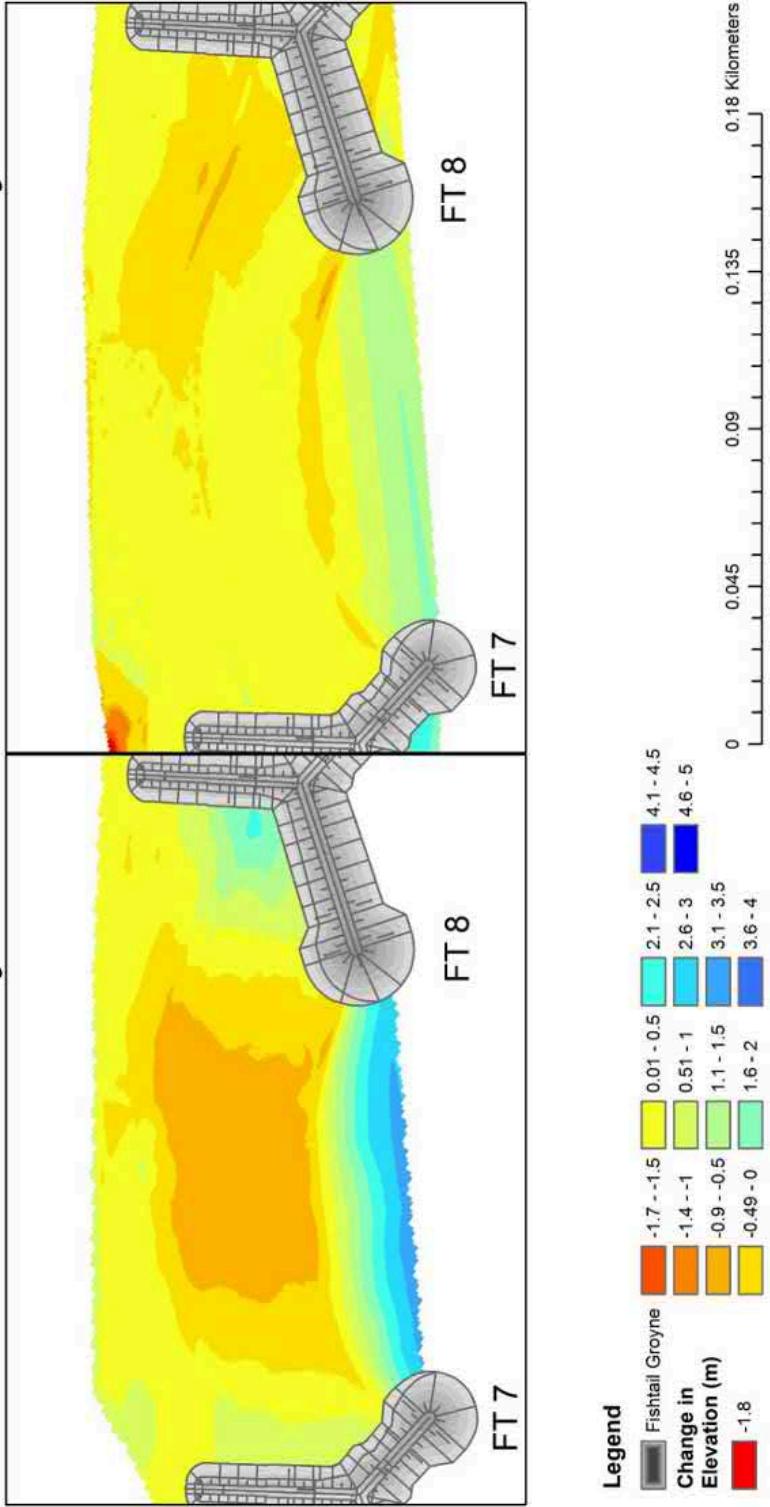
Erosion and Accretion Map for Bay 7 - 8**Comparing As Built with Summer 2018 Survey****Comparing Summer 2017 Survey with Summer 2018 Survey**

- Highest erosion has occurred along the berm and in the middle of the bay, by -0.9m to -0.5m decrease in beach elevation along the berm.
- Accretion has been highest behind FT8 at a high of 2.1m to 2.5m increase in beach elevation and is the largest area of accretion in this bay.
- These observations are a continued trend from 2017. Though the berm has been an area of more beach lowering in 2018 than in 2017, See Appendix A
- There has been less intense lowering in the middle of the bay and between summer 2017, and 2018 the middle of the bay appears to have accreted a little, by 0.01-0.5m.
- Generally, the bay has experienced lowering of the beach nearest FT8 and a slight increase in elevation closest to FT7 and the middle of the bay. This is unlike the trends found in other bays and could be the influenced by the setback promenade and the beach adjusting to this.

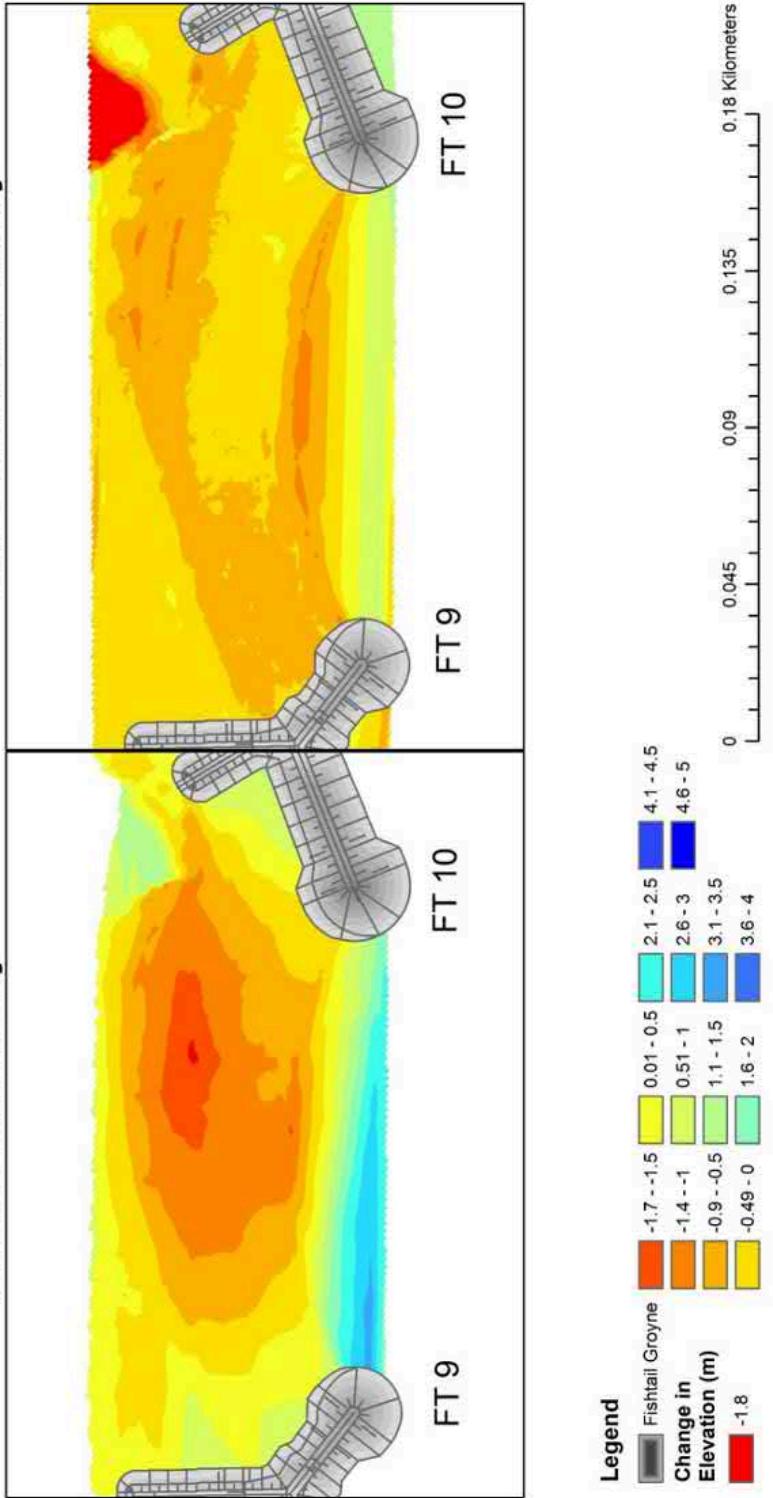
Erosion and Accretion Map for Bay 9 - 10**Comparing As Built with Summer 2018 Survey****Comparing Summer 2017 Survey with Summer 2018 Survey**

- Highest erosion has occurred along the berm and in the middle of the bay at a high of over -1.8m decrease in beach elevation along the berm.
- Accretion has been highest behind FT9 at 0.51m to 1m increase in beach elevation. It is the largest area of accretion in the bay.

- The whole bay has experienced an overall lowering of the beach. This is typical of a sandy beach to move towards a flatter gradient as the small particles are evenly distributed and that water takes longer to percolate through the sand than at shingle beaches. Therefore, more sand is removed with the backwash.

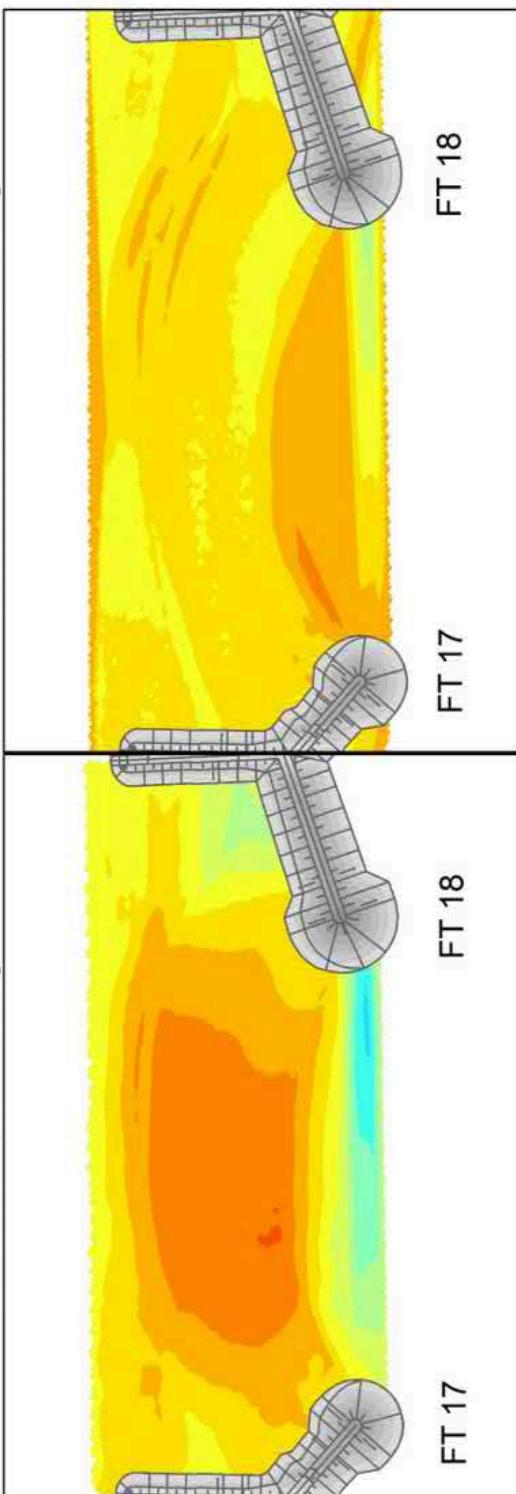
Erosion and Accretion Maps for Bay 17 - 18**Comparing As Built with Summer 2018 Survey****Comparing Summer 2017 Survey with Summer 2018 Survey**

- Highest erosion has occurred along the berm of the beach and in the middle of the bay with a high of -1.4m to -1m decrease in beach elevation.
- Accretion highest behind FT18 at a high of 1.1m to 1.5m.
- These observations are a continued trend from 2017. Though the berm and has been an area of more beach lowering in 2018 than in 2017.
- In general, between summer 2017 and 2018 surveys the middle of the bay to FT18 has experienced a small increase by 0.01m to 0.5m. Whereas behind FT17 to the middle of the bay and from the middle of the bay along the upper beach to behind FT17 the beach has generally lowered. It is likely the material from these areas is being moved via a backwash wave out towards the sea, hence the accretion of sand in front of these areas of beach lowering.
- Generally, the whole bay has experienced an overall lowering of the beach.

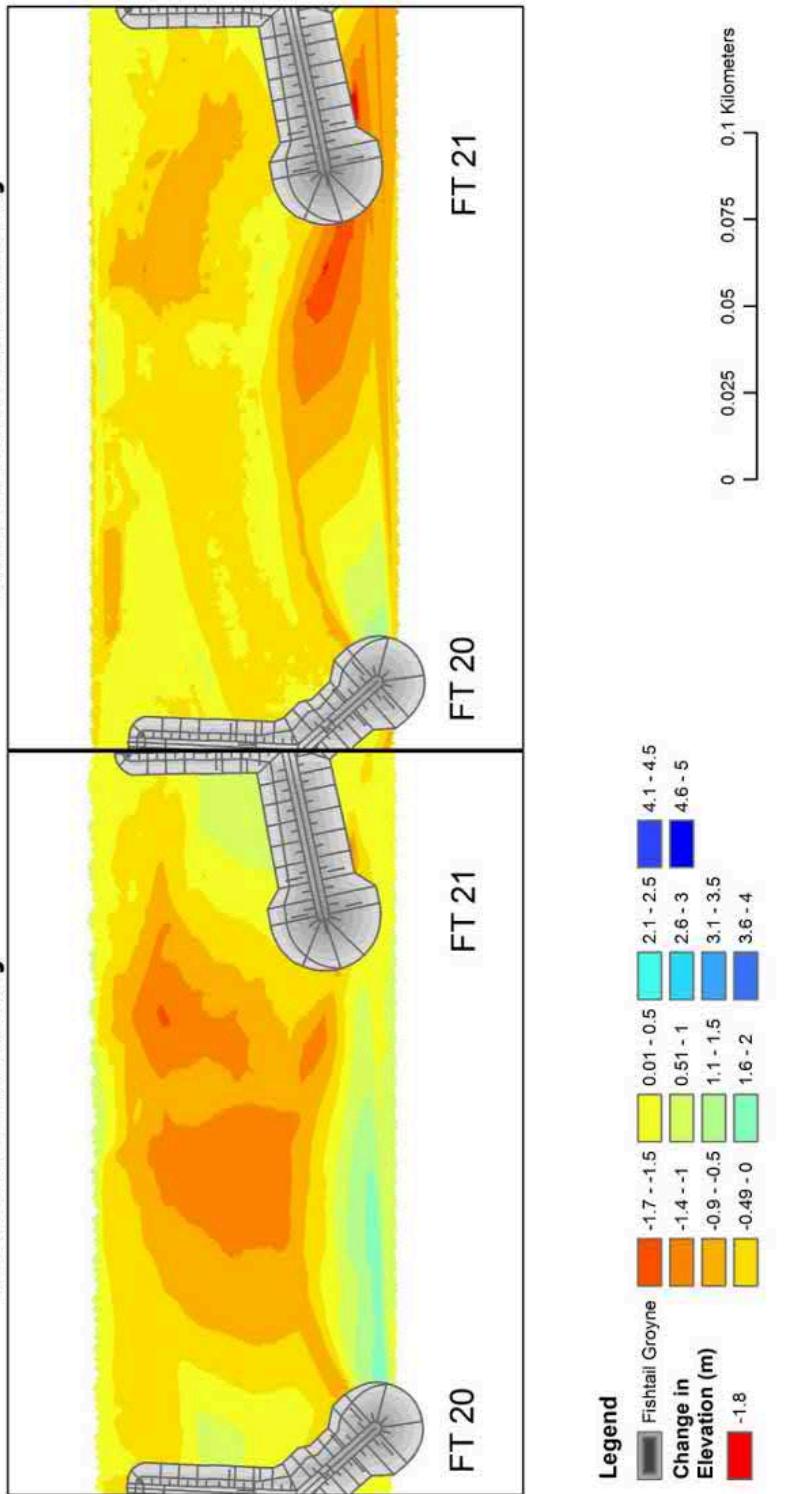
Bays Accretion and Erosion Maps**Description of the key changes in the bay****Erosion and Accretion Maps for Bay 20 - 21****Comparing As Built with
Summer 2018 Survey****Comparing Summer 2017 Survey
with Summer 2018 Survey**

- Highest erosion has occurred along the berm of the beach and in the middle of the bay with a high of -1.7m to -1.5m, but a more general high of -1.4m to -1m decrease in beach elevation.

- Accretion highest behind FT21 at a high of 0.51m to 1m.
- These observations are a continued trend from 2017. Though the berm and middle of the bay has been an area of more beach lowering in 2018 than in 2017. There is an area of intense beach lowering from As Built between the middle of the bay and FT 21, this is where a ramp from the promenade comes down onto the beach. Therefore, this area of beach lowering could be a result of human activity rather than wave processes alone.

- In general, between summer 2017 and 2018 surveys the middle of the bay to FT21 has experienced a small increase by 0.01m to 0.5m. Whereas from the middle of the bay, along the upper beach, to behind FT22 the beach has generally lowered. This is unlike any other bay. However, during the profile survey it was noted that this area experiences significant aeolian sand. Potentially this could be the reason for the accumulation near FT21.

- There has been some lowering behind FT22 but some accumulation near the head of the protruding arm of FT22 as well. It is likely the material from these areas is being moved via a backwash wave out towards the sea, hence the accretion of sand in front of these areas of beach lowering.

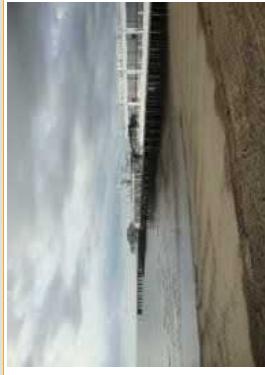
The beach width varies along this profile, with the beach being wider closer to the rock groyne and narrow towards the pier, indicating this profile has experienced longshore drift in a northward direction. Closer to the pier the gradient from the berm to the foreshore is steeper than at the rock groyne. A more defined berm and beach scalp has formed closer to the rock groyne, indicating that erosive processes for a bay formation has occurred.
3	2018

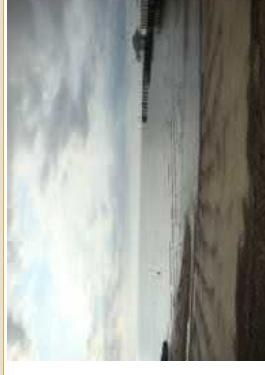
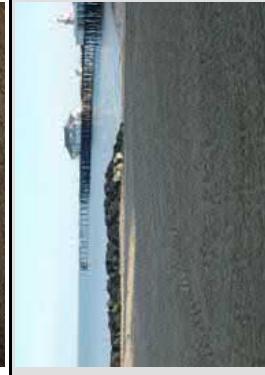
It is evident the beach width is narrower at the pier and wider closer to the rock groyne. This indicates longshore drift has been experienced in this bay in a northly direction. Further, it suggests the pier does not trap beach material here like the rock groynes and allows this part of the beach to be more exposed to erosive wave action. The observation is in line with observations from 2017. However, the beach in the 2018 survey nearest the rock groyne appears to be steeper than nearer the pier. This is likely due to the beach levelling out from wave action closer to the pier.

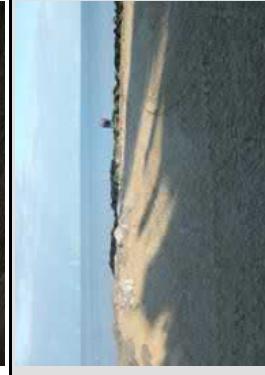
Little visual change from 2017, suggesting beach is relatively stable.

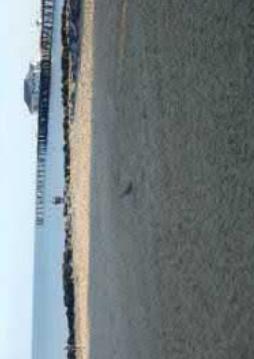
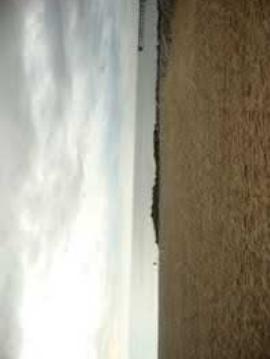
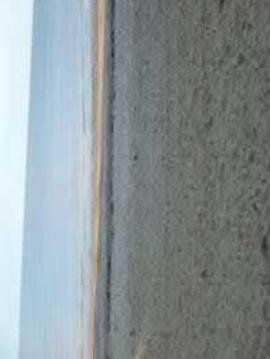
The berm and scallop are not as marked in the 2018 photographs compared to the 2017. However, in the 2018 photos it is evident, from the vehicle tracks in the sand, that there have been beach management activities undertaken. These activities are likely to have reduced the definition of the berm and its corresponding scallop.
6	2017

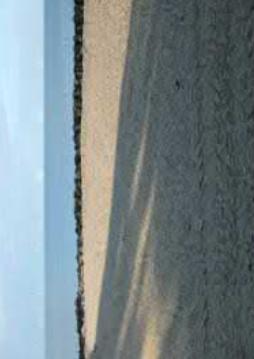
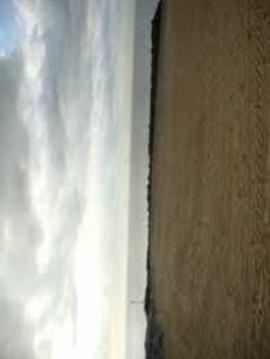
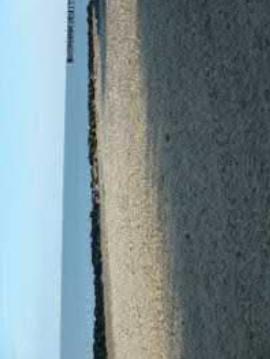
The end of the groyne (protruding into the sea) has little sediment around it, suggesting erosion due to wave diffraction has occurred.
8	2017

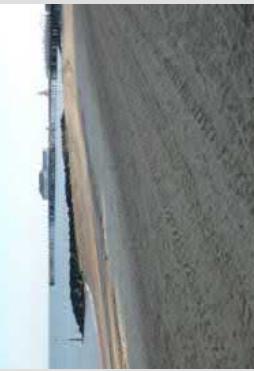
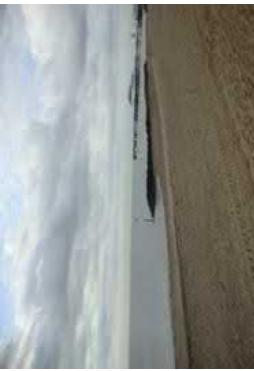
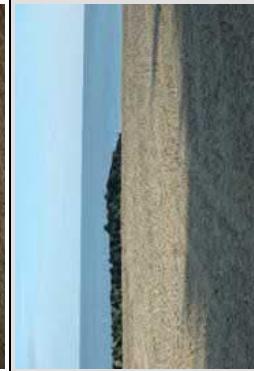
Noticeably there is more sediment around the end of the rock groyne to the north than the one in the south. This suggest the coastline has experienced longshore drift in a northwards direction here.
9	2018

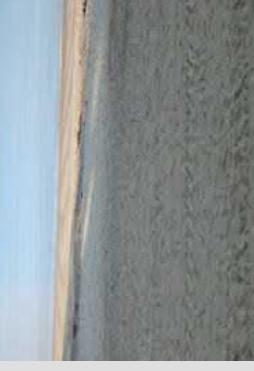
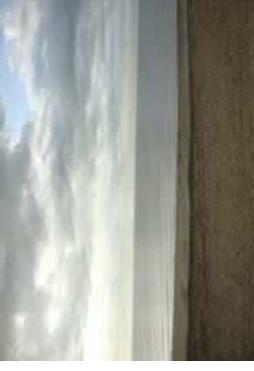
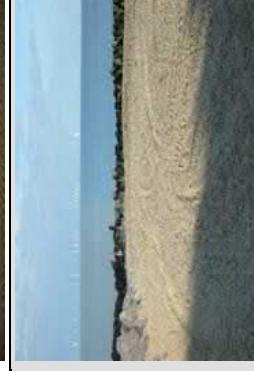
Similar to 2017, more sediment has gathered around the end of the rock groyne to the north, than the one in the south, suggesting longshore drift has occurred in a northly direction. Further, vehicle tracks can be identified in the sand for both the 2017 and 2018 surveys, indicating beach management activities have been undertaken. The beach management activities are likely to have reduced the definition of the berm and its corresponding scallop.
10	2017

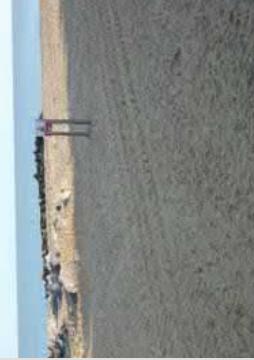
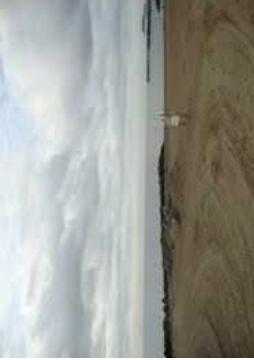
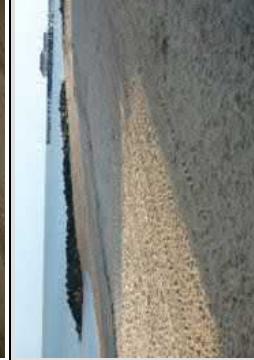
Noticeably there is more sediment around the end of the rock groyne to the north than the one in the south. This suggest the coastline has experienced longshore drift in a northwards direction here.
12	2017

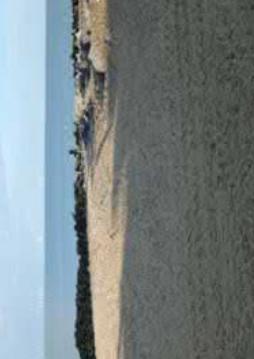
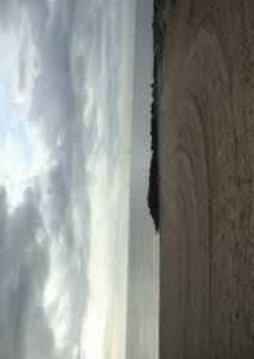
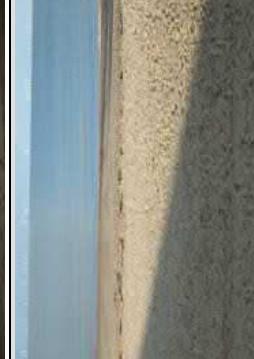
From the 2018 photos it is clear that a vehicle has driven over the area, likely to be part of beach management activities. Additionally, the spine of the groyne appears to have less sand cover in 2018 than in 2017, where the rocks appeared to be more exposed.
11	2018

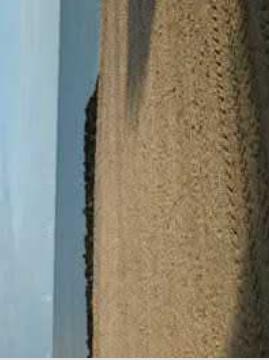
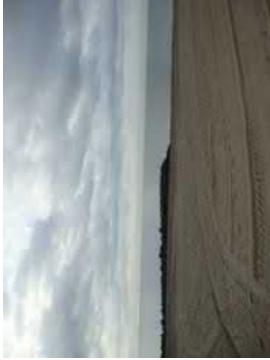
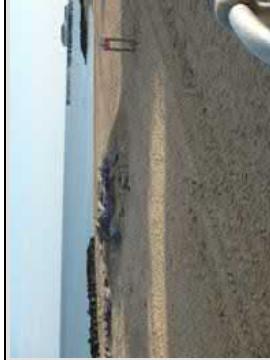
From the 2018 photos it is clear that a vehicle has driven over the area, likely to be part of beach management activities. Additionally, the spine of the groyne appears to have less sand cover in 2018 than in 2017, where the rocks appeared to be more exposed.
13	2018

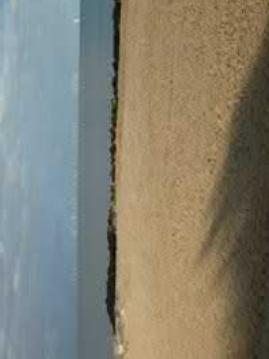
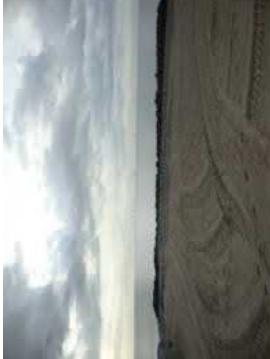
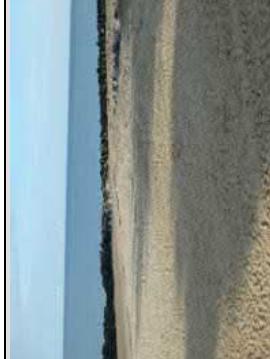
The end of the groyne (protruding into the sea) has little sediment around it, suggesting erosion due to wave diffraction has occurred.
14	2017

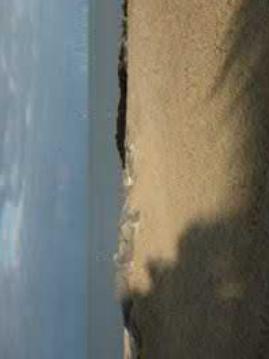
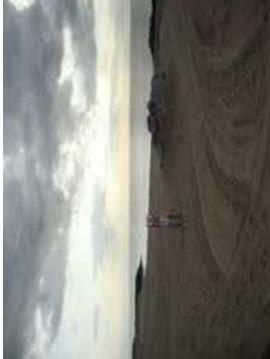
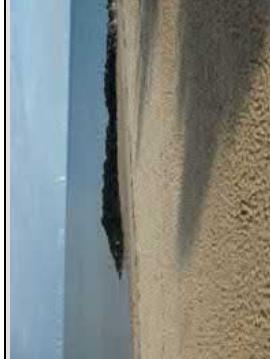
From the 2018 photos it is clear that a vehicle has driven over the area, likely to be part of beach management activities. Additionally, the spine of the groyne appears to have less sand cover in 2018 than in 2017, where the rocks appeared to be more exposed.
14	2018

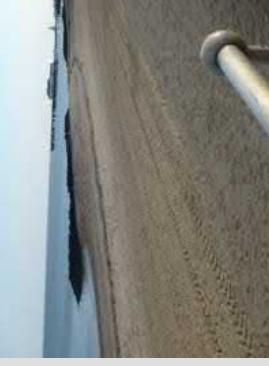
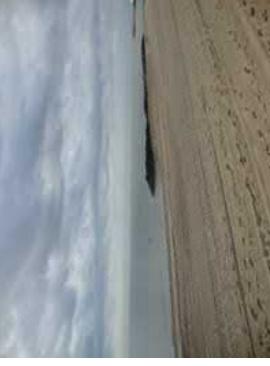
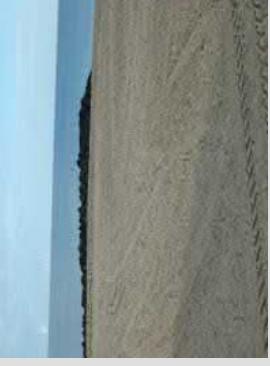
Noticeably there is more sediment around the end of the rock groyne to the north than the one in the south. This suggests the coastline has experienced longshore drift in a northwards direction here.
15	2018

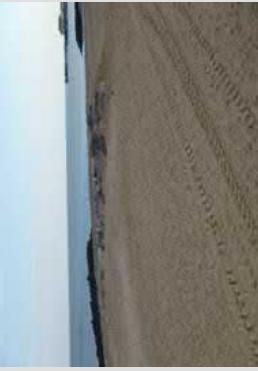
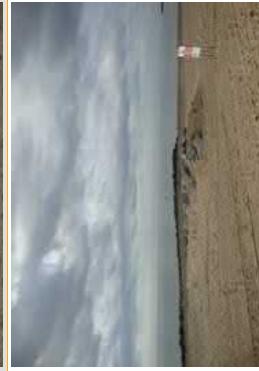
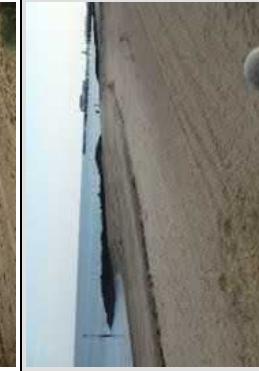
The end of the groyne (protruding into the sea) has little sediment around it, suggesting erosion due to wave diffraction has occurred.
17	2018

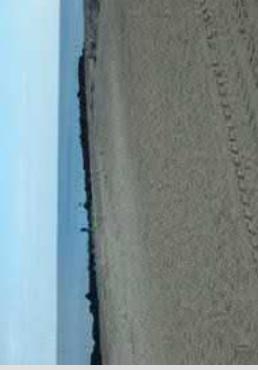
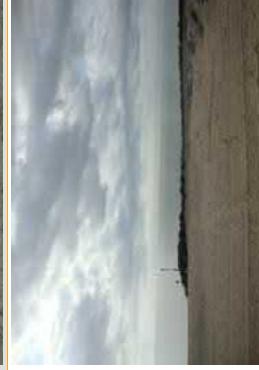
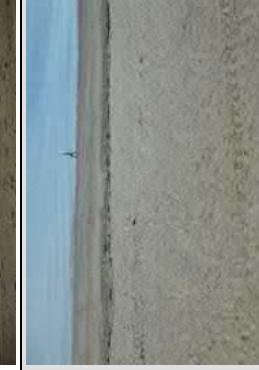
The spine of the groyne appears to have less sand cover in 2018 than in 2017, where the rocks appeared to be more exposed.
18	2017

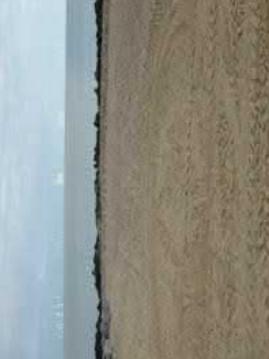
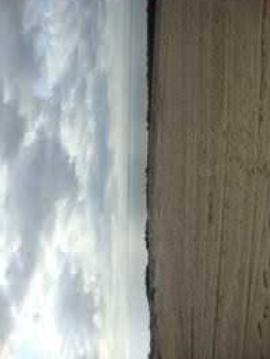
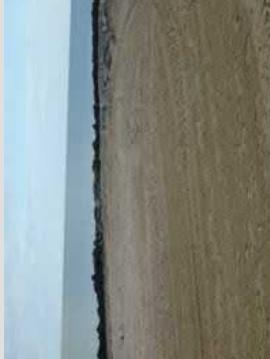
The end of the groyne (protruding into the sea) has little sediment around it, suggesting erosion due to wave diffraction has occurred.
20	2017

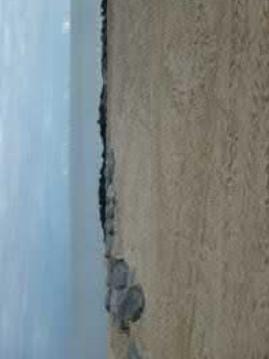
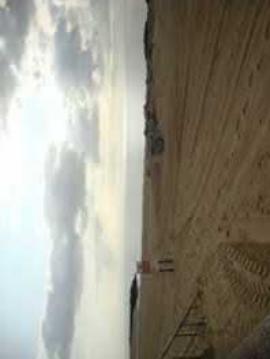
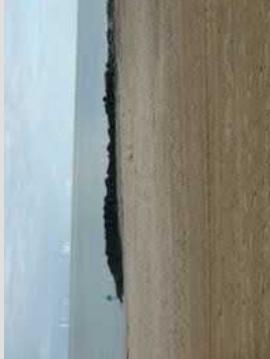
Little visual change from 2017, suggesting beach is relatively stable.
20	2018

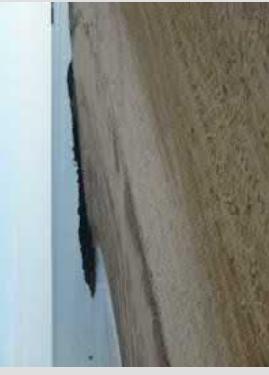
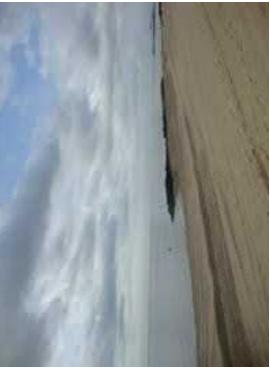
Little visual change from 2017, suggesting beach is relatively stable.
21	2018

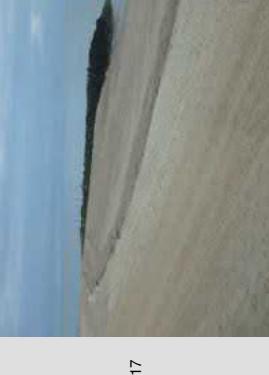
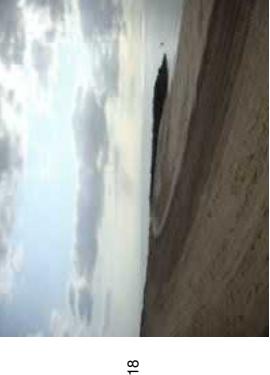
Little visual change from 2017, suggesting beach is relatively stable.
22	2018

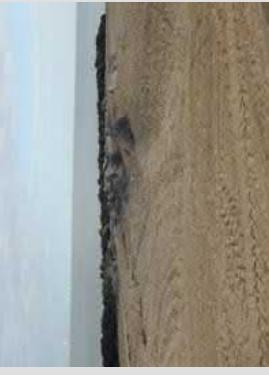
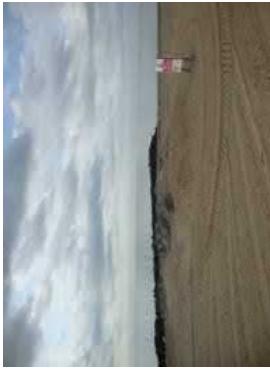
The end of the groyne (protruding into the sea) has little sediment around it, suggesting erosion due to wave diffraction has occurred.
23	2018

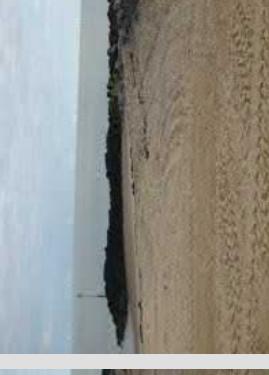
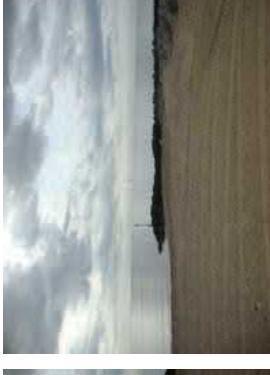
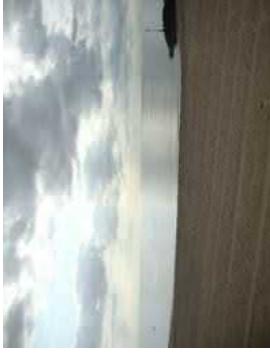
Little visual change to the beach since 2017, indicating the beach is relatively stable. Furthermore, the end of the rock groyne still has little sediment around it, suggesting a similar wave environment has persisted.
24	2017

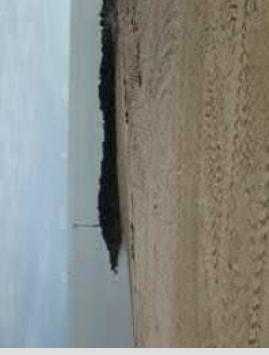
Noticeably there is more sediment around the end of the rock groyne to the north than the one in the south. This suggest the coastline has experienced longshore drift in a northwards direction here.
24	2018

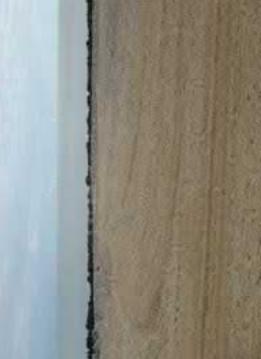
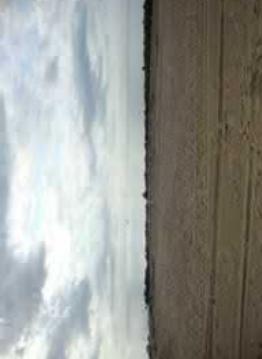
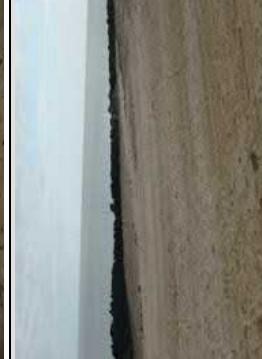
The end of the groyne (protruding into the sea) has little sediment around it, suggesting erosion due to wave diffraction has occurred.
26	2017

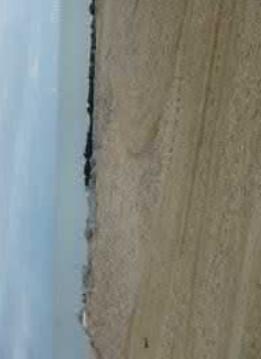
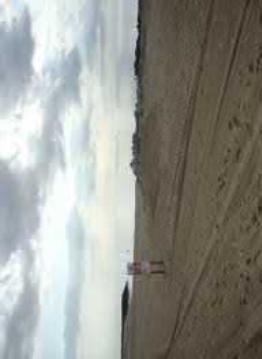
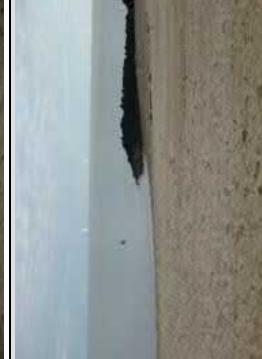
The spine of the groyne appears to have less sand cover in 2018 than in 2017, where the rocks appeared to be more exposed.
26	2018

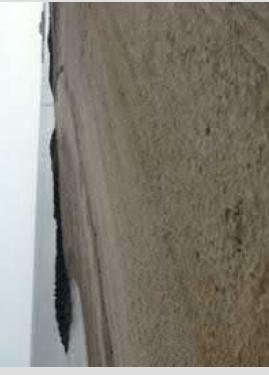
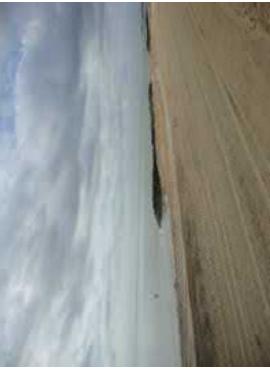
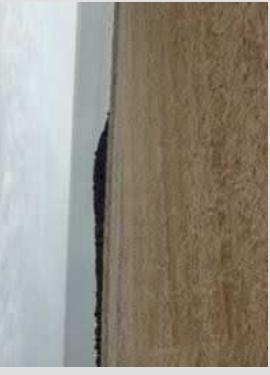
Noticeably there is more sediment around the end of the rock groyne to the north than the one in the south. This suggests the coastline has experienced longshore drift in a northwards direction here.
27	2018

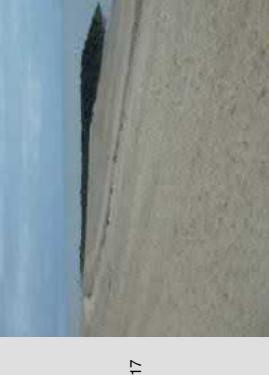
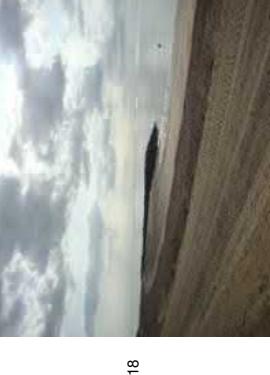
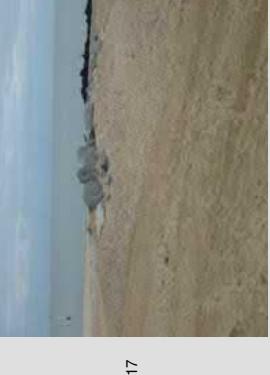
28	2018

Little visual change from 2017, suggesting beach is relatively stable.

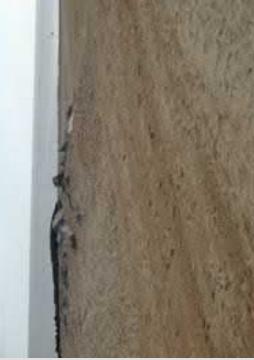
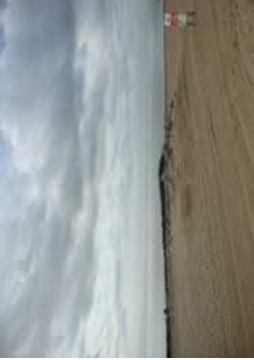
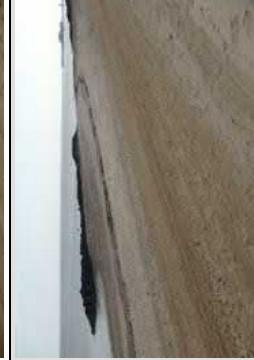
Little visual change from 2017, suggesting beach is relatively stable.
29	2018

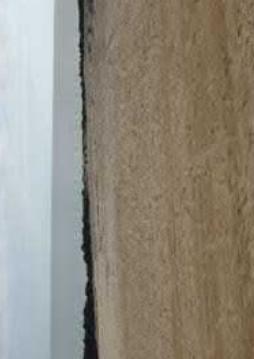
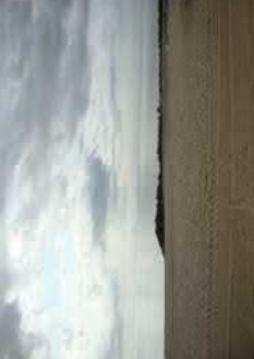
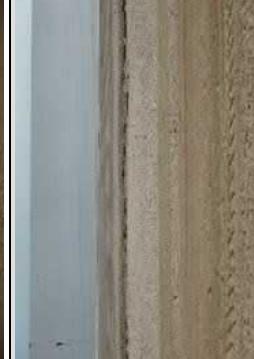
Noticeably there is more sediment around the end of the rock groyne to the north than the one in the south. This suggest the coastline has experienced longshore drift in a northwards direction here.
30	2017

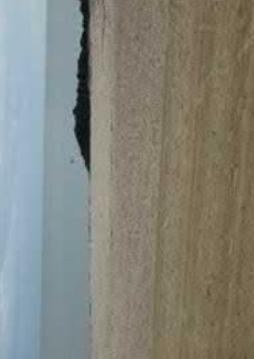
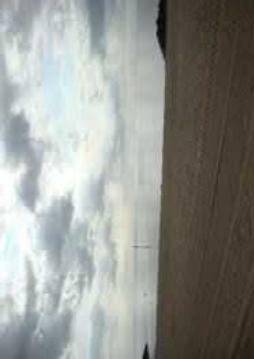
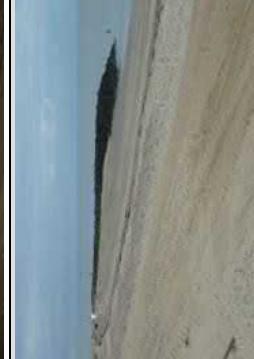
Unlike in 2017, the more southern rock groyne has more material around the arm projecting into the sea.
30	2018

In the 2018 picture, it appears as fine sediment has gathered around it, with more boulder stone like material scattered close by. This is likely to have been caused by activities on the beach or a storm event.

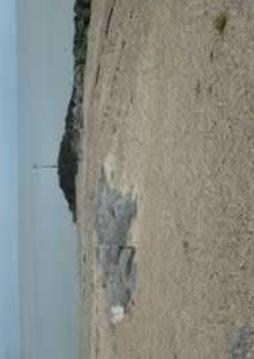
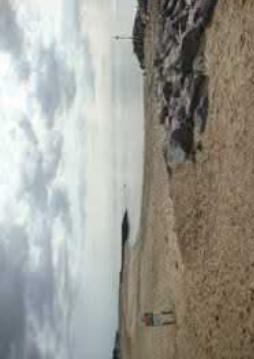
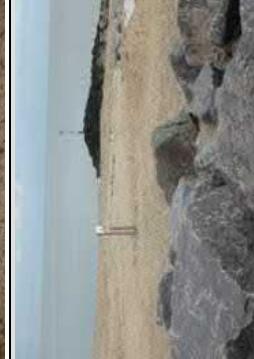
32	2018

Note, 2018 photos were taken to the north of the fishtail groyne to be in line with the rest of the photos in the survey.

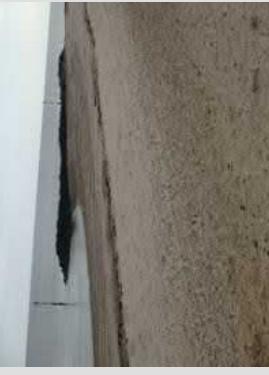
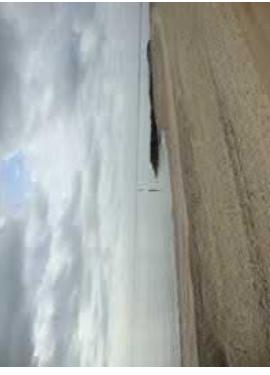
Little visual change from 2017, suggesting beach is relatively stable.
	2018

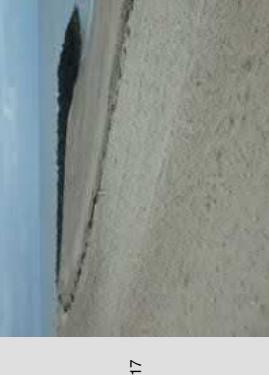
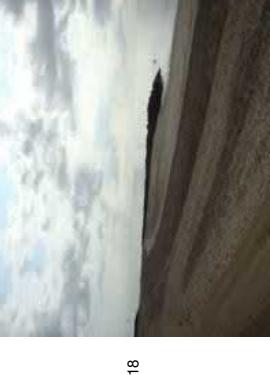
Little visual change from 2017, suggesting beach is relatively stable.
	2018

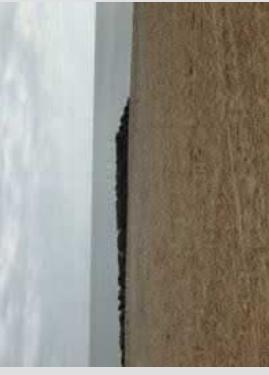
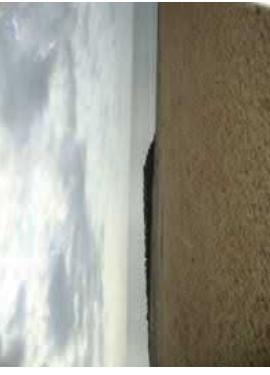
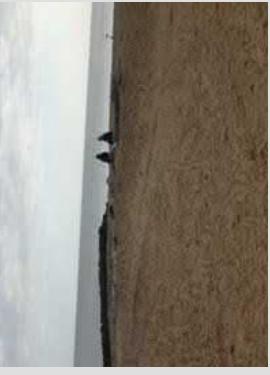
Little visual change from 2017, suggesting beach is relatively stable.
37	2018

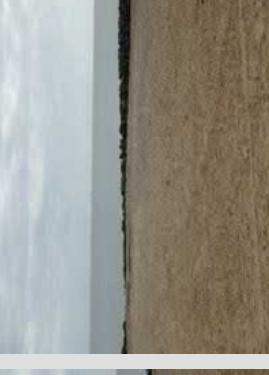
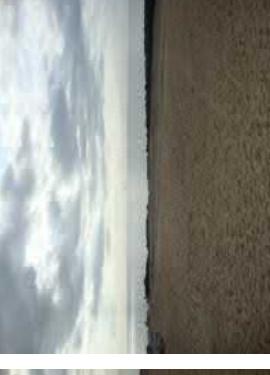
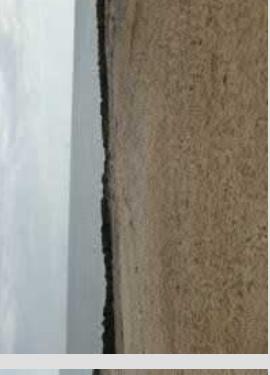
The end of the groyne (protruding into the sea) has little sediment around it, suggesting erosion due to wave diffraction has occurred.
38	2017

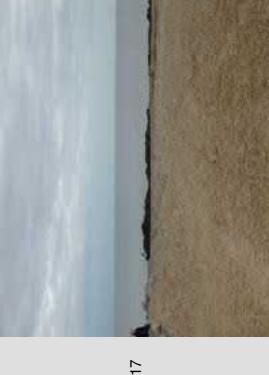
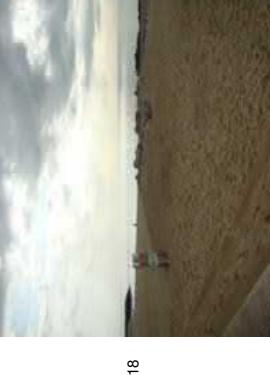
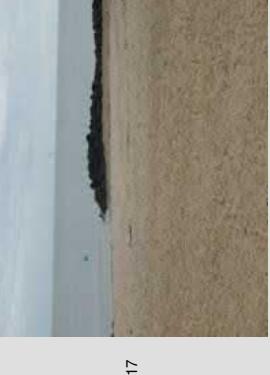
The spine of the groyne appears to have less sand cover in 2018 than in 2017, where the rocks appeared to be more exposed.
38	2018

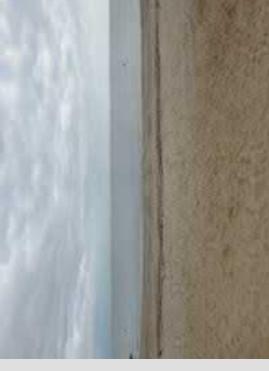
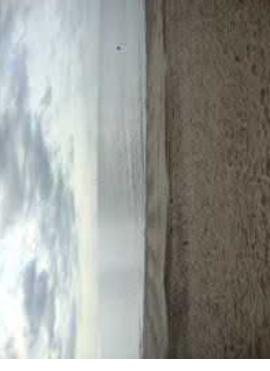
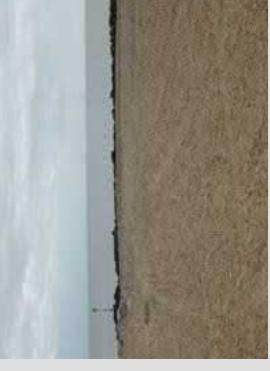
Unlike in 2017, the more southern rock groyne has more material around the arm projecting into the sea. In the 2018 picture, it appears as fine sediment has gathered around it, with more boulder/stone like material scattered close by. This is likely to have been caused by activities on the beach or a storm event.
39	2018

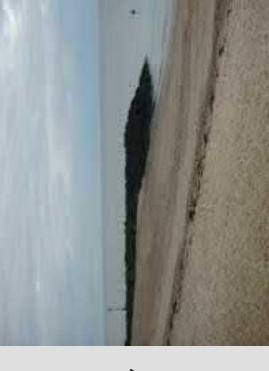
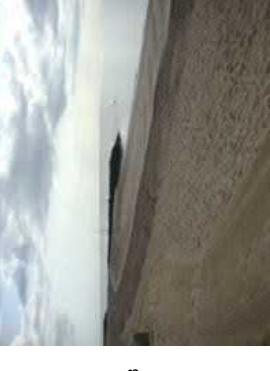
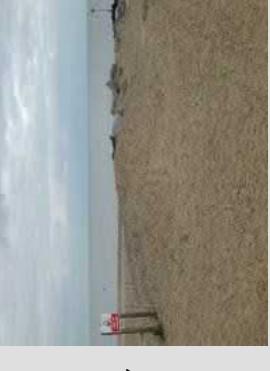
Little visual change from 2017, suggesting beach is relatively stable.
40	2017

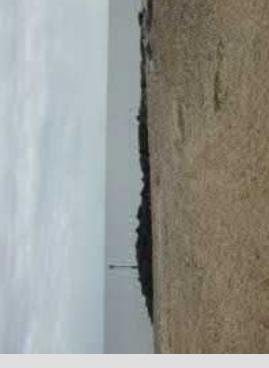
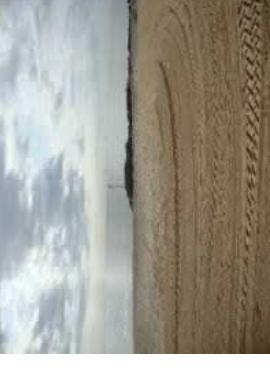
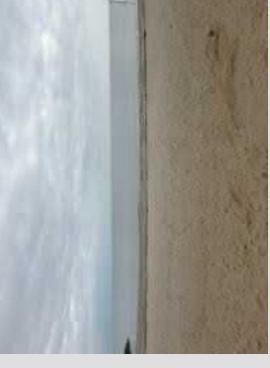
The spine of the groyne appears to have less sand cover in 2018 than in 2017, where the rocks appeared to be more exposed.
41	2018

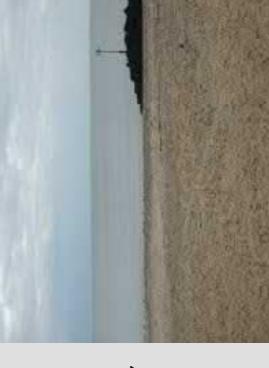
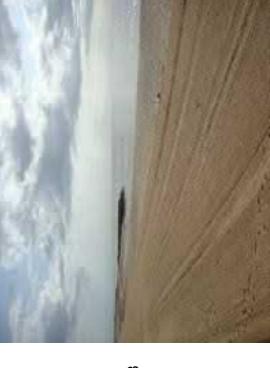
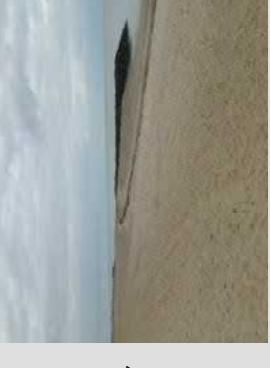
Little visual change from 2017, suggesting beach is relatively stable.
42	2017

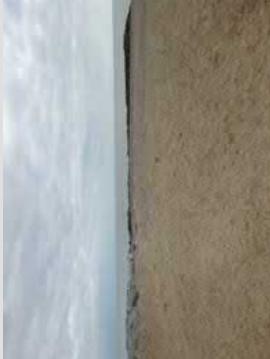
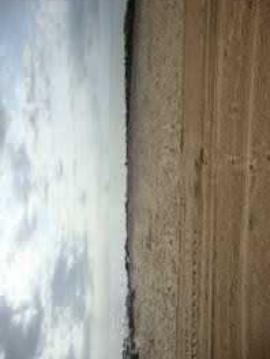
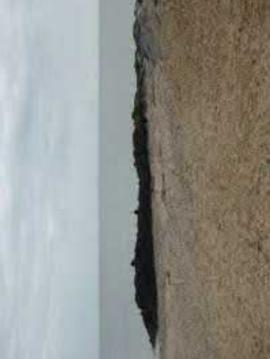
The spine of the groyne appears to have less sand cover in 2018 than in 2017, where the rocks appeared to be more exposed.
43	2018

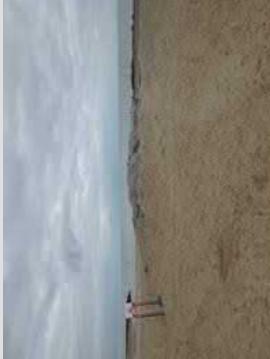
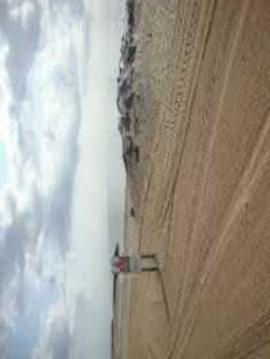
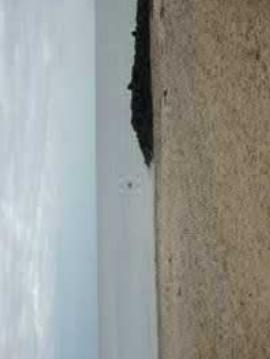
The end of the groyne (protruding into the sea) has little sediment around it, suggesting erosion due to wave diffraction has occurred.
44	2017

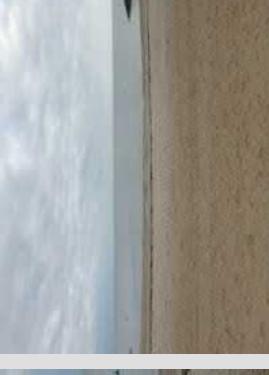
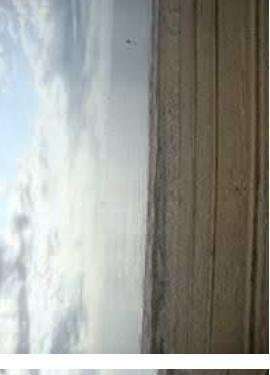
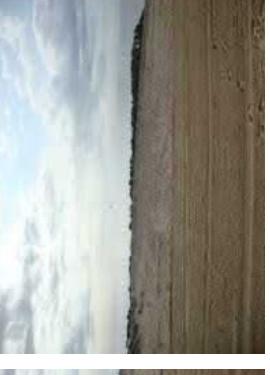
Little visual change from 2017, suggesting beach is relatively stable.
45	2018

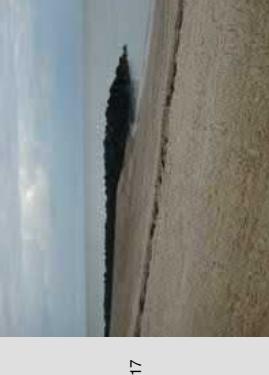
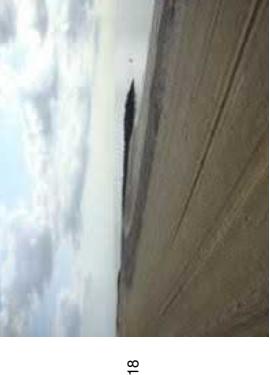
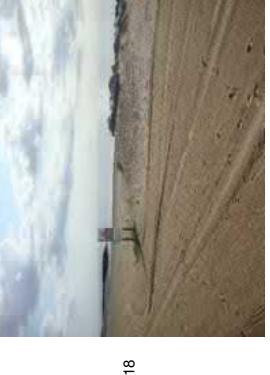
The spine of the groyne appears to have less sand cover in 2018 than in 2017, where the rocks appeared to be more exposed.
46	2017

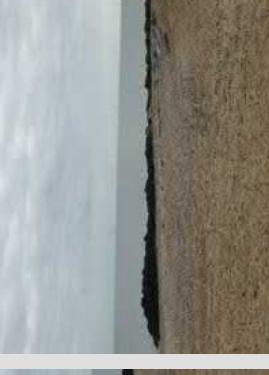
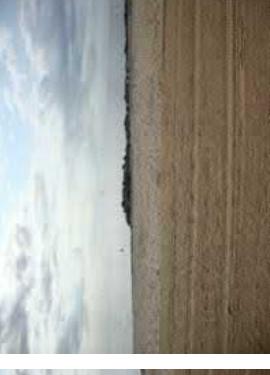
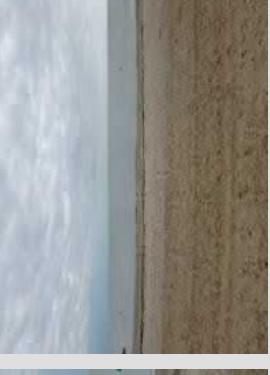
Little visual change from 2017, suggesting beach is relatively stable.
48	2017

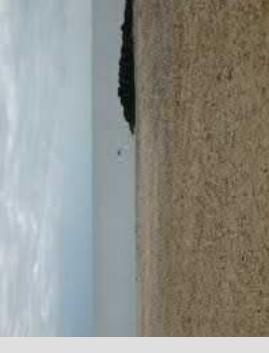
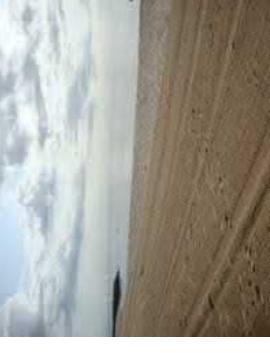
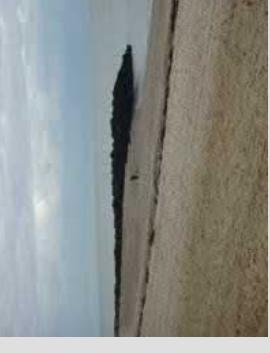
Little visual change from 2017, suggesting beach is relatively stable.
48	2018

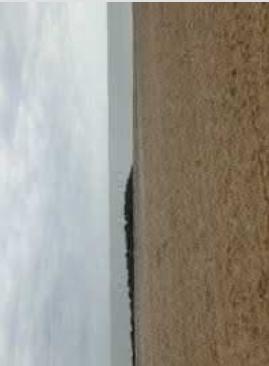
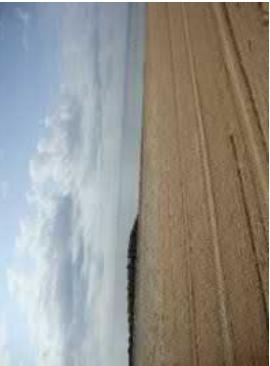
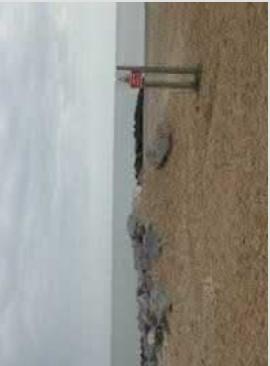
The spine of the groyne appears to have less sand cover in 2018 than in 2017, where the rocks appeared to be more exposed.
49	2018

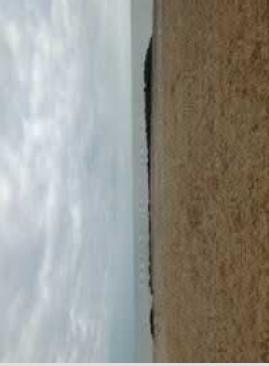
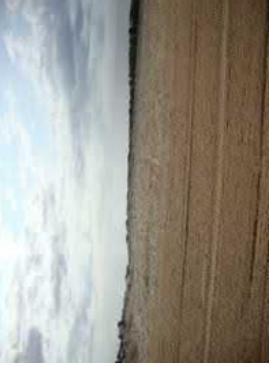
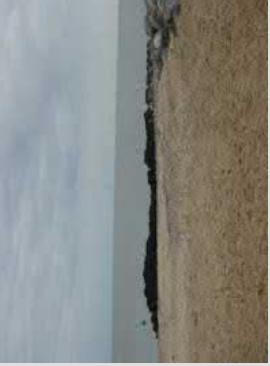
Little visual change from 2017, suggesting beach is relatively stable.
50	2017

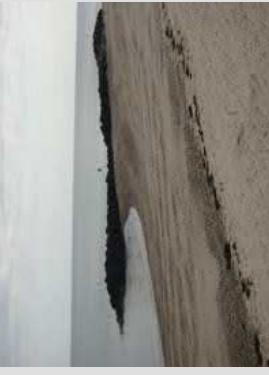
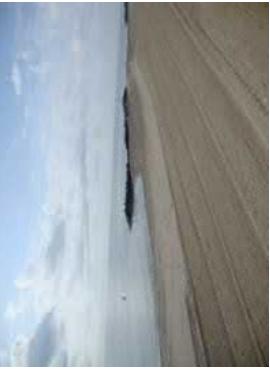
Little visual change from 2017, suggesting beach is relatively stable.

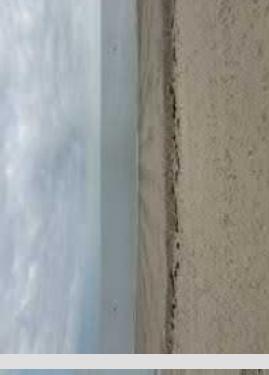
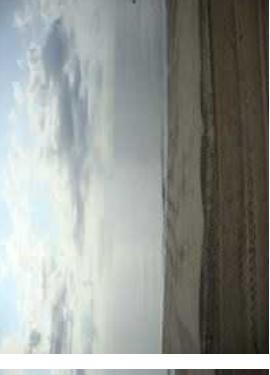
Little visual change from 2017, suggesting beach is relatively stable.
52	2017

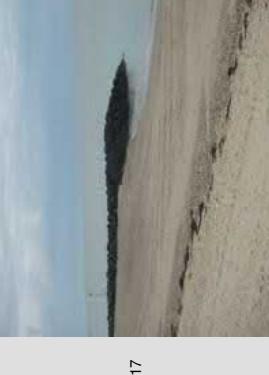
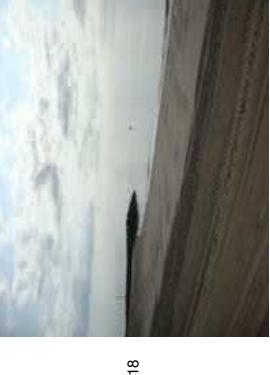
Little visual change from 2017, suggesting beach is relatively stable.

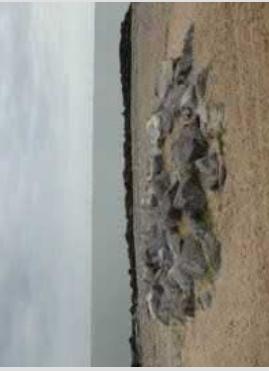
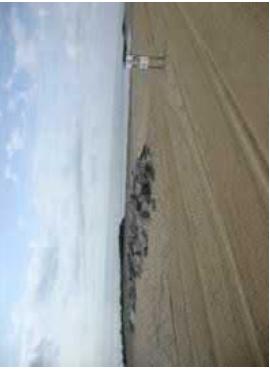
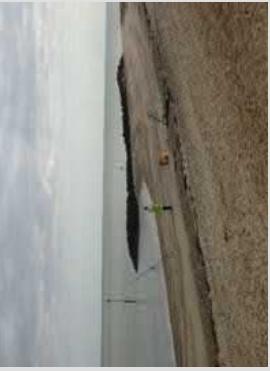
The end of the groyne (protruding into the sea) has little sediment around it, suggesting erosion due to wave diffraction has occurred.
53	2018
