Clacton and Holland-on-Sea Beach Monitoring Report

12 December 2018

Tendring District Council
Town Hall,
Station Road,
Clacton-on-Sea,
Essex,
CO15 1SE

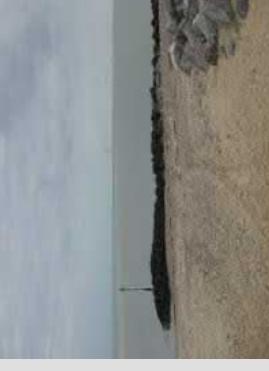
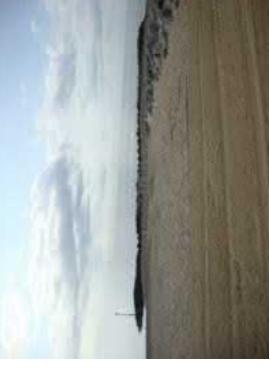
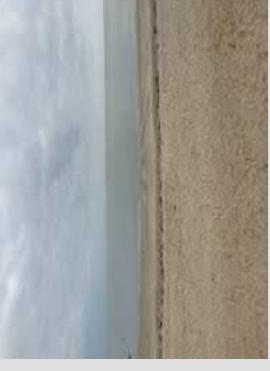
Little visual change from 2017, suggesting beach is relatively stable.
54	2017

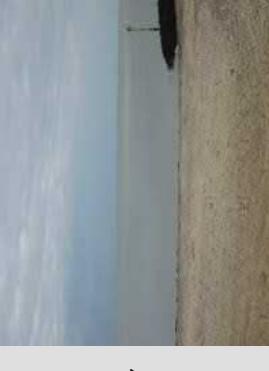
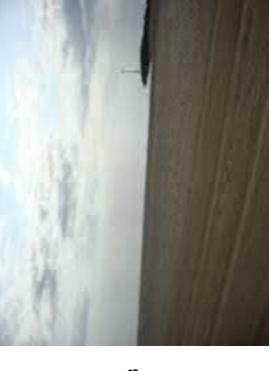
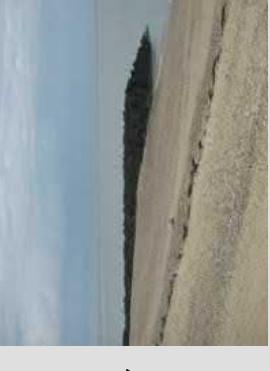
Noticeably there is more sediment around the end of the rock groyne to the north than the one in the south. This suggest the coastline has experienced longshore drift in a northwards direction here.
54	2018

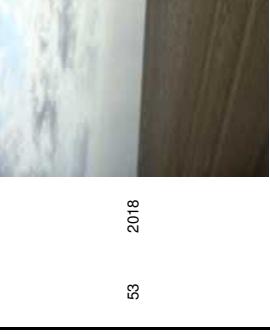
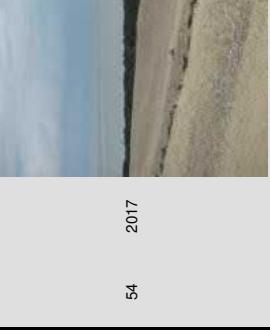
Similar to what was observed in 2017, there is more sediment around the end of the rock groyne to the north than the one in the south. This suggests the continued trend of longshore drift in a northerly direction.

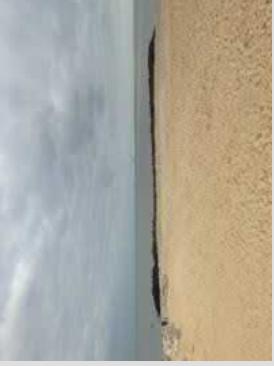
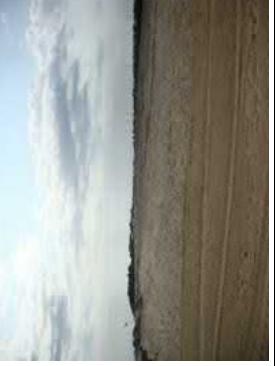
The end of the groyne (protruding into the sea) has little sediment around it, suggesting erosion due to wave diffraction has occurred.
56	2017

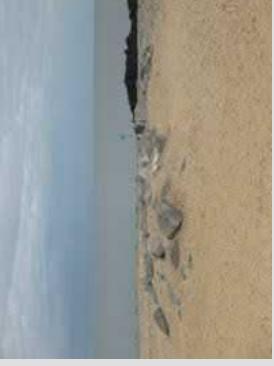
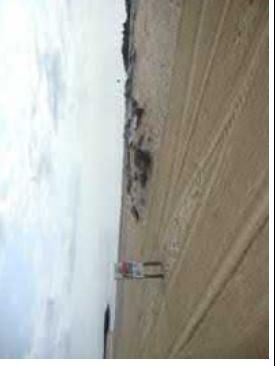
Little visual change from 2017, suggesting beach is relatively stable.
56	2018

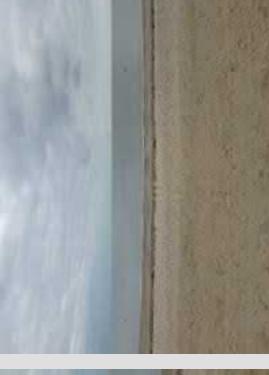
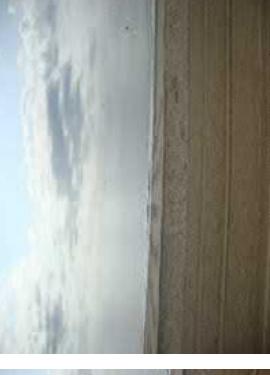
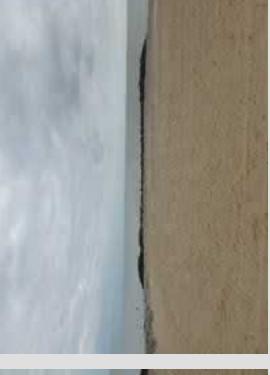
Little visual change from 2017, suggesting beach is relatively stable.
58	2017

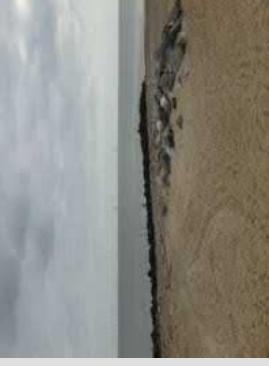
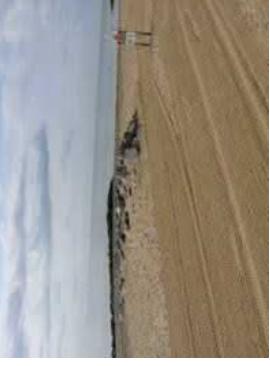
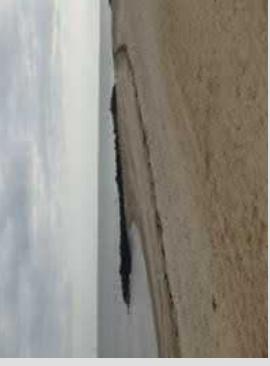
Profile	Year	45° north to promenade	Perpendicular to promenade	45° south to promenade	Description
59	2017

The end of the groyne (protruding into the sea) has little sediment around it, suggesting erosion due to wave diffraction has occurred.
59	2018

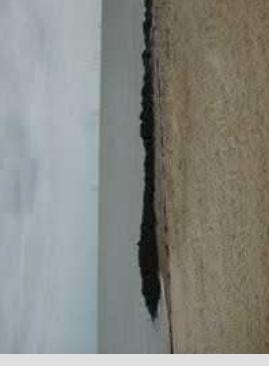
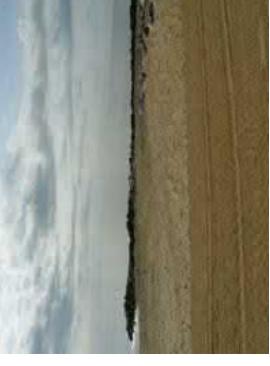
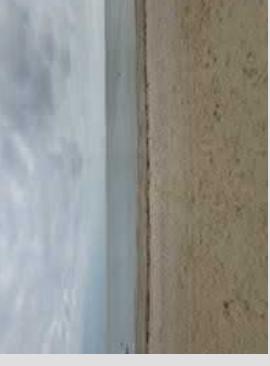
Little visual change from 2017, suggesting beach is relatively stable.
60	2017

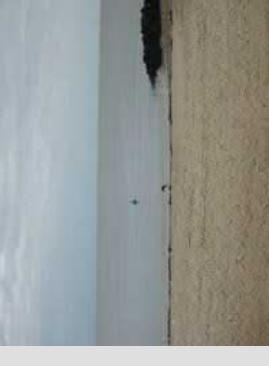
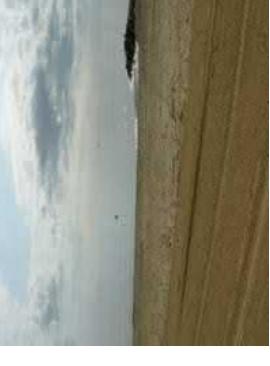
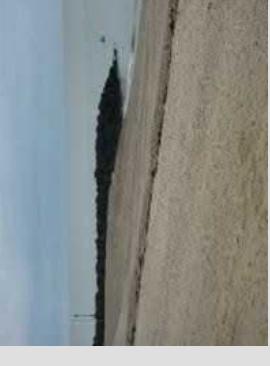
Noticeably there is more sediment around the end of the rock groyne to the north than the one in the south. This suggest the coastline has experienced longshore drift in a northwards direction here.
60	2018

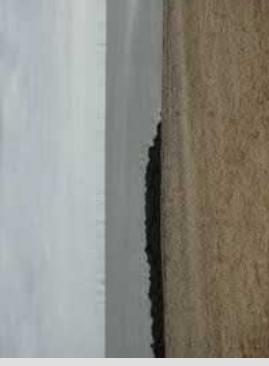
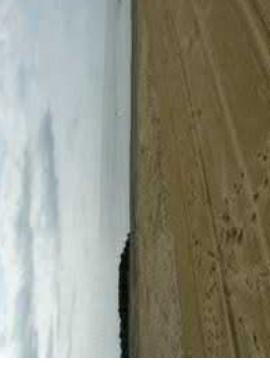
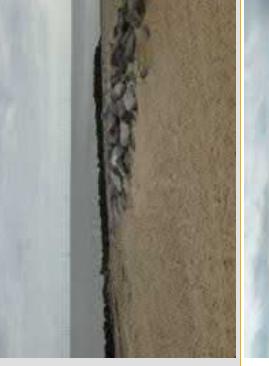
Profile	Year	45° north to promenade	Perpendicular to promenade	45° south to promenade	Description
61	2017

Little visual change from 2017, suggesting beach is relatively stable.
61	2018

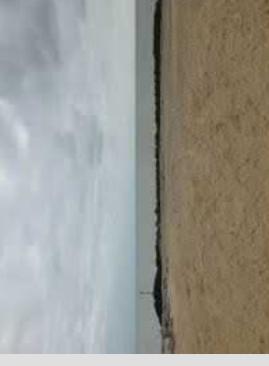
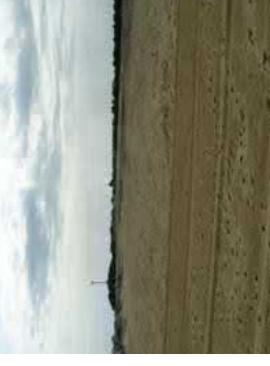
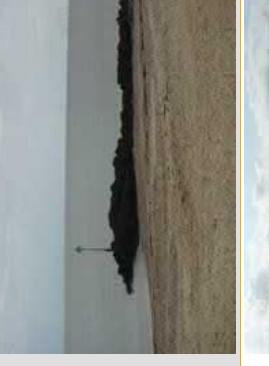
The end of the groyne (protruding into the sea) has little sediment around it, suggesting erosion due to wave diffraction has occurred.
62	2017

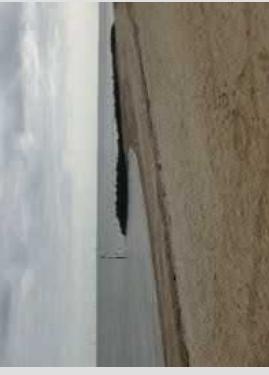
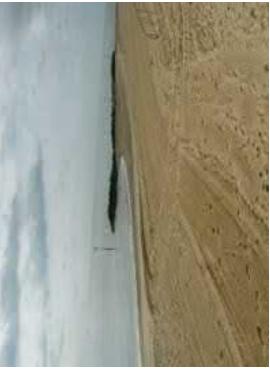
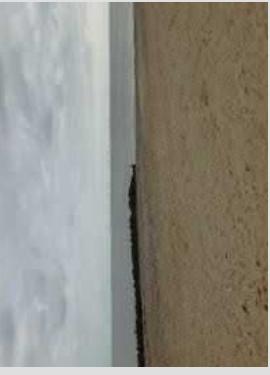
Profile	Year	45° north to promenade	Perpendicular to promenade	45° south to promenade	Description
63	2017

Noticeably there is more sediment around the end of the rock groyne to the north than the one in the south. This suggests the coastline has experienced longshore drift in a northwards direction here.
63	2018

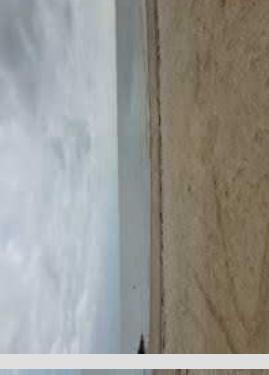
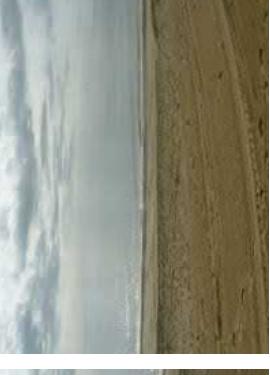
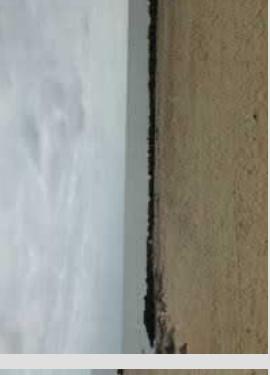
Similar to what was observed in 2017, there is more sediment around the end of the rock groyne to the north than the one in the south. This suggests the continued trend of longshore drift in a northerly direction.
64	2017

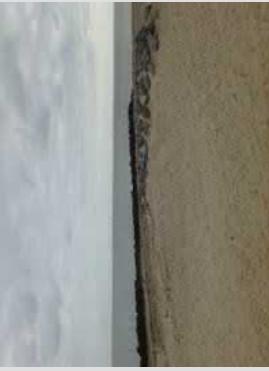
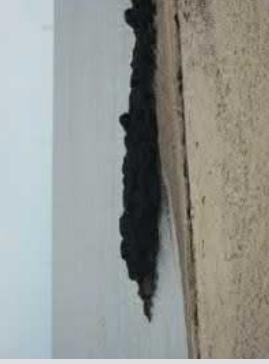
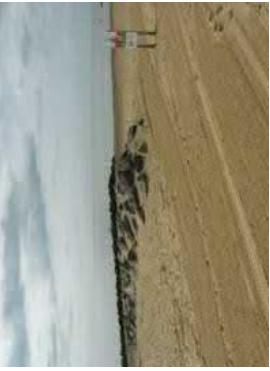
Profile	Year	45° north to promenade	Perpendicular to promenade	45° south to promenade	Description
65	2017

The end of the groyne (protruding into the sea) has little sediment around it, suggesting erosion due to wave diffraction has occurred.
65	2018

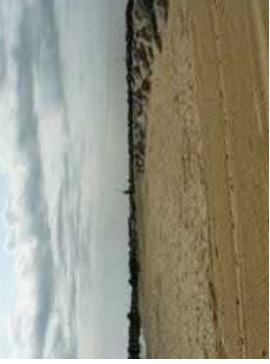
The spine of the groyne appears to have less sand cover in 2018 than in 2017, where the rocks appeared to be more exposed.
66	2017

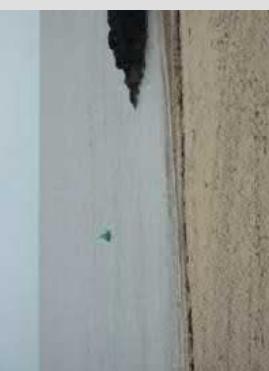
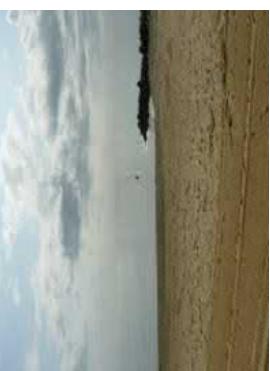
Noticeably there is more sediment around the end of the rock groyne to the north than the one in the south. This suggest the coastline has experienced longshore drift in a northwards direction here.
66	2018

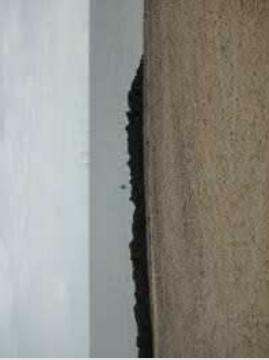
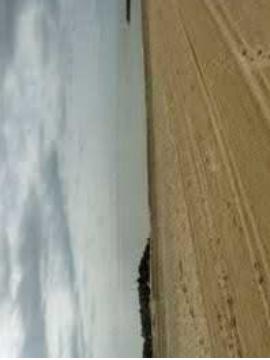
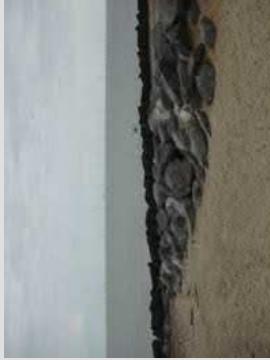
Profile	Year	45° north to promenade	Perpendicular to promenade	45° south to promenade	Description
67	2017

Little visual change from 2017, suggesting beach is relatively stable.
67	2018

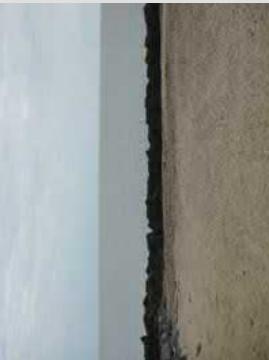
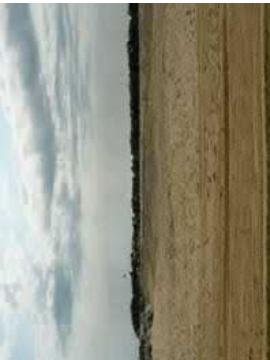
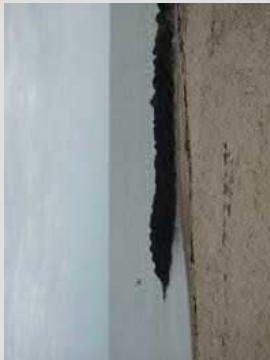
The end of the groyne (protruding into the sea) has little sediment around it, suggesting erosion due to wave diffraction has occurred.
68	2017

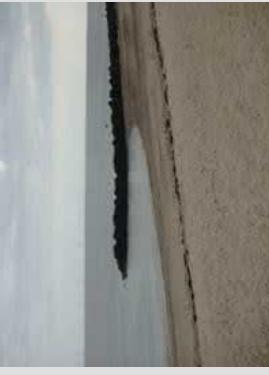
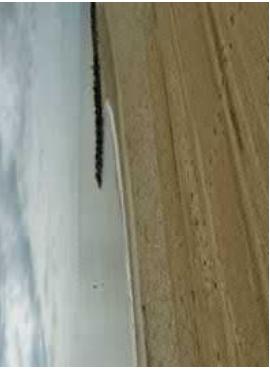
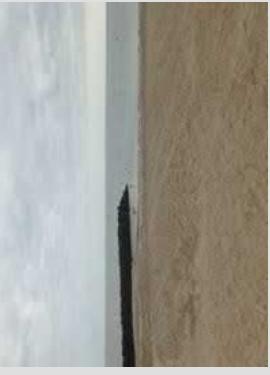
Profile	Year	45° north to promenade	Perpendicular to promenade	45° south to promenade	Description
69	2017

Unlike other bays, there is a significant amount of erosion at either end of the rock groyne. This is likely due to the slight change in orientation at this point along the frontage and the extended arm of the rock groyne affecting wave diffraction.
69	2018

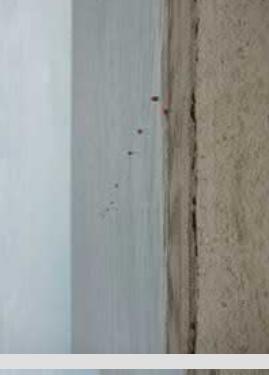
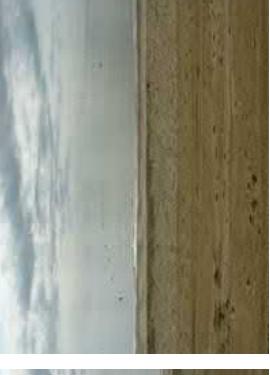
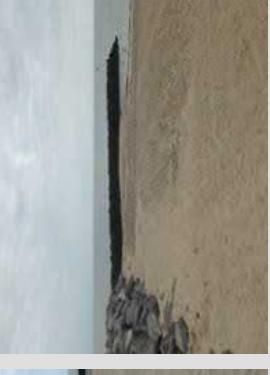
Little visual change from 2017, suggesting beach is relatively stable.
70	2017

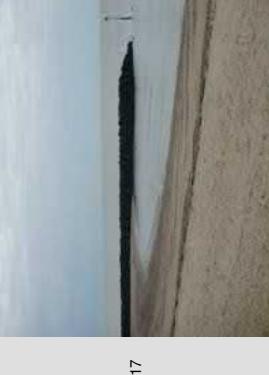
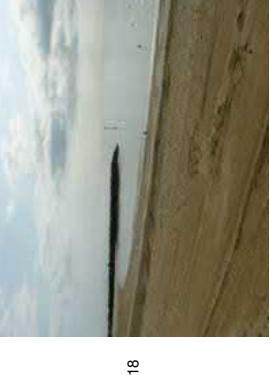
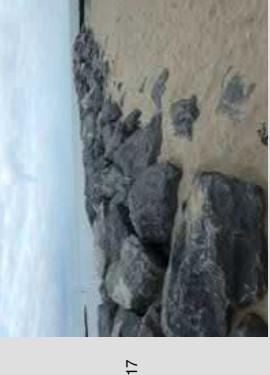
The beach is very wide with a good amount of beach material. However, unlike other profiles taken on the south side of the groyne, there is very little sediment around the end of the groyne (protruding out to sea). This is likely due to the slight change in orientation at this point along the frontage and the extended arm of the rock groyne affecting wave diffraction.
70	2018

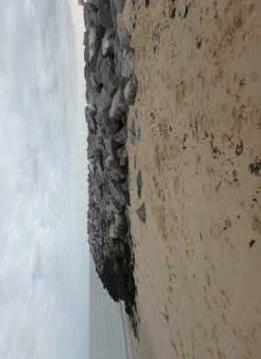
Profile	Year	45° north to promenade	Perpendicular to promenade	45° south to promenade	Description
71	2017

The beach is very wide, with the slope from the berm down to the foreshore at low tide being quite level. The beach appears to be relatively stable, though no accretion processes appear to have occurred here.
71	2018

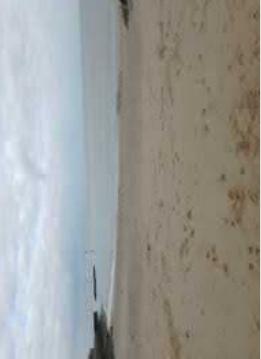
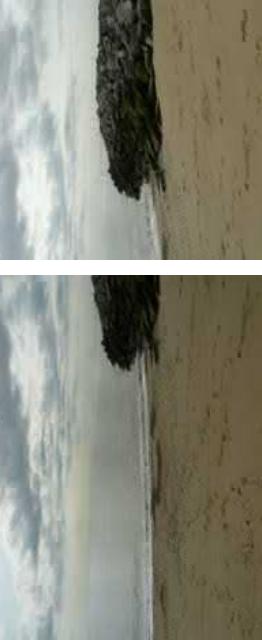
Little visual change from 2017, suggesting beach is relatively stable.
Source: Mott MacDonald, 2017
