St Osyth Conservation Area Character Appraisal and Management Plan

Client:
Tendring District Council

Date:
June 2020

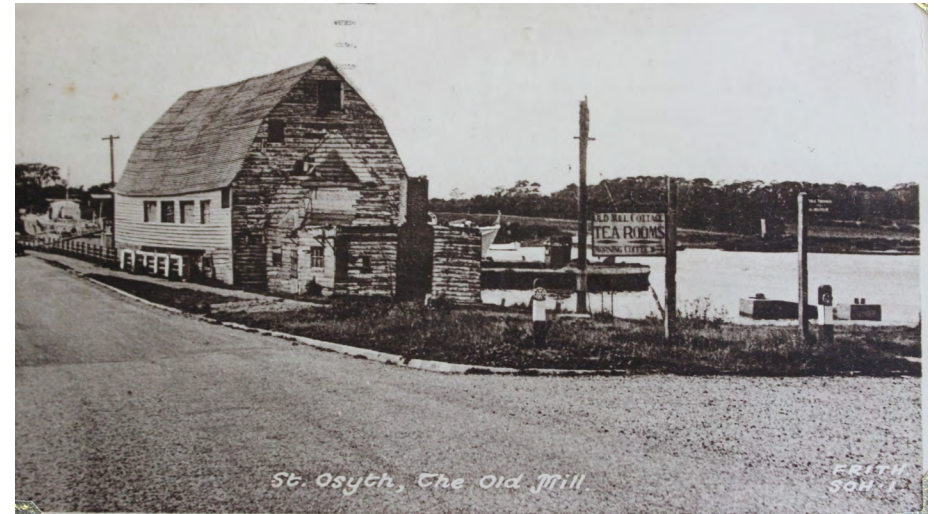
Figure 15 The Old Mill (Essex County Archives, D/DU 14647)

It is unknown when the land to the west of the Priory stopped being a densely populated section of the village, as suggested by the discovery of archaeological finds in this area, however it is thought that a large storm of 1663 may have been a factor in this. The storm may have caused the destruction of the wharf investigated by Time Team. A tidal corn-mill was constructed in 1730 on the causeway across the creek, forming a mill pond on the eastern side (Figure 15).

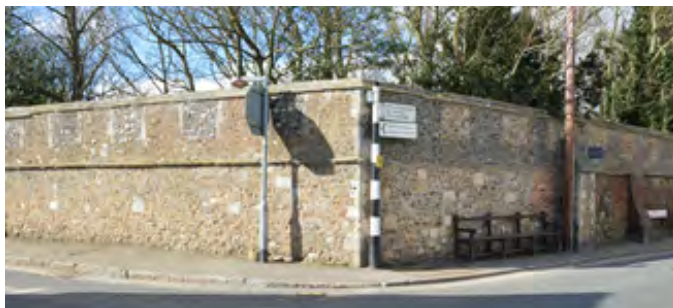
Figure 30 Stone section of wall

At the southern section of Character Area One, the Priory's boundary wall is prominent feature of the street scene. The wall is a unique feature of the village centre and has an imposing presence, due to its height and material construction. Built partially in stone and flint work, not seen elsewhere in Character Area One, the most southernly section of the wall contrasts with the building materials used on domestic properties, highlighting its importance and different function. Predominantly sixteenth century in date, the wall has been patch repaired in places and is mostly constructed in brick along Colchester Road, excluding the stone section shown in Figure 30. Changes in the wall's height, appearance and detailing suggest it has been altered and rebuilt many times since its initial construction; a long brick section of the wall was rebuilt in 2003.

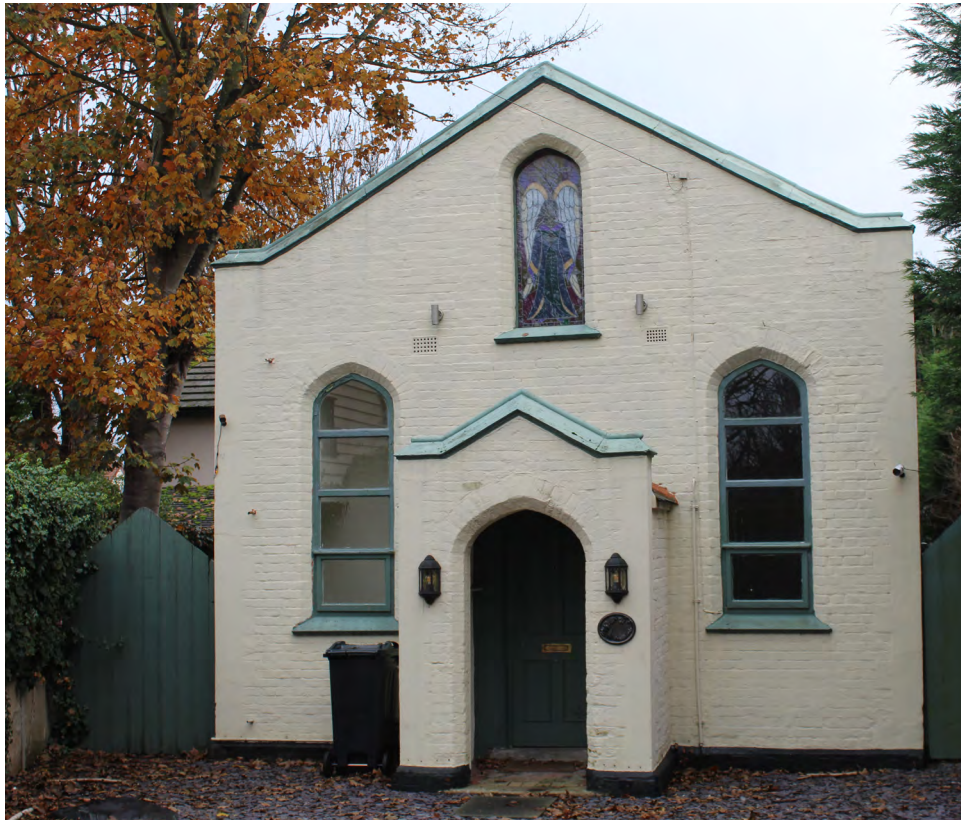
Figure 31 The Old Chapel 30 Colchester Road

Set back from the road and now in residential use, The Old Chapel, 30 Colchester Road (Figure 31), makes an interesting contribution to the street scene. The building is marked on the First Edition OS map and features a central first floor stained glass

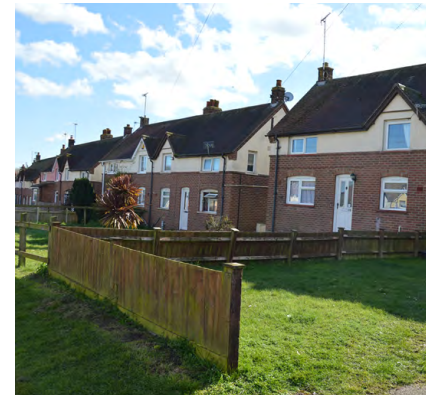
Figure 39 Twentieth century semi-detached houses

The Conservation Area boundary has been extended along Spring Road to include eleven pairs of twentieth century semi-detached houses (Figure 39). Dating from the early twentieth century, the properties are largely unaltered at the front and are good examples of inter-war housing. Although few original windows and doors survive, the retention of front gardens, hedgerow and the original appearance of the vast majority of these properties provide a uniform, orderly appearance to this section of the Character Area (Figure 41). It is hoped that their inclusion within the Conservation Area boundary will encourage a sense of value and appreciation of these buildings, which

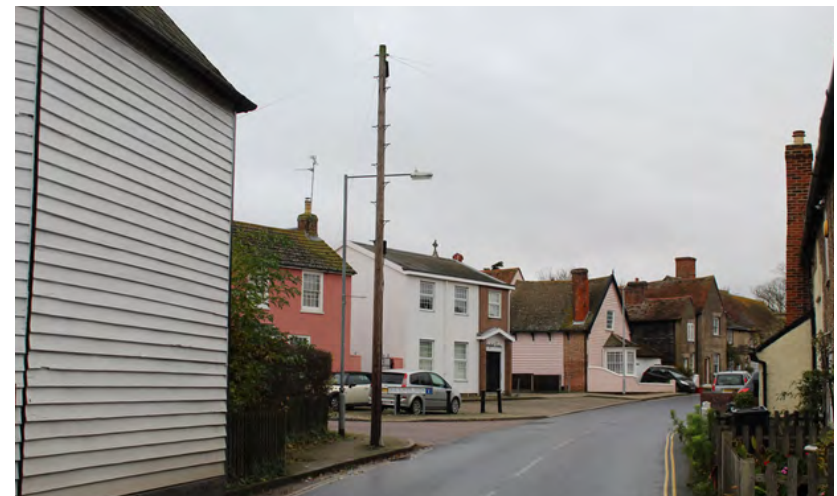
Figure 46 Render and weatherboarding

Weatherboarding is also a prominent building material within the Character Area, used on both the main façade and side return of dwellings. Often painted black on side returns or outbuildings and white on the main façade of a dwelling, the weatherboarding is typically hardwood and feather edged. Weatherboarding is found only on ancillary or smaller buildings, such as cottages, or modern infill, whilst grander historic houses and buildings are rendered.

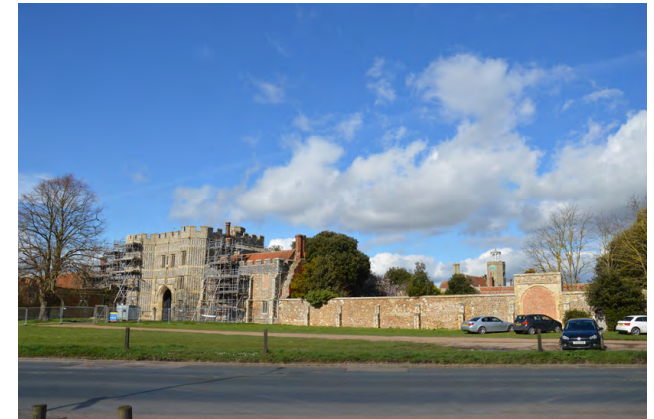
Figure 71 Flushwork of the Priory gatehouse

The outer Priory Gatehouse (as seen from the public realm) is an outstanding example of flushwork (Figure 71), a building technique where decorative sections of ashlar stonework are infilled with carefully knapped and squared sections of flint. The use of flushwork was notoriously dictated by the lack of good building stone in East Anglia, where examples of the technique is most commonly found, and its exemplary application at St Osyth means the Gatehouse is of national importance. Built in the late fifteenth century, the Gatehouse was converted to residential accommodation in 1958 when the external façade was restored and renovated. It features carvings of St Michael and the dragon on the arch spandrels of the gateway, which is vaulted internally. The gateway leads to a vast quadrangle known as the Green or South Lawn (Figure 72), which is largely enclosed by buildings or walls and has a collegiate appearance.
