Thorpe-Le-Soken Conservation Area Character Appraisal and Management Plan

Client:
Tendring District Council

Date:
March 2020

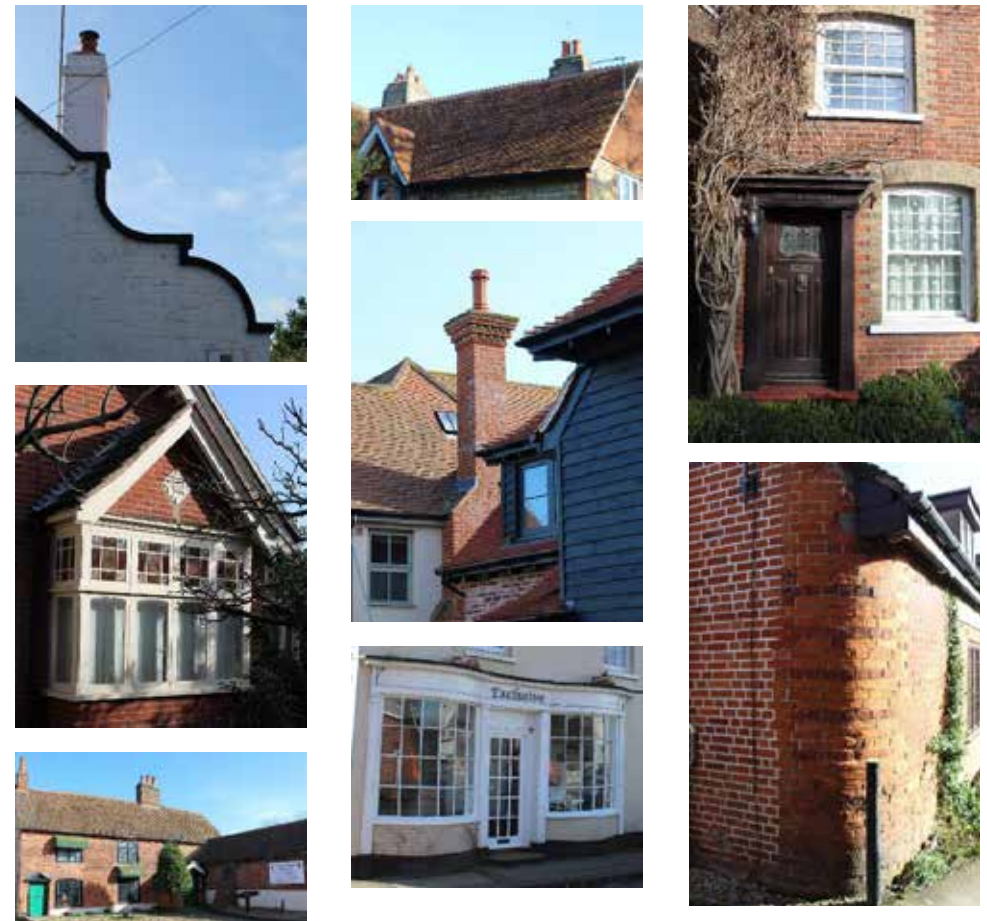
Figure 46 Building Material Palette

There is variation in the building materials used throughout this character area which reflects the historical development of the village from the fifteenth century to present day. The most commonly used building materials are red brick and red clay roof tiles are most prominent on the tower and porch of Parish Church of St Michael's are mirrored throughout the area. Painted brick is also commonly seen throughout the area which provides a variety of texture and appearance. There are several rendered houses within the village core such as The Trossachs, The Mill House and Norfolk House which break up the use of red brick and are complimentary to the High Street's appearance. Timber framed buildings are common with many concealed behind later brick facades or render. There are some examples of exposed timber framing. Le Soken Antiques is a sixteenth century timber framed and plastered building with some exposed framing and weather boarding and it also makes a positive contribution to the area.

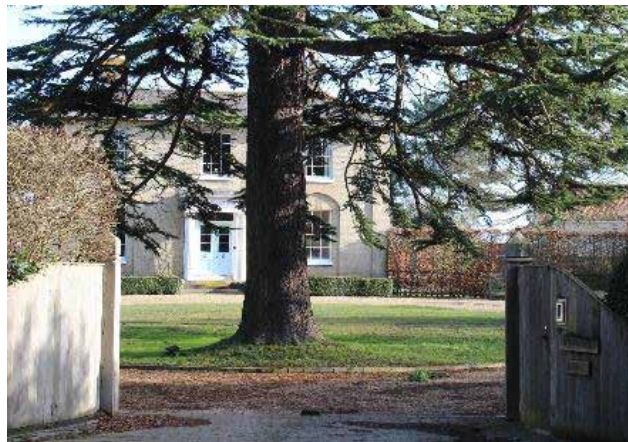
Figure 47 The Old Vicarage

The Limes shares a similar material palette to the materials used in The Old Vicarage which is a Grade II listed property in gault and red brick in Flemish bond and roofed with slate. Each are distinctively different in scale and materials to other properties in the Conservation Area. The Limes is not listed; however, it has been identified as building that makes a positive contribution to the area. It's differing use of materials makes it an attractive and interesting focal point of the High Street.

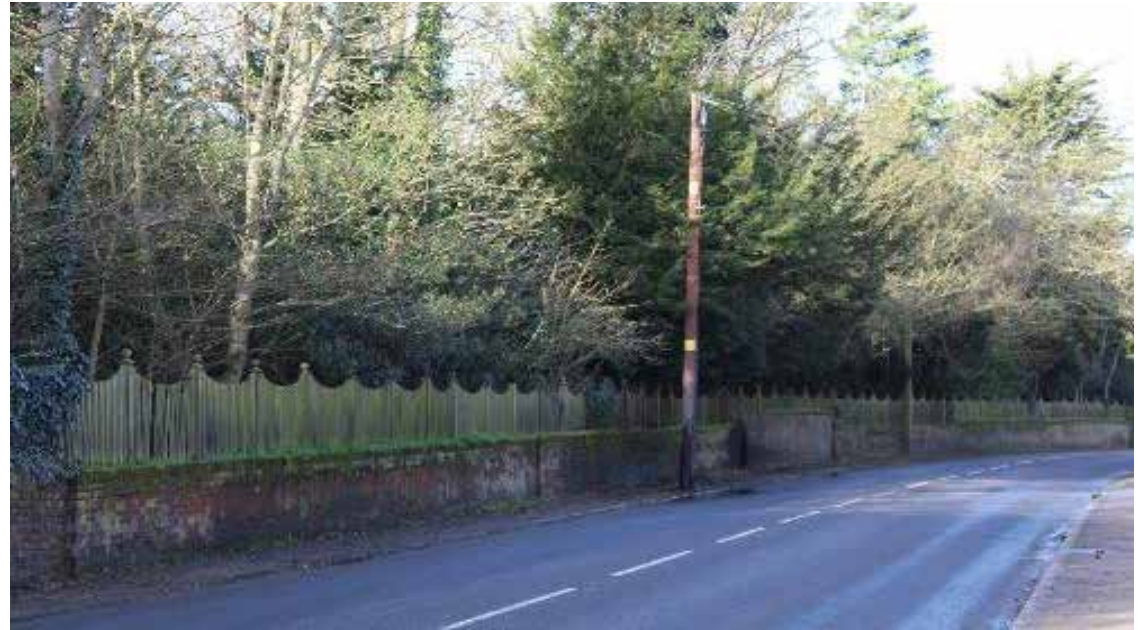
Figure 50 Fences are common in the Conservation Area's periphery, though post and panel fences do not make a beneficial contribution to the character

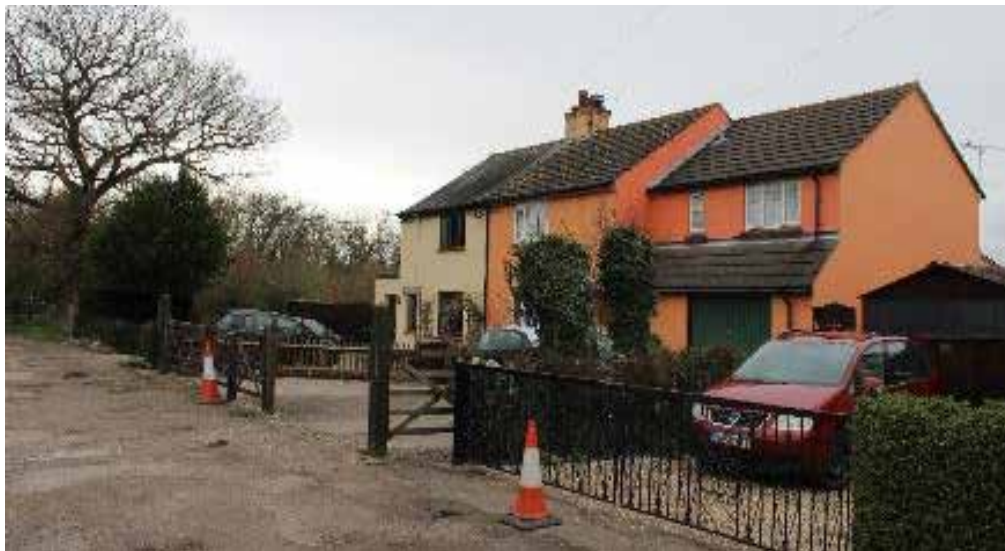
Figure 63 Examples of Boundary Treatments

Some properties along Hall Lane have introduced substantial hardstanding and inappropriate boundary treatments which detract from the rural character of the secondary smaller lanes. Bollards and lighting along pathways are not complimentary of the character to the Registered Park and Garden. Hardstanding in the immediate area of the site previously occupied by the manor, is modern and detracts from the appearance of the Park and Garden and Character Area.

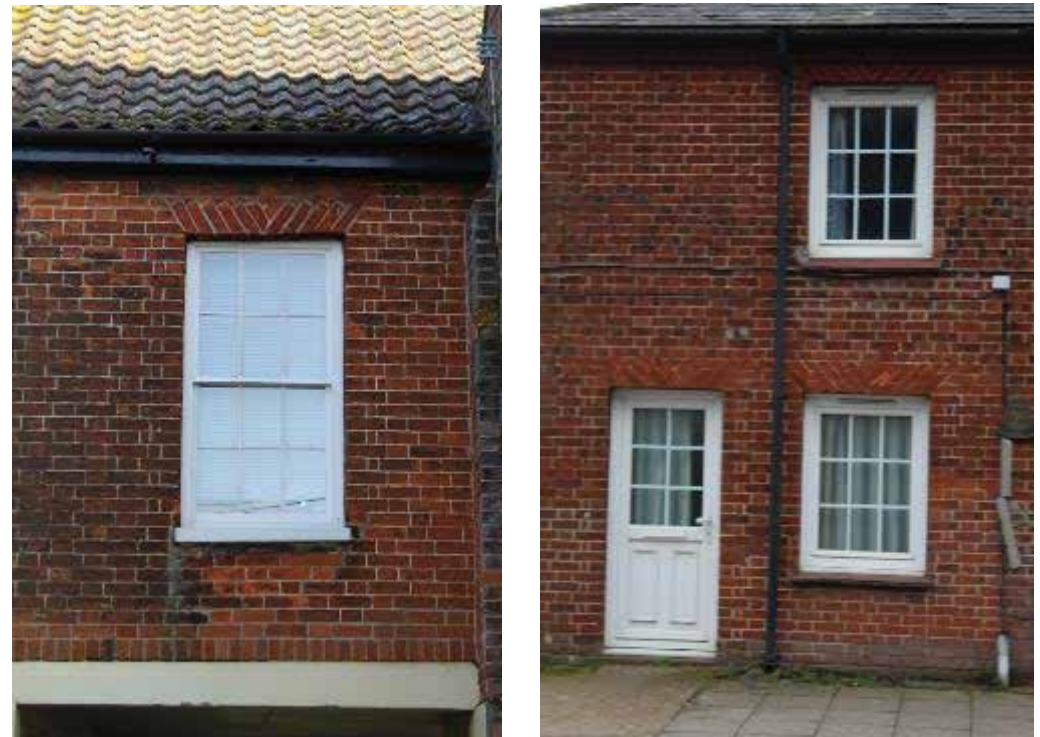
Figure 64 Examples of 'V' shaped red brick lintels

Curved bay windows are present throughout the High Street and at Charfield. These are indicative of their prior function as High Street shops, the majority have now been converted to residential use. Although weatherboarding is not a typical building material within the Conservation Area, there are several properties with weather boarding on side and rear elevations of properties.

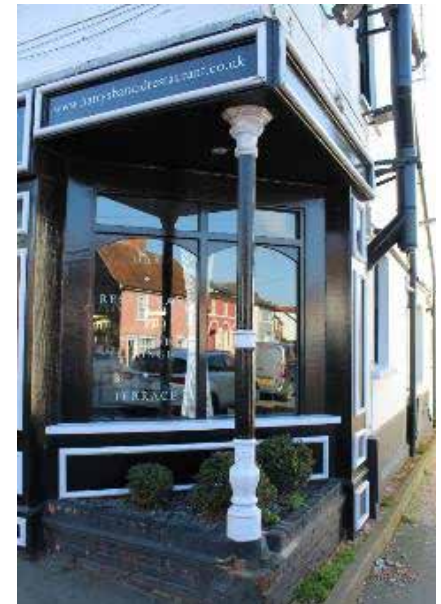
Figure 65 Built Material Palette

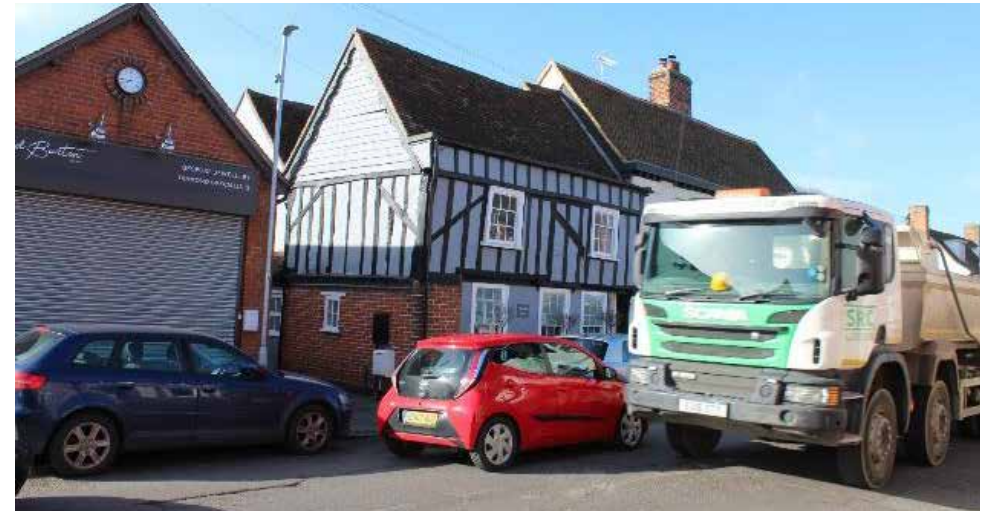
Figure 70 Parking and heavy traffic on the High Street

Along the High Street residential parking is limited to private driveways and on-street and pavement parking. The on-street parking detracts from the character and appearance of the Conservation Area. However, the addition of front driveways and removal of front gardens and boundary treatments along the High Street is inappropriate and the retention, or reinstatement, of street front boundaries should

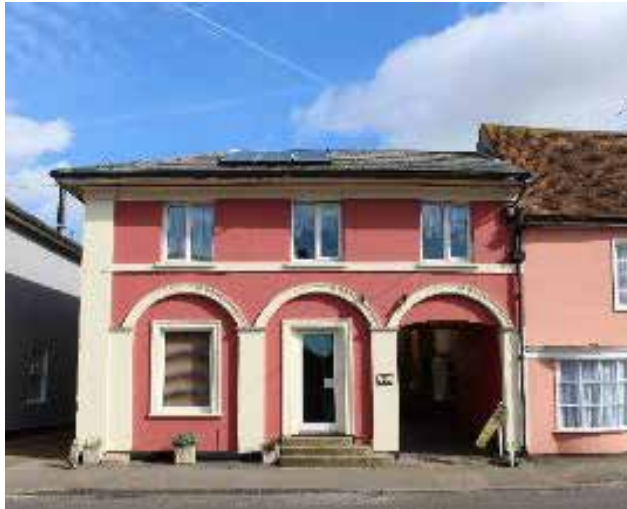
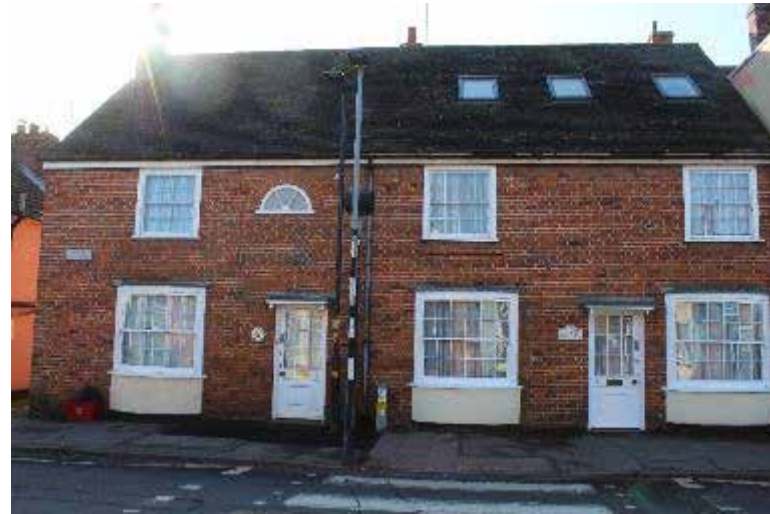
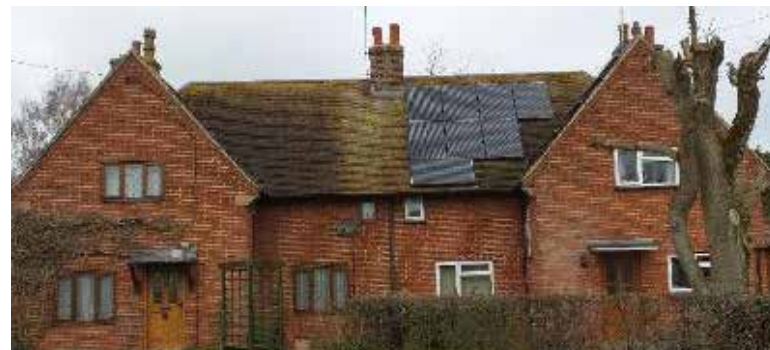
Figure 78 Examples of inappropriate Solar Panels and Rooflights

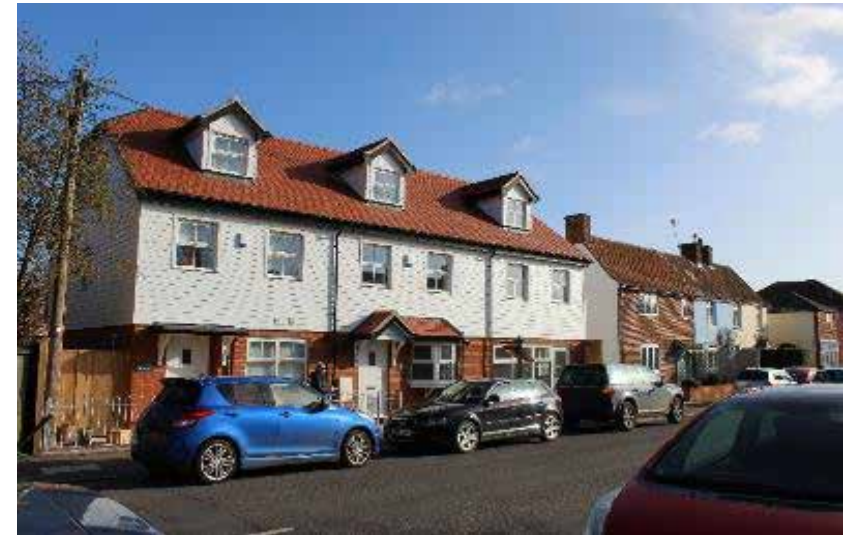
Figure 79 Modern development along the High Street

There are several cases within the Conservation Area where the plots of historic and listed buildings have been subdivided and developed with modern dwellings. Most notably at Hawthorns, a Grade II listed eighteenth century timber framed property (list entry no: 1112109). This is considered inappropriate, land plots and curtilages are a key indication of an area's development, by dividing historic plots it will dilute the special interest and have a detrimental impact on the context of the Conservation Area's development. Not only does the division of historic plots diminish the historical integrity of the property, it can also have an adverse effect on the setting of the individual heritage asset.

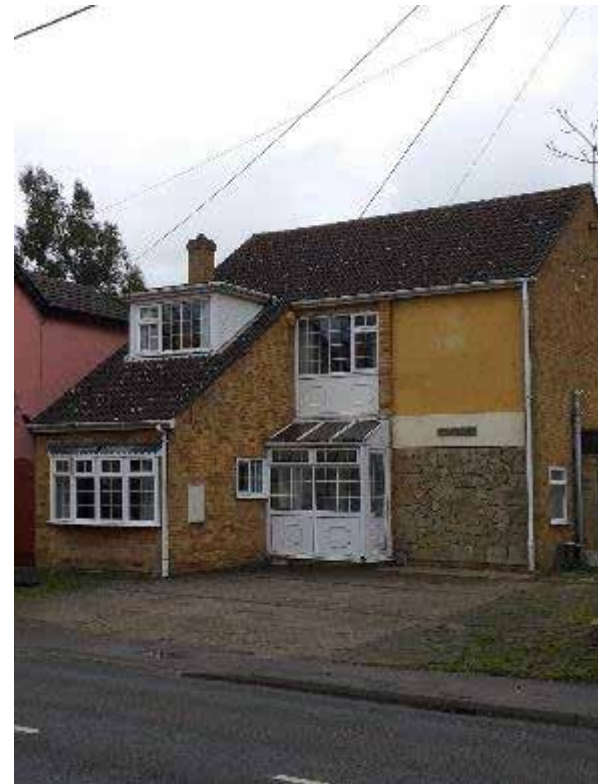
Figure 86 Modern development that does not reflect form, design or material of the Conservation Area

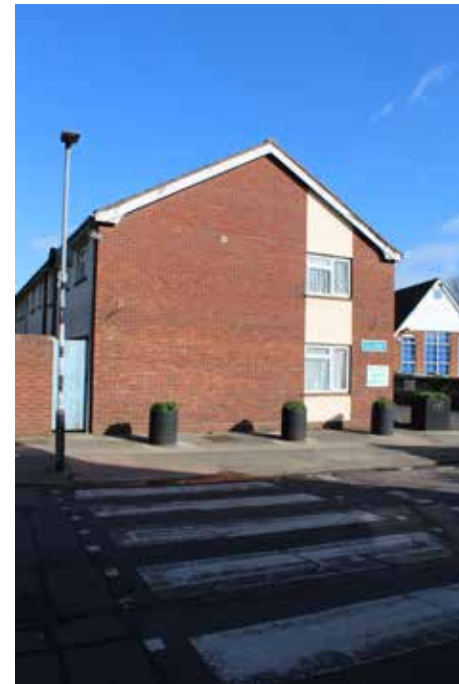
Figure 87 Unsympathetic street lighting

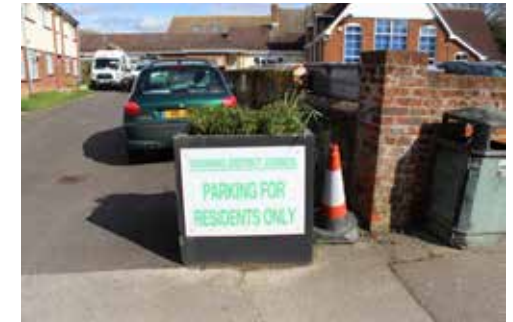
Figure 88 Signage and bin in poor condition

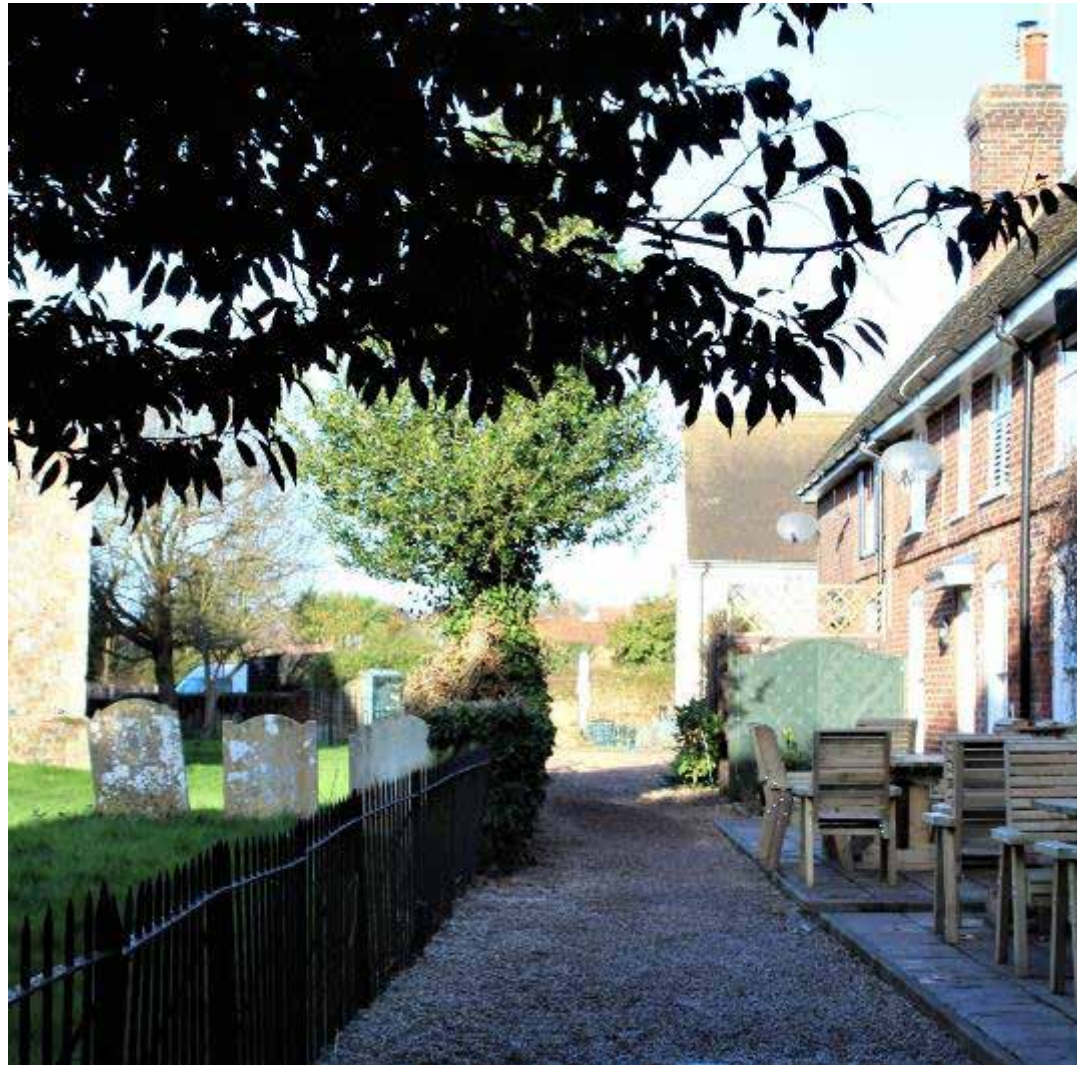
Figure 89 Sympathetic example of boundary treatment and hard landscaping alongside the churchyard
