Brightlingsea Conservation Area Character Appraisal and Management Plan

Tendring
District Council

Date:
April 2022

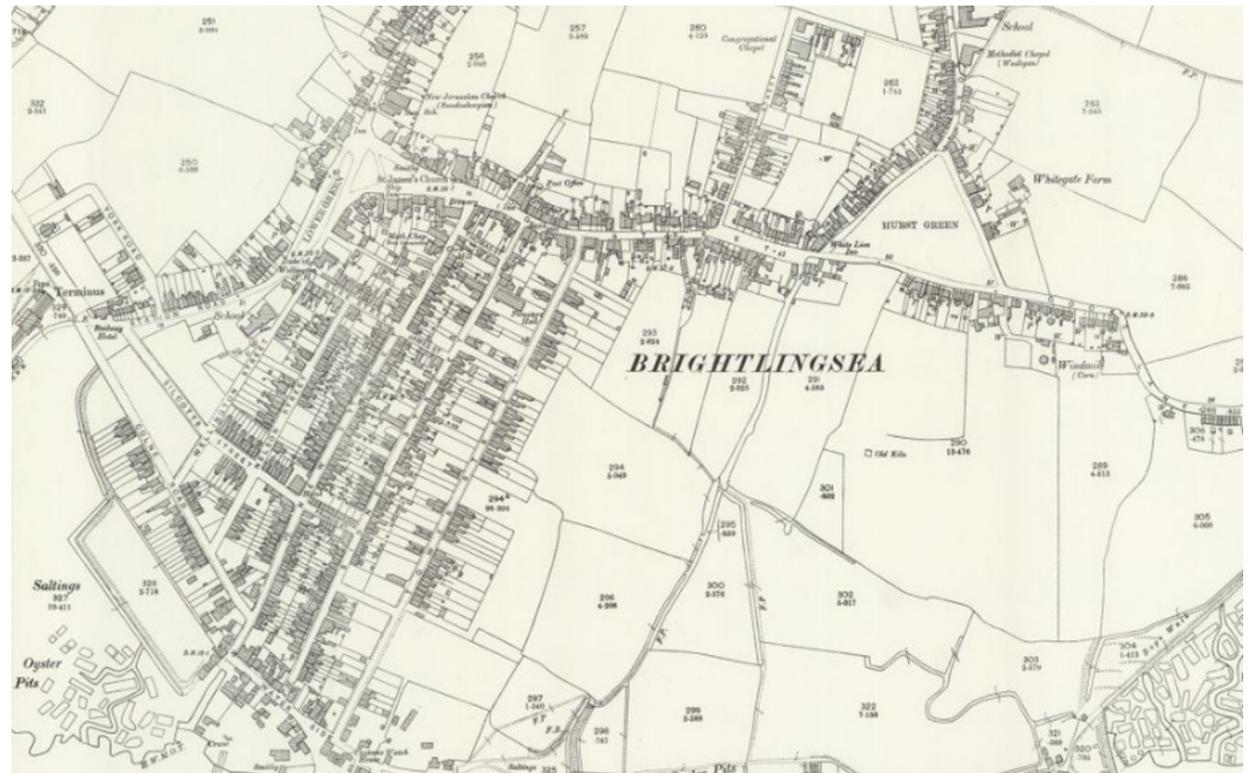
Figure 8 Ordnance Survey Map 1897

During the late nineteenth and early twentieth century, further expansion of the town took place. This expansion is demonstrated on the Ordnance Survey Map of 1897 (Figure 8), with development along Colne Road, Wellington Street, Nelson Street, Silcott Street, to the west side of New Street and along Tower Street. This rapid influx of residential terraced houses demonstrates the population growth of Brightlingsea at this time. Further terraced houses also appear on Station Road and York Road, close to the station.

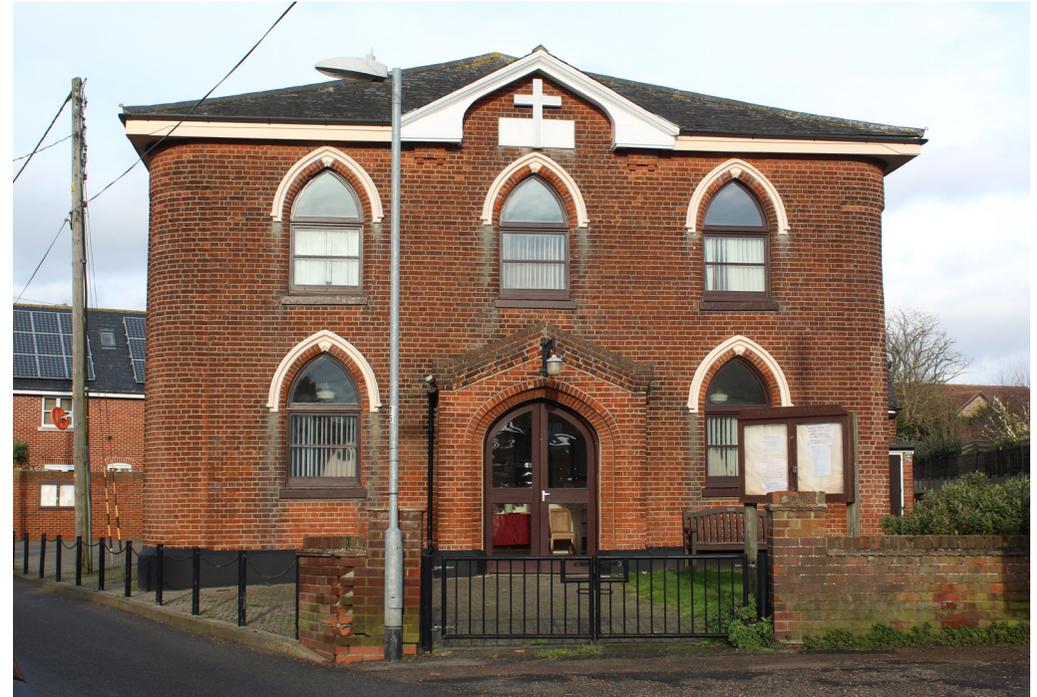
Figure 29 Detail of the United Church (Methodist U.R.C.)

The Chapel is a prominent building on Chapel Road and makes a positive contribution to the area. It is red brick with arched windows and a pedimented porch and roof. Its corners are curved, adding architectural interest to the building. The size and orientation of the building set it apart from others within the area.

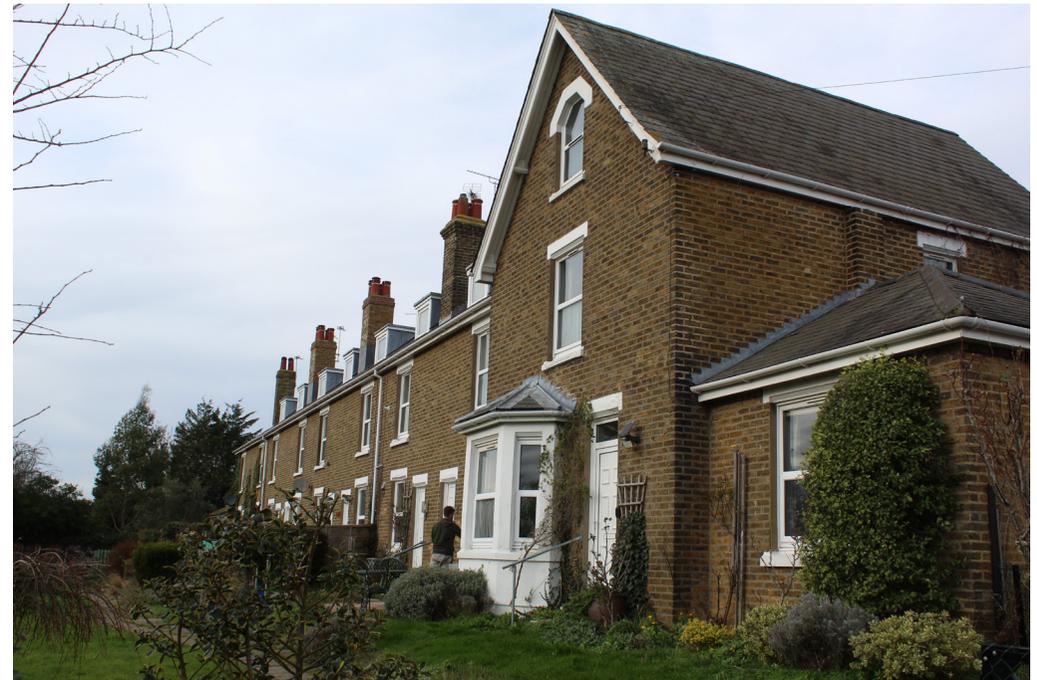
Figure 37 Florence Cottages

Florence Cottages are set back from the High Street to the south, accessed by Back Waterside Lane. The nine cottages were originally accommodation for coastguards and are now occupied by retired officers of the Salvation Army. They are attractive in yellow brick and are well-maintained with consistent roofing and dormer details (though using modern materials) and a communal garden. They overlook wide reaching views to the south, stretching to the river.

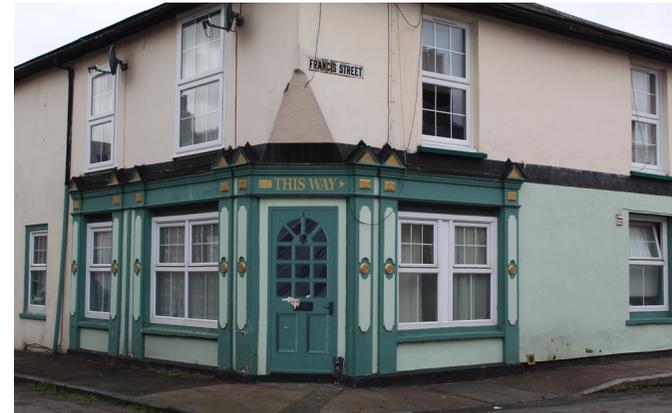
Figure 46 Historic shopfront on Sydney Street

Continuing south along the street, buildings are predominantly two-storey residential dwellings in red brick or painted render. Many have retained original architectural detailing, which add to their interest and contribute positively to the area, and there are examples of historic shopfronts on the corner with Francis Street (Figure 46). There are also

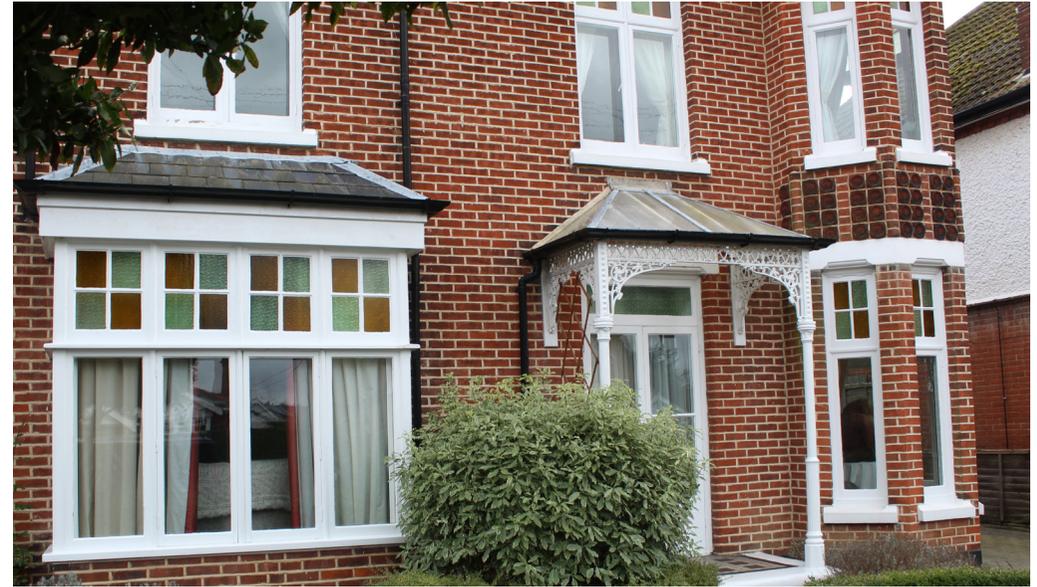
Figure 74 Number 40 Regent Road

Number 40 Regent Road is notable and makes a positive contribution to the streetscape. It has interesting original decoration, including windows with stained glass panes, a porch canopy, decorative barge boarding and other architectural elements such as the turret with pyramid roof which contributes positively to the architectural interest of the building.

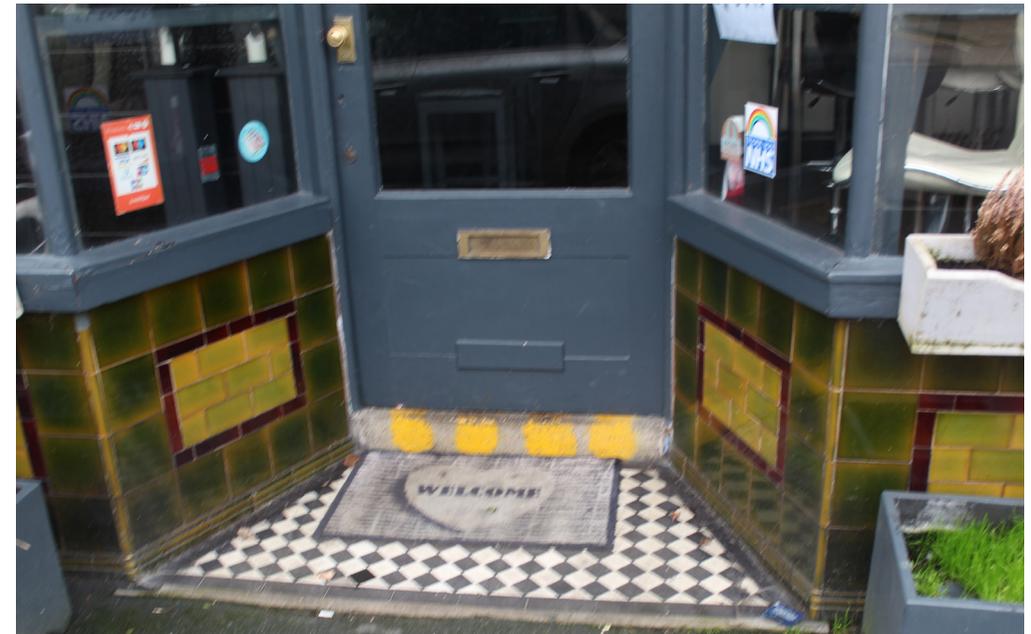
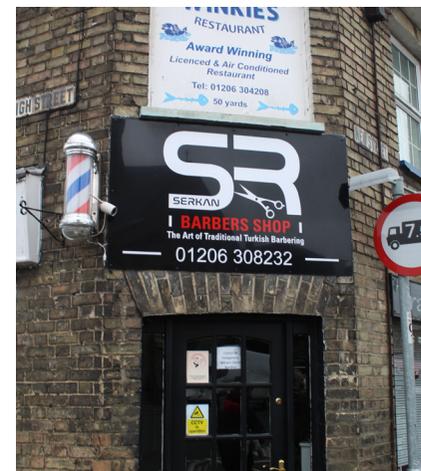
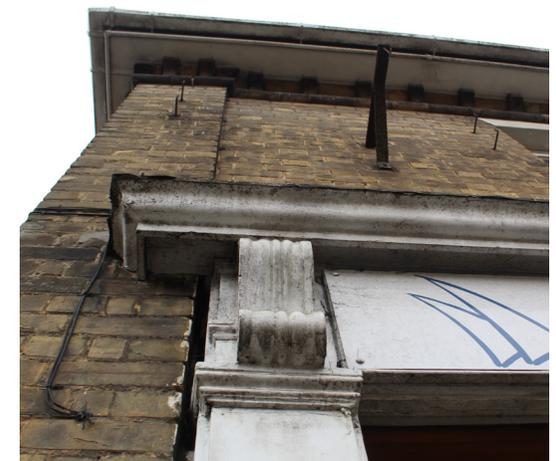
Figure 84 Clockwise from top: Porch and tile detailing, historic shopfront detail and modern signage
